# Brooks Free Library

739 Main Street  
Harwich, Massachusetts 02645

## Exterior Assessment Report

July 17, 2015

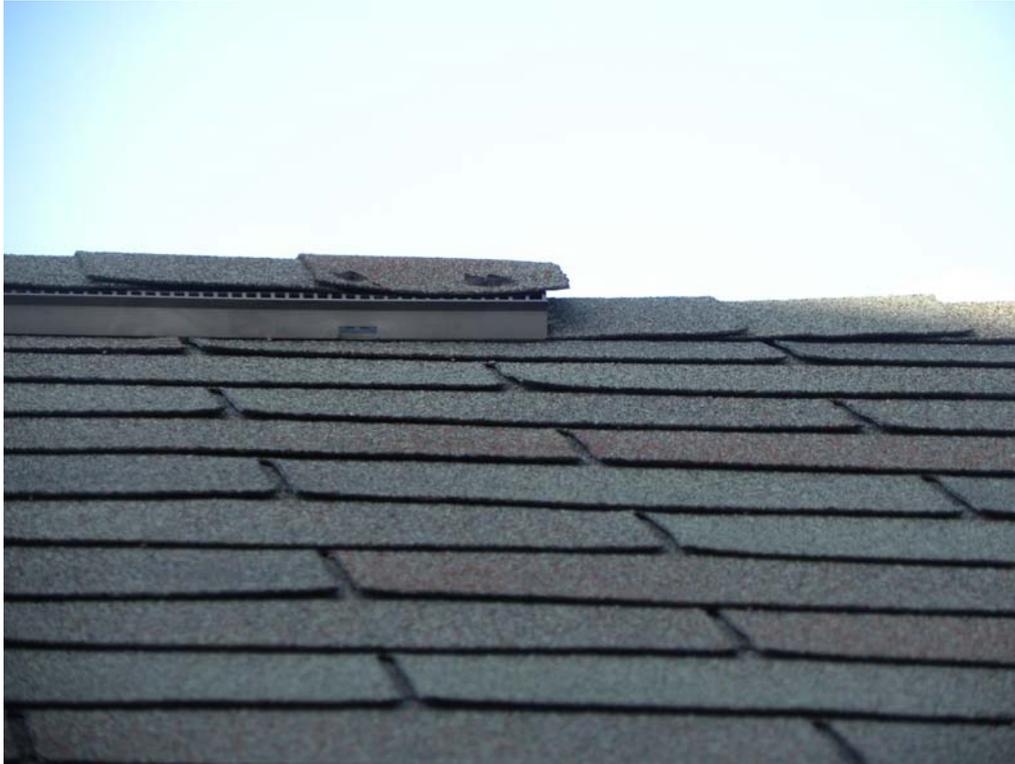
The existing roof is a fiberglass reinforced three-tab asphalt shingle roof that was installed as part of the 1998 renovation and addition to the Library. Details from the 1996 drawings indicate that the shingles were to be installed on asphalt felt, and that an underlayment membrane to aid in preventing ice dams was to be installed at the eaves. Destructive exploration was not conducted as part of this building assessment, but it is a reasonable assumption that the roof was installed per the contract documents. The roof is presently in good condition. The normal life expectancy of an asphalt shingle roof is 25-30 years, so there is still useful life remaining with the current roof. (See photo 1)

**Photo 1: Detail of existing asphalt roof.**

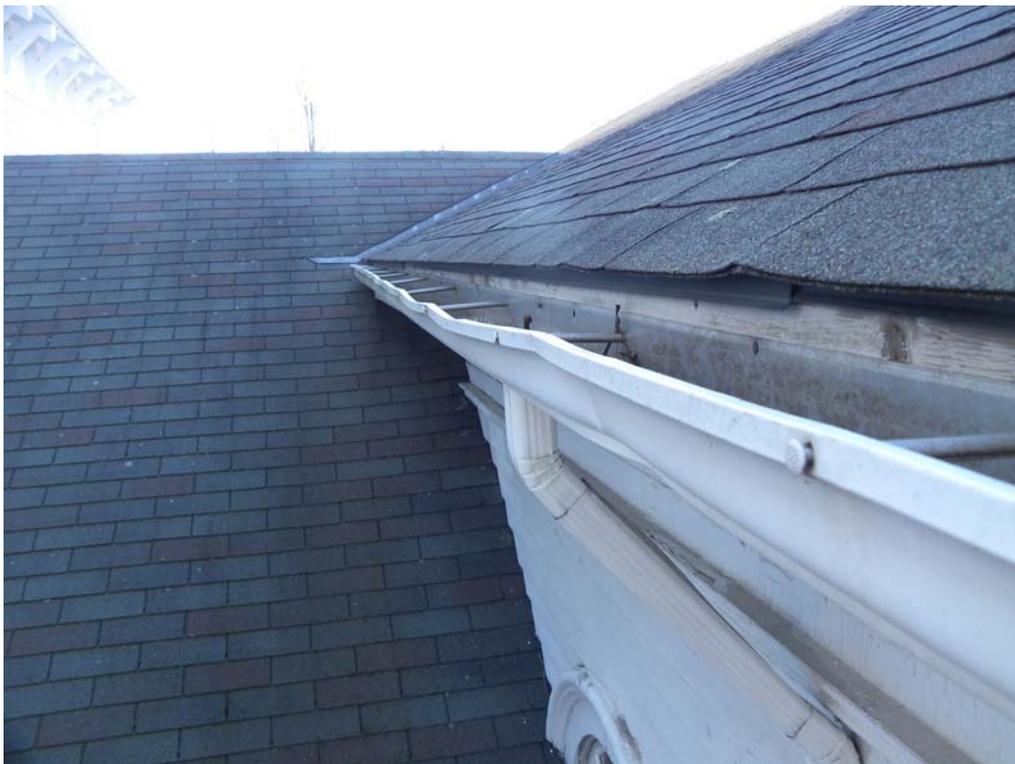
Gutters and downspouts are a residential quality aluminum with baked enamel (white) finish. The gutters are 5" Ogee-shaped, attached to building fascias via a spike-and-ferrule system. (see photo 2) The downspouts are 2" x 5" corrugated rectangle with aluminum mounting straps. Generally, these lightweight materials and fastening systems do not provide the long-term durability of other metals and systems, and we don't normally recommend them for our institutional clients. However, at the Brooks Library, the existing system is in good condition, and we see no reason for replacement at this time. There is a need for some minor repairs and adjustments, such as locations where the connection of downspout to gutter has slipped (see photo 3)

**Photo 2: Detail view of aluminum gutter with spike and ferrule attachment.**

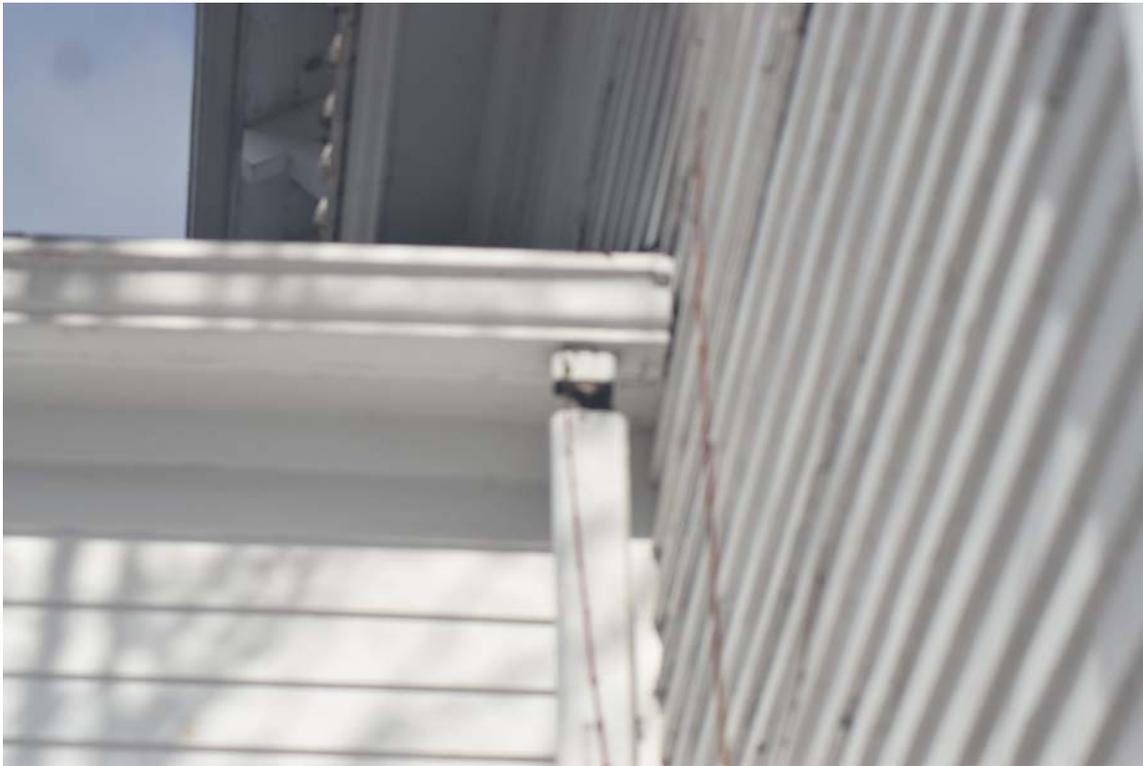
**Photo 3: Detail shows gap at slipped downspout.**

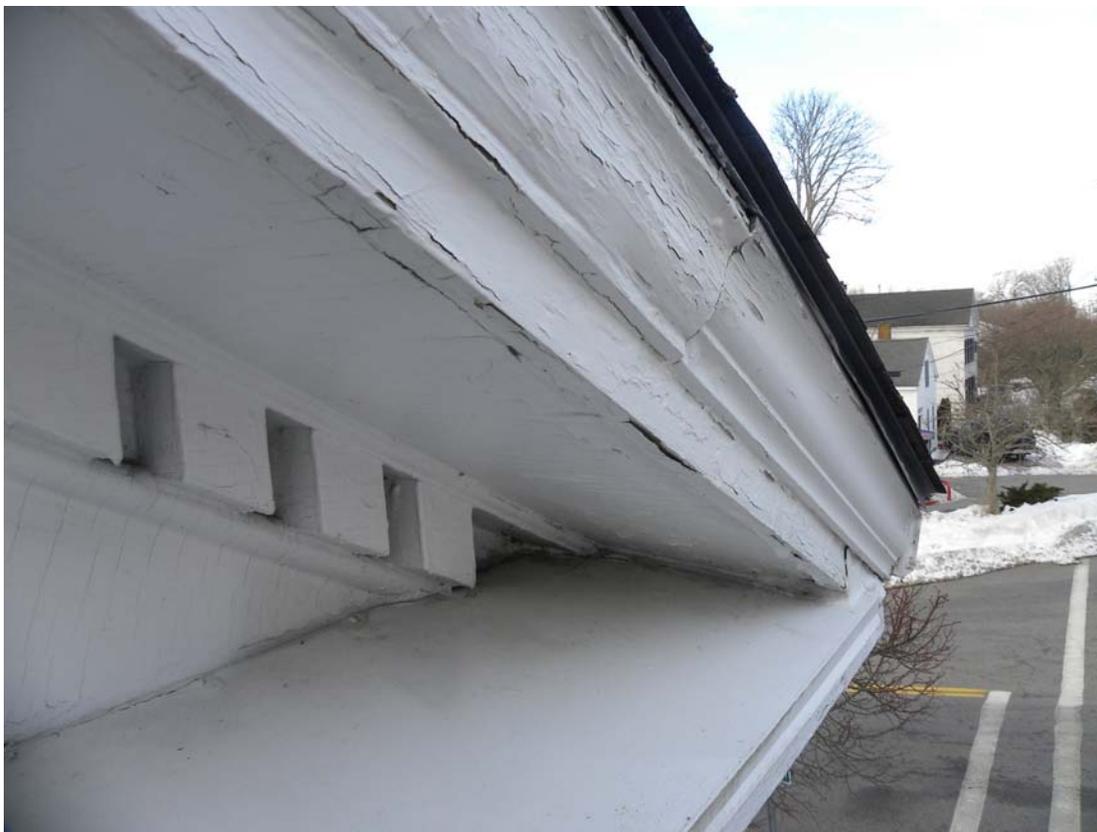
The upward facing parts of horizontal cornice projections are covered with lead coated copper flashings, as directed in the drawings for the 1998 renovation. (see photo 4) These flashings are in good condition. Their top leg was installed in a reglet that was cut in the existing flush board siding, also as directed in the drawings. The sealant joint at this reglet does require replacement on about a 15 year basis, so the sealant should be replaced soon. (see photo 5)

**Photo 4: Detail shows lead coated copper flashing at cornice return, installed in 1998.**

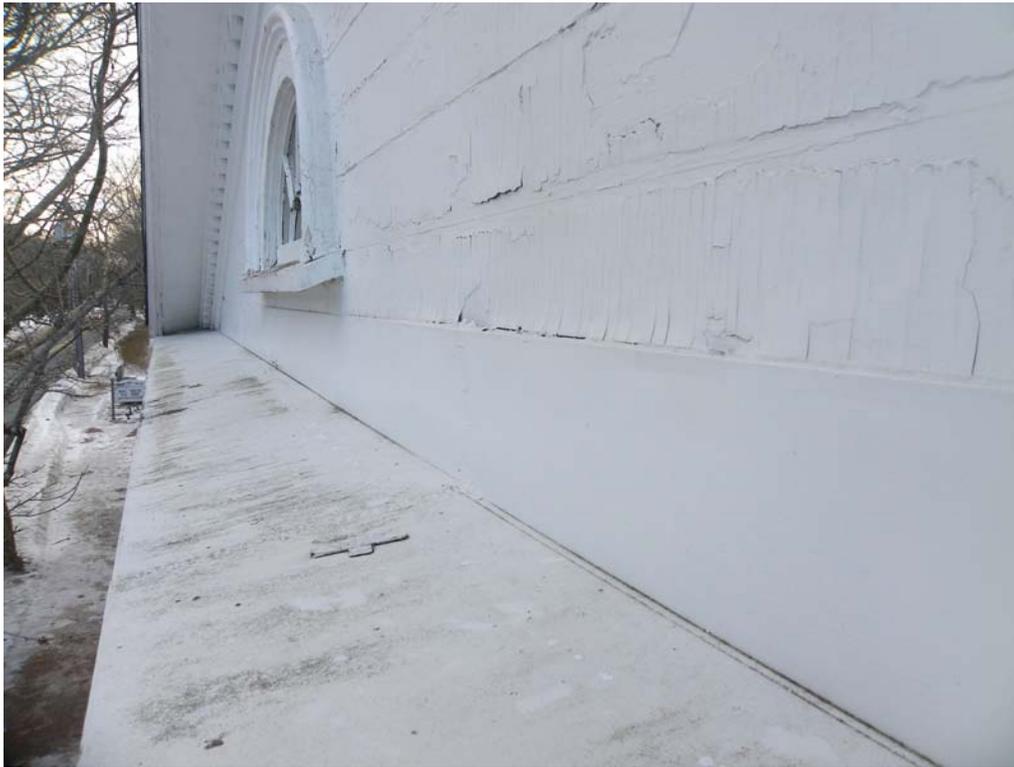
**Photo 5: Detail shows reglet at cornice flashing.**

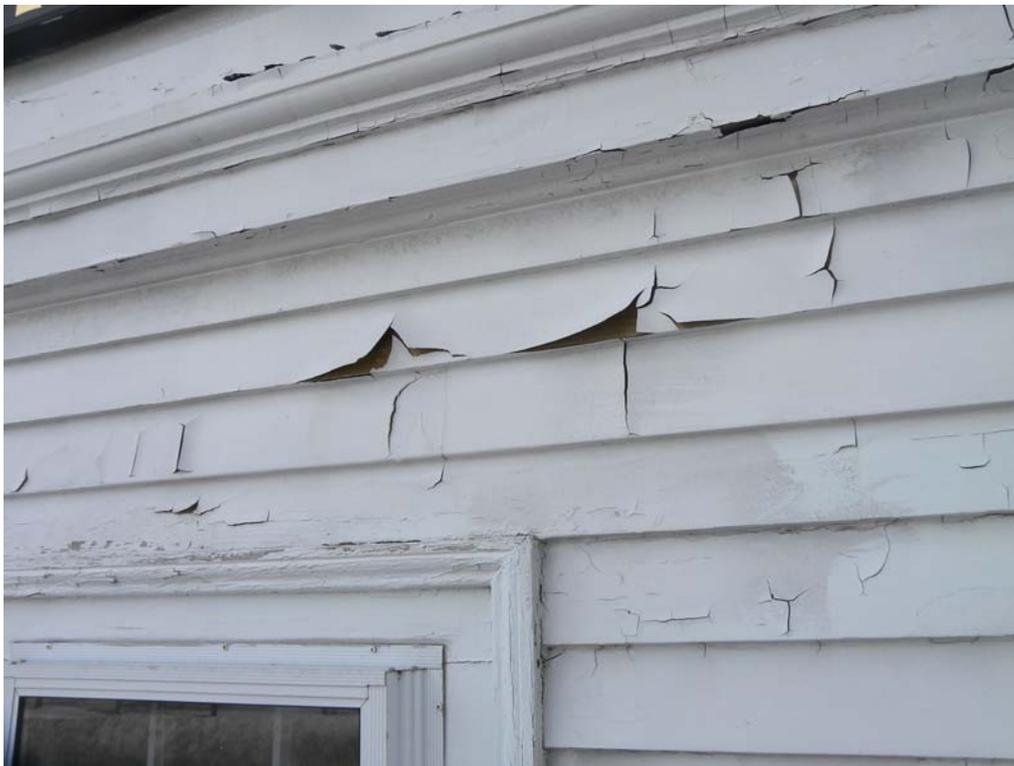
The most noticeable condition problem at the Library is cracked, peeling, and blistering paint at the siding and trim. (see photos 6-12) For the life of the historic block buildings, the approach taken in attempting to correct this condition, has been to scrape loose areas of paint and then repaint. During the 1998 renovation, this method of scraping and repainting was repeated, as that project focused mostly on interior renovation of the buildings of the historic block to function with the new addition. A close examination of the current paint condition shows that peeling is noticeably more prevalent at the older wood elements, while the paint at newer clapboard and trim replacements from 1998 is intact. (see photos 13 and 14). This is because the replacement wood currently has the appropriate thickness of paint layers, since the layering began anew. Paint failure at the older wood is due to the heavy build up of paint layers that has become inflexible and brittle, unable to move with the wood substrate. The maintenance approach of scraping and applying additional layers of paint does not solve the inherent problem. At about 100 years, the recommended long-term preservation solution is to chemically strip all existing paint, to bring the exterior wood to a nearly bare condition, apply a new prime coat of paint and 2 finish coats of paint. Chemical stripping and the required follow-up preparation of siding and trim are needed to provide a substrate that primer and paint can adhere to. Modern high-quality latex paints provide flexibility to allow the finish to move with seasonal and moisture related movements of the wood without cracking, crazing and peeling. This preservation approach has been shown to be the only effective way to begin anew the cycle of paint finish maintenance. This approach allows the sound historic wood siding and trim to remain in place and to continue as viable substrate while preserving the historic fabric of the structure.

**Photo 6: Detail view of paint failure.**

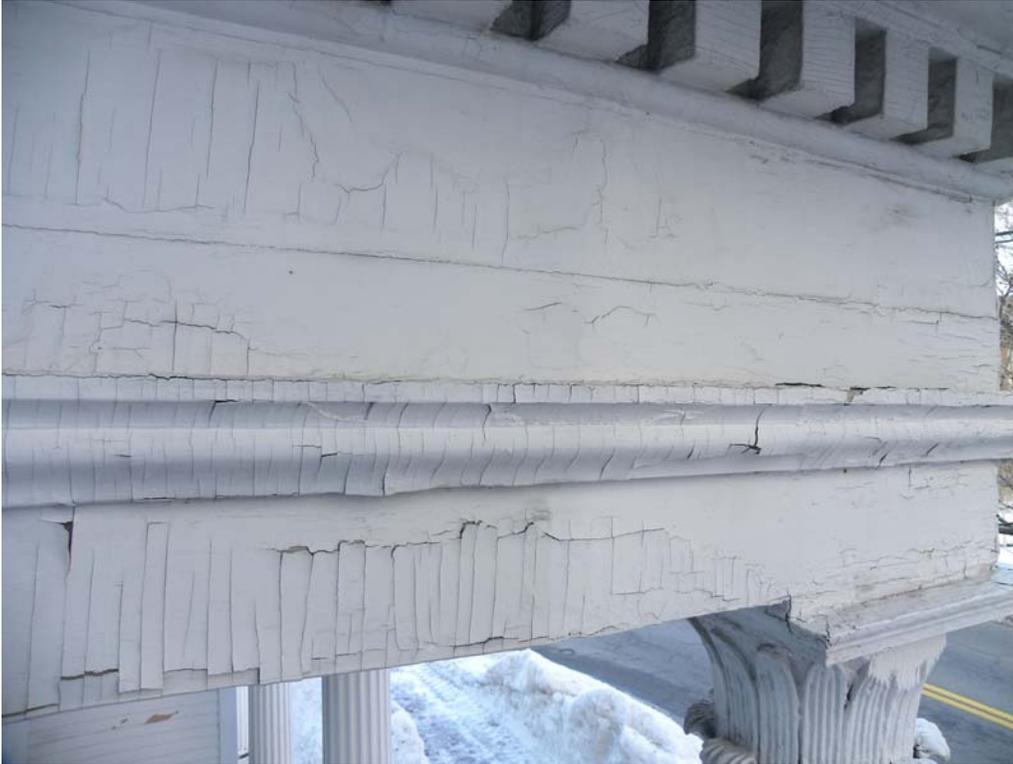
**Photo 7: Typical paint condition.**

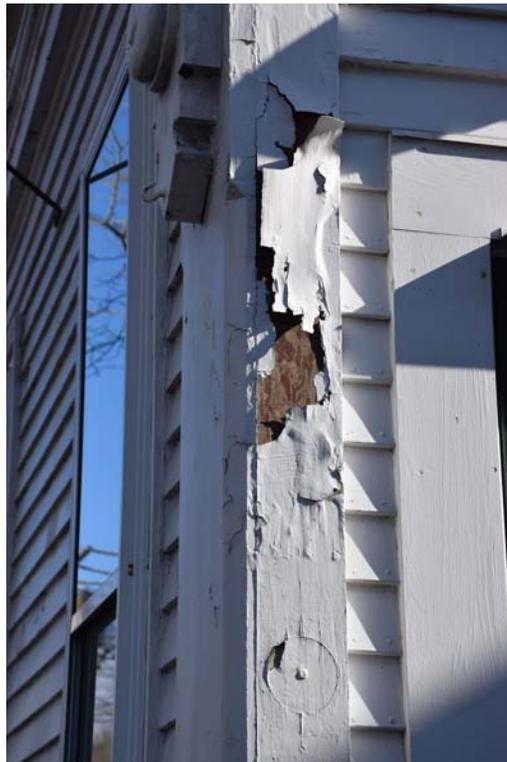
**Photo 8: Detail of paint failure at wood trim.**

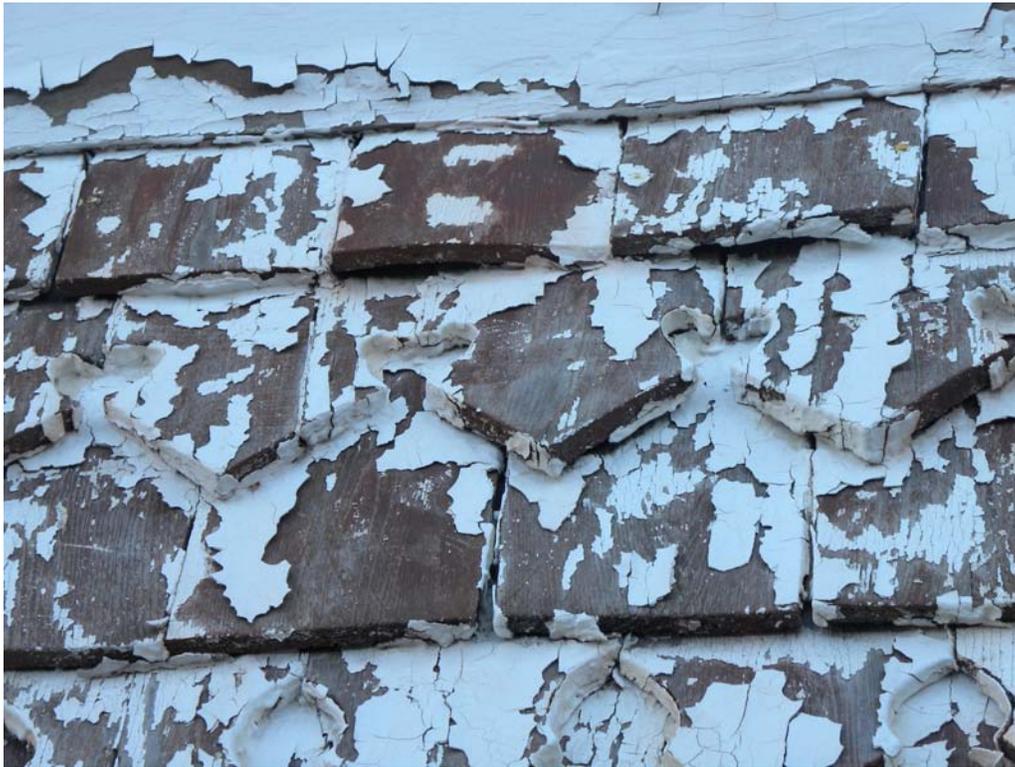
**Photo 9: Detail of paint failure at shingles**

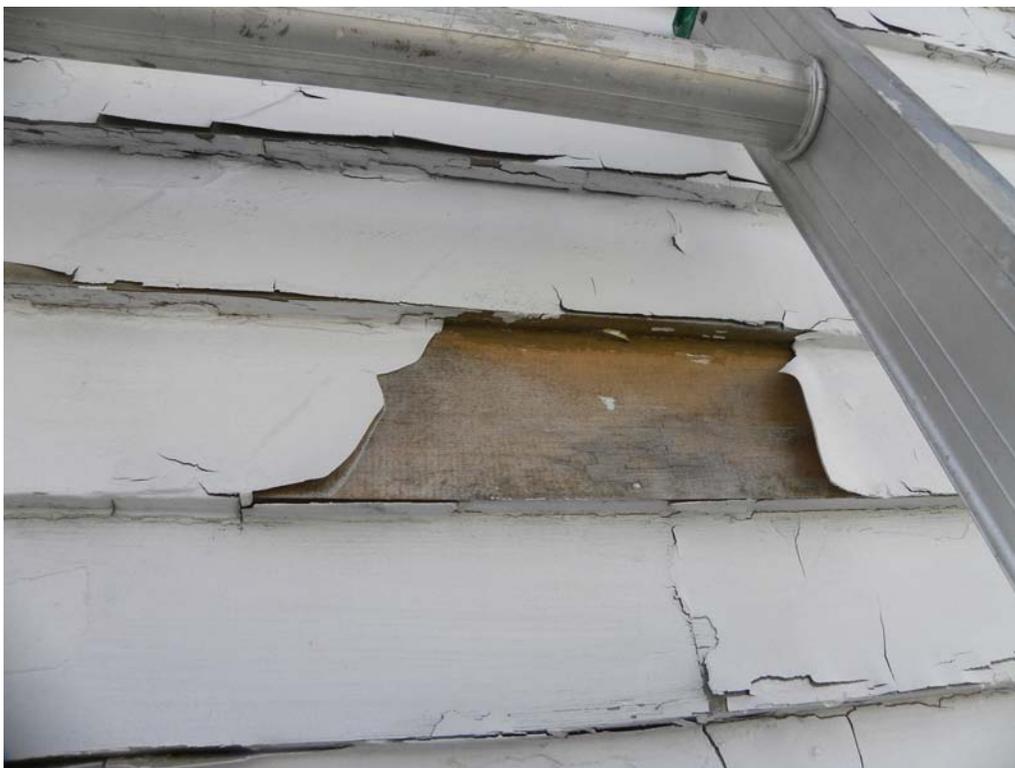
**Photo 10: Detail of paint failure at clapboards**

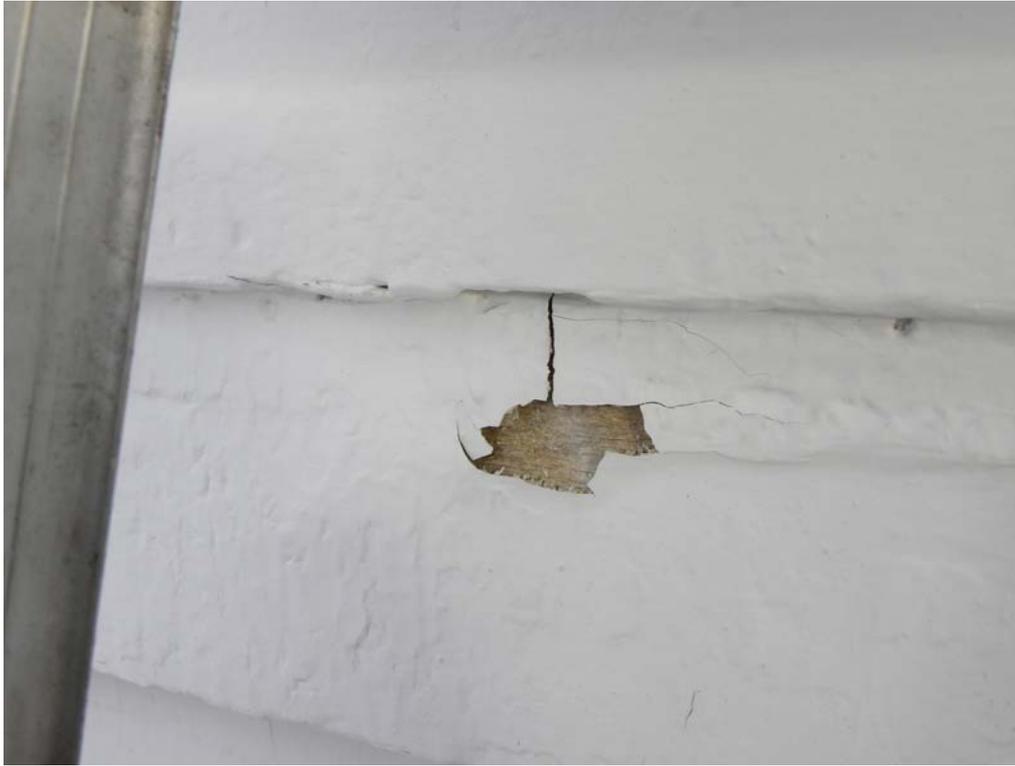
**Photo 11: Detail of paint failure at clapboards.**

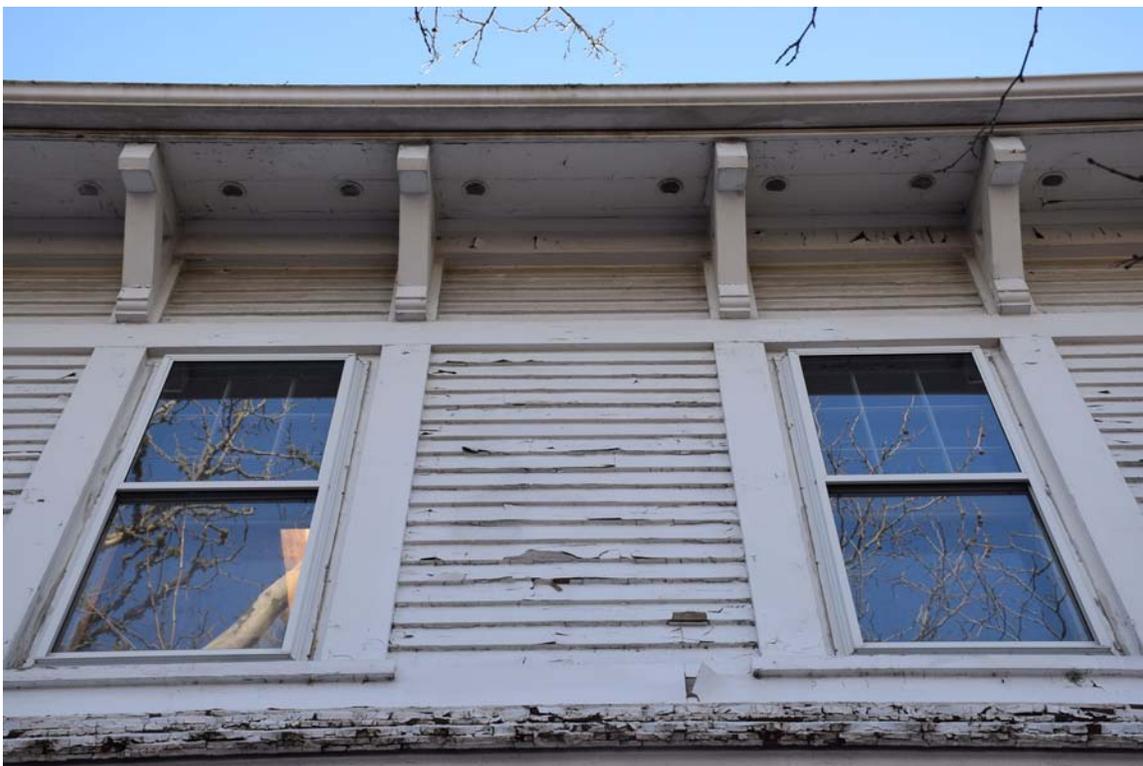
**Photo 12: Detail of paint failure**

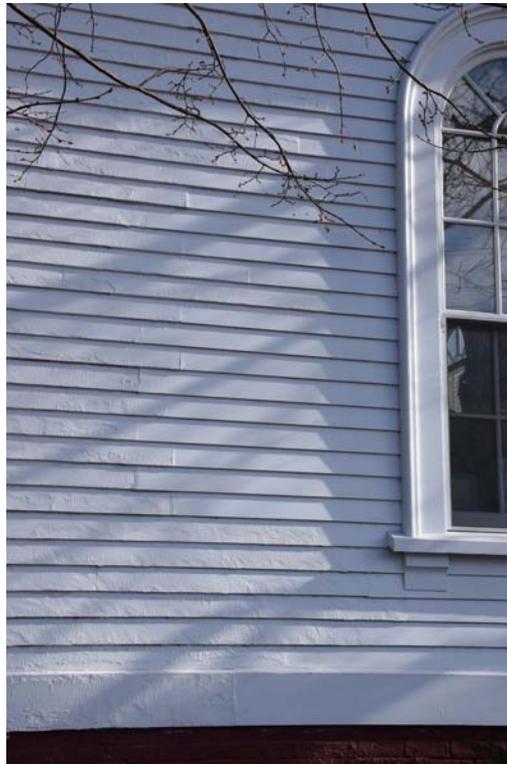
**Photo 14: Current photo shows good paint adhesion at new clapboard vs. poor condition at old clapboard.**

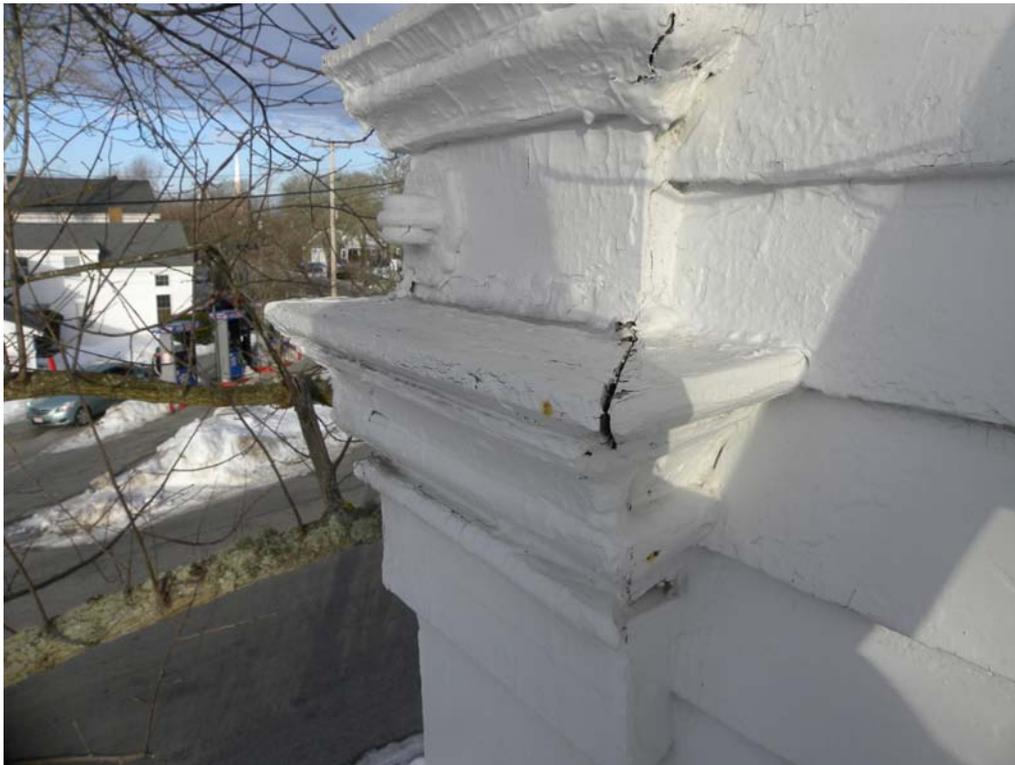
When the wood siding and trim is stripped of paint, the true condition of the wood will be revealed and can be assessed. During our inspection we were able to identify some obvious locations of wood deterioration, splitting, and open joints (see photos 17-21), but the full extent of these conditions is presently concealed with the multiply coats of paint. With the wood condition fully revealed and assessed, loose wood should be re-nailed and deteriorated wood can be repaired by epoxy consolidation if deterioration is minor, or if the wood is too deteriorated for repair, it should be replaced with new decay-resistant wood (such as mahogany). When replacing wood trim it should be primed on all surfaces prior to installation, then finish coats of paint can be applied following installation of trim.

**Photo 17:** Detail of deteriorated wood trim.

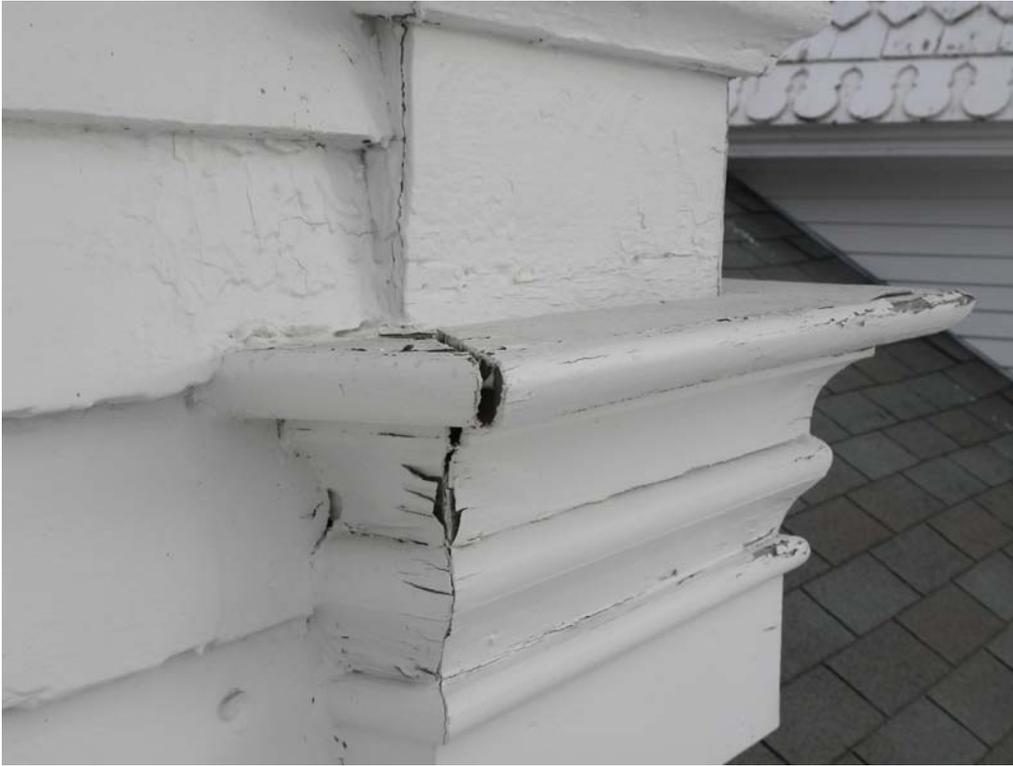
**Photo 18: Detail of deteriorated wood trim.**

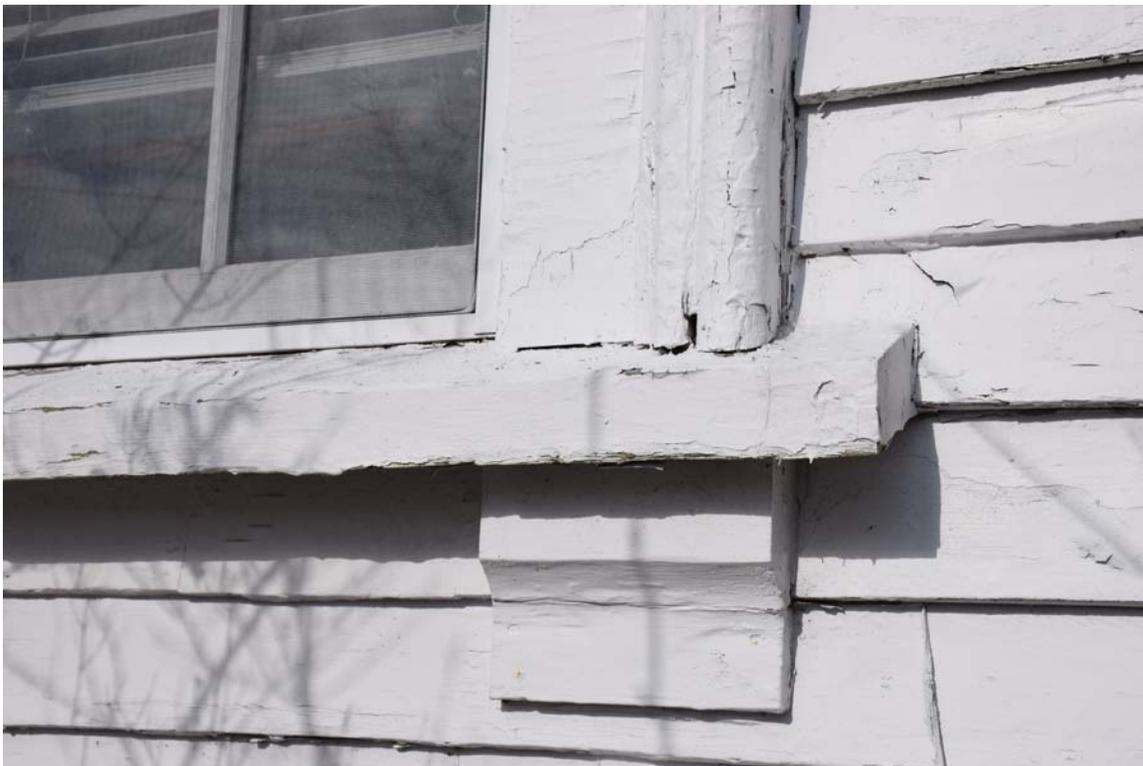
**Photo 19: Detail of deteriorated wood at an exterior window casing.**

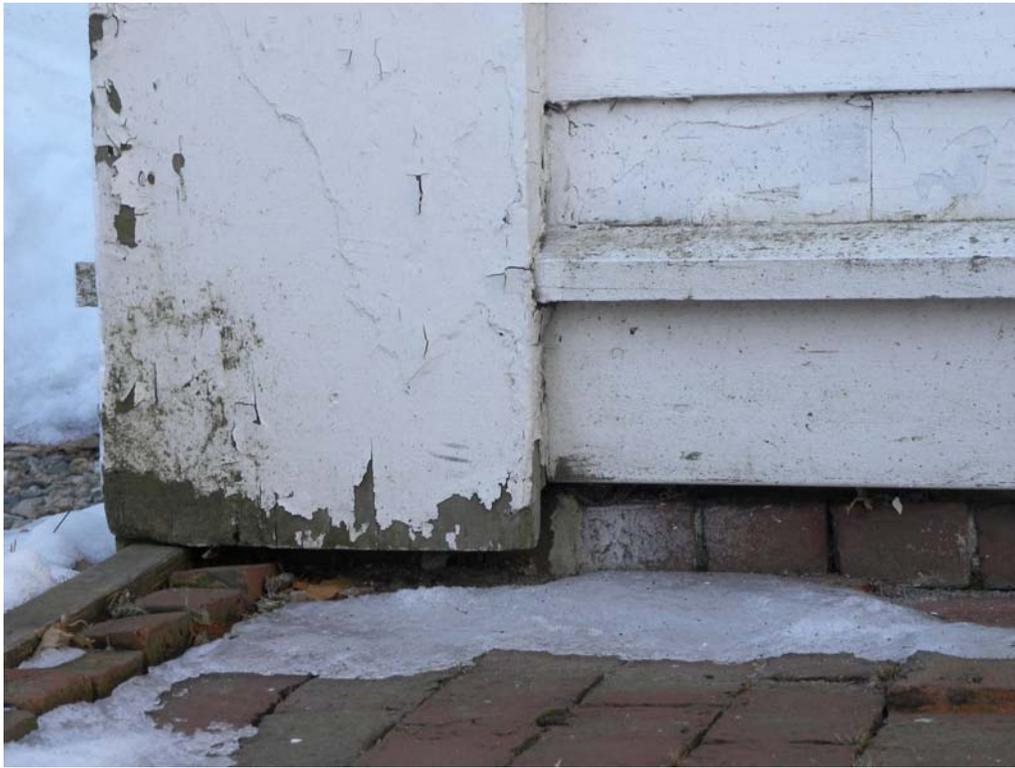
**Photo 20: Detail of deteriorated wood cornerboard.**

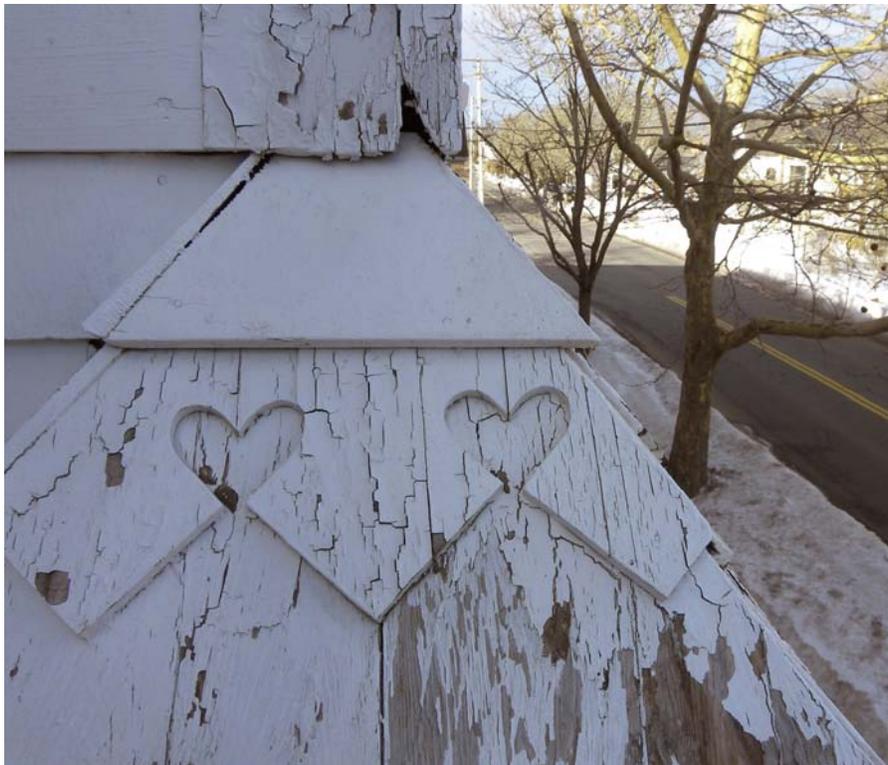
**Photo 21: Detail deteriorated wood cornerboard**

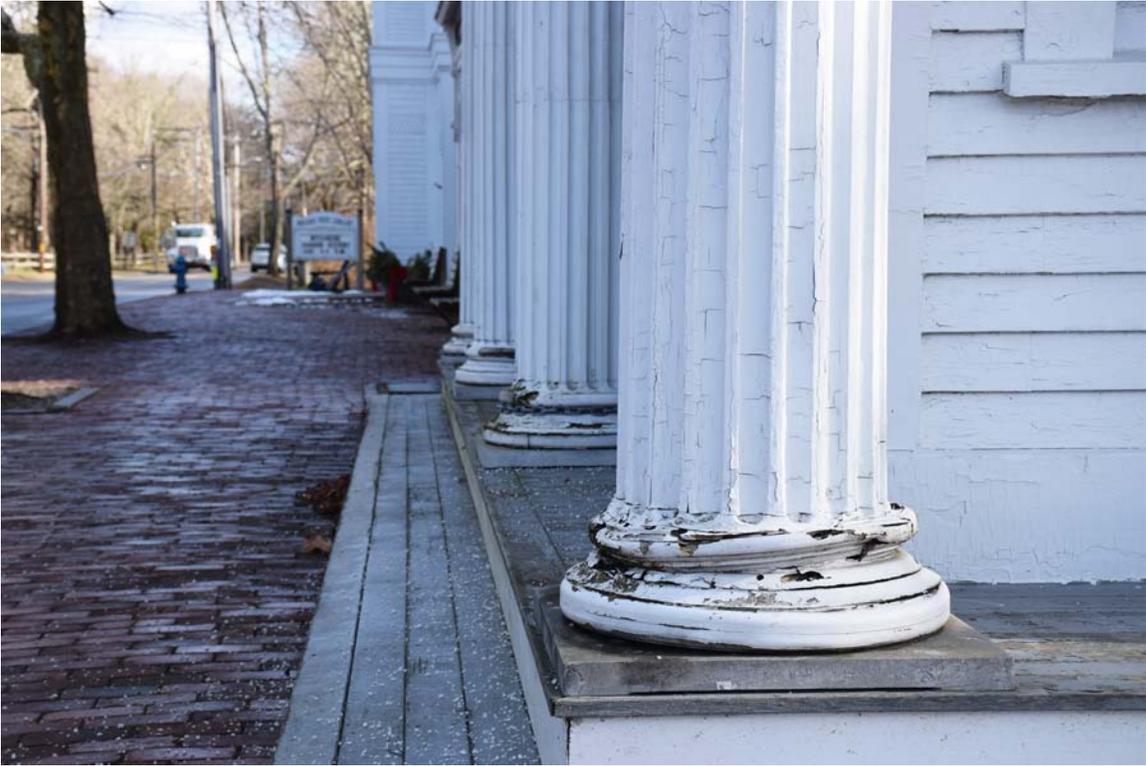
One item of particular concern is the condition of the four Corinthian columns at the portico on the north elevation of the former bank building (see photo 22) The wood column bases are severely deteriorated, particularly at the northwest column (see photo 23). At this column the base has compressed to the point that there is about a 3/4" gap between the fluted wood shaft and capital (see photo 24) The portico overhang should be shored, to allow for column base replacement at all four columns with new decay-resistant wood. We recommend

**Photo 22: View of column bases at former bank building.**

that temporary shoring be installed soon, since the roof framing condition is not known as it is concealed and was inaccessible for inspection without destructive exploratory methods.

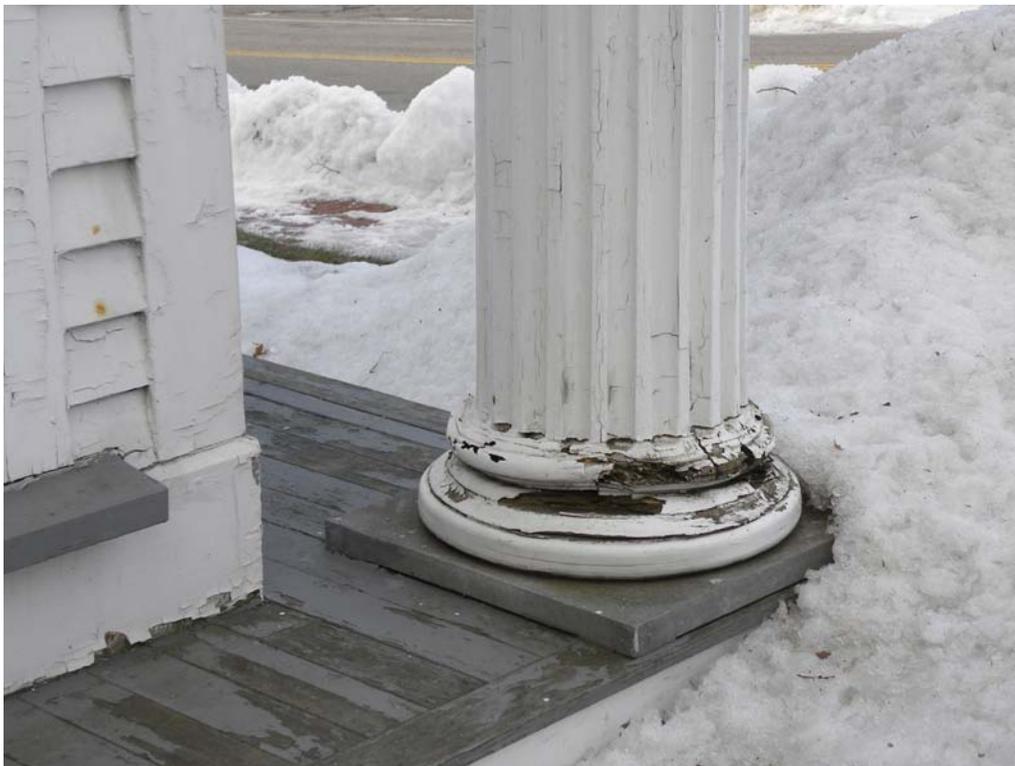
**Photo 23: Detail of northwest column base.**

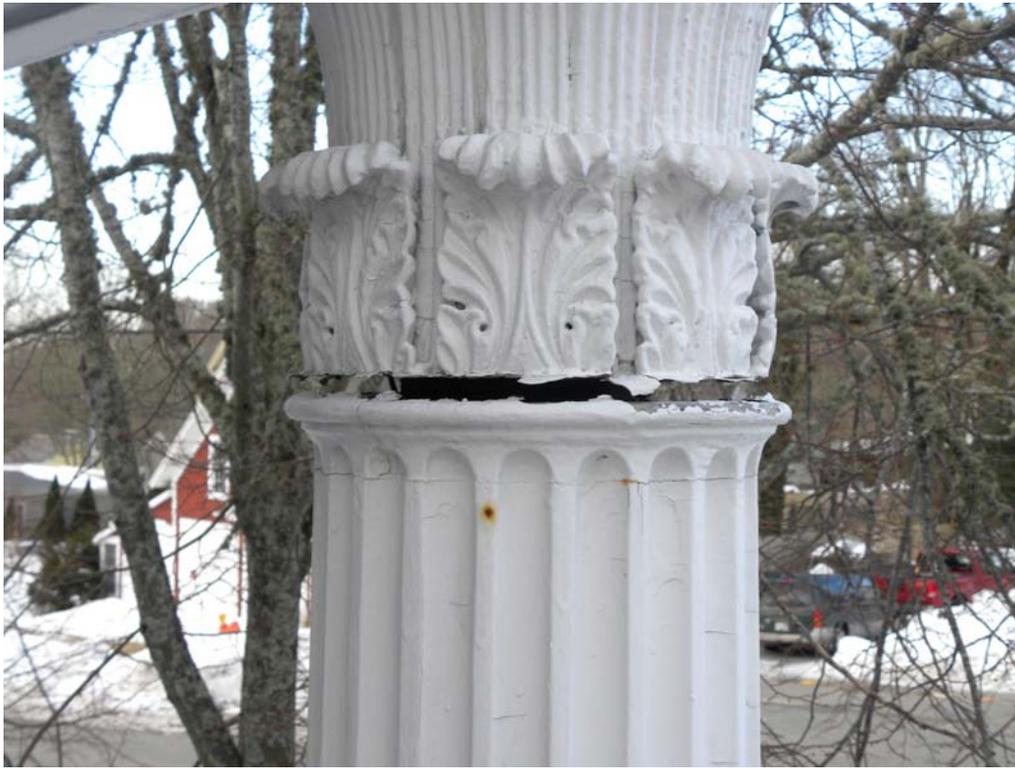
**Photo 24: Detail shows separation at column capital and shaft.**

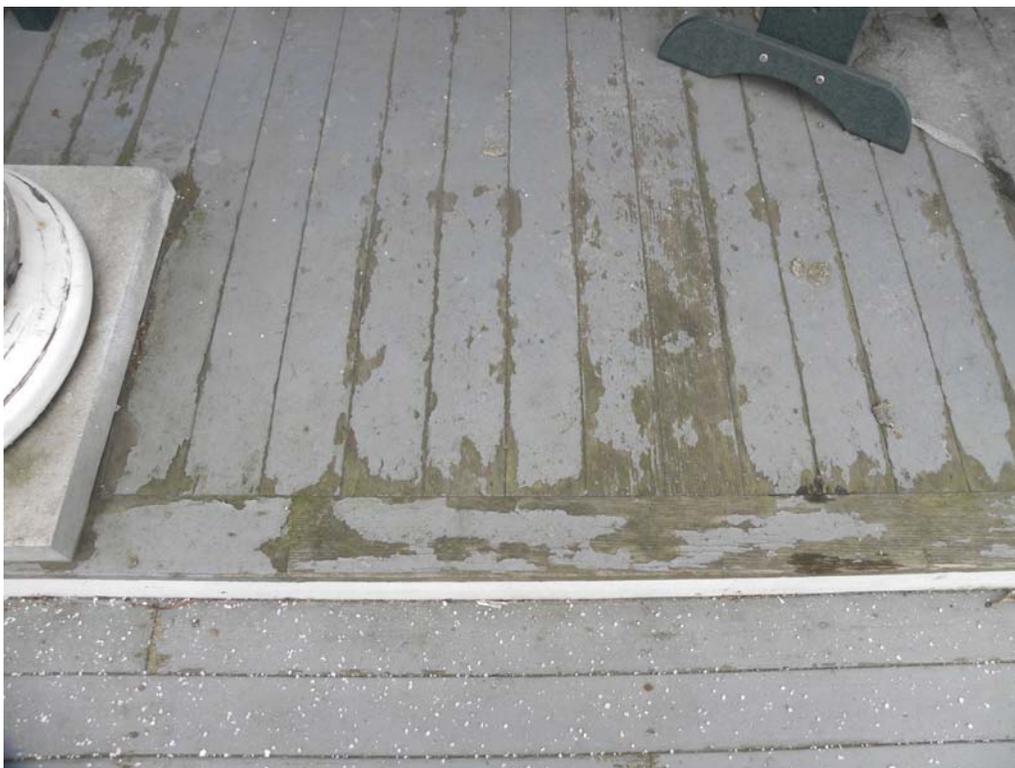
**Photo 25: Detail at wood portico deck.**

At the wood floor of the portico there is paint failure and evidence of organic growth which would be expected on this shady side of the building (see photo 25). The porch should be power washed to remove the growth, cleaned with a fungicide, and then repainted when the wood is dry.

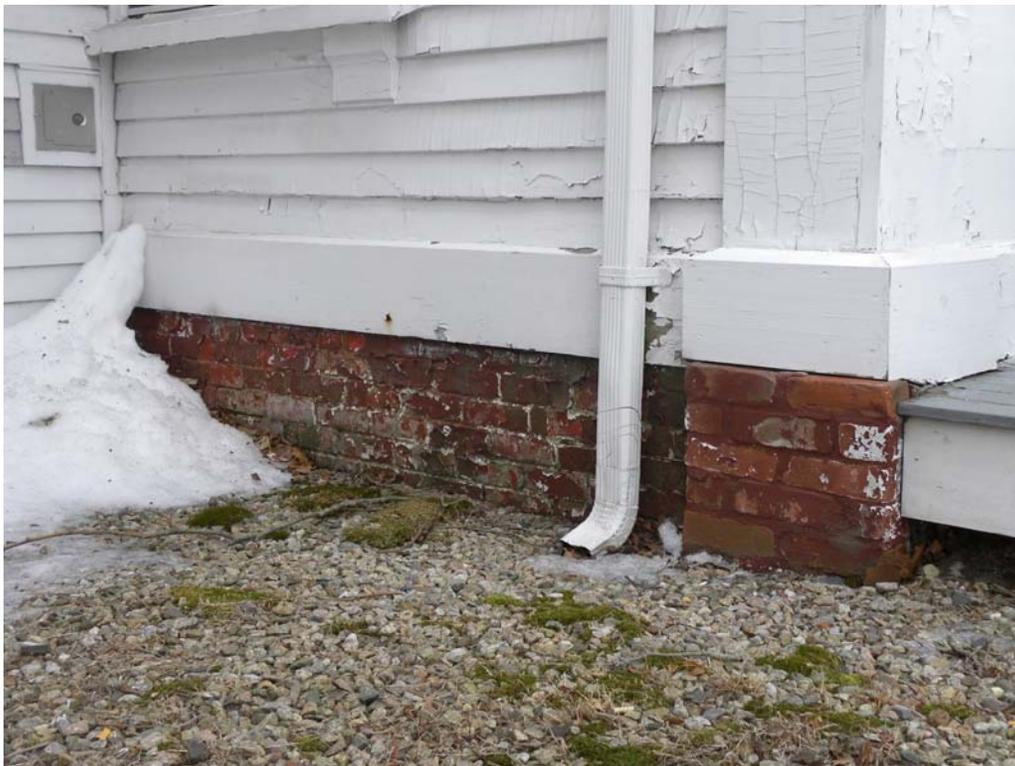
The building features an exposed brick foundation that varies in height around the building. On the south and west elevations, the brick has been painted. Overall the brick is in good condition on these elevations, with only some minor re-pointing required (see photo 26). The grade line has eroded somewhat, leaving a 2” high line at grade that is un-painted. The grade could be raised to correct this (probably by merely adding mulch). There are also areas of painted brick that have peeling paint and these areas should be scraped and painted. At the north elevation, mortar joints are in worse condition (see photo 27) and require pointing (see photo 28)

**Photo 27: Brick foundation, North Elevation**

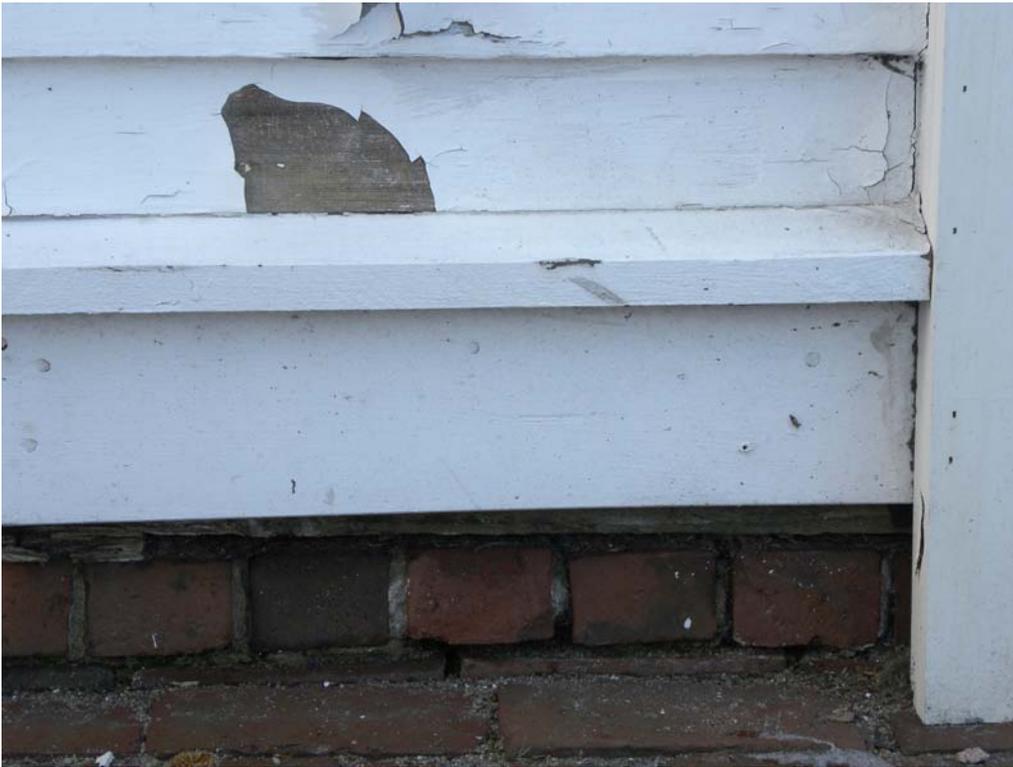
**Photo 28: Detail at Brick foundation, North Elevation shows need for pointing.**

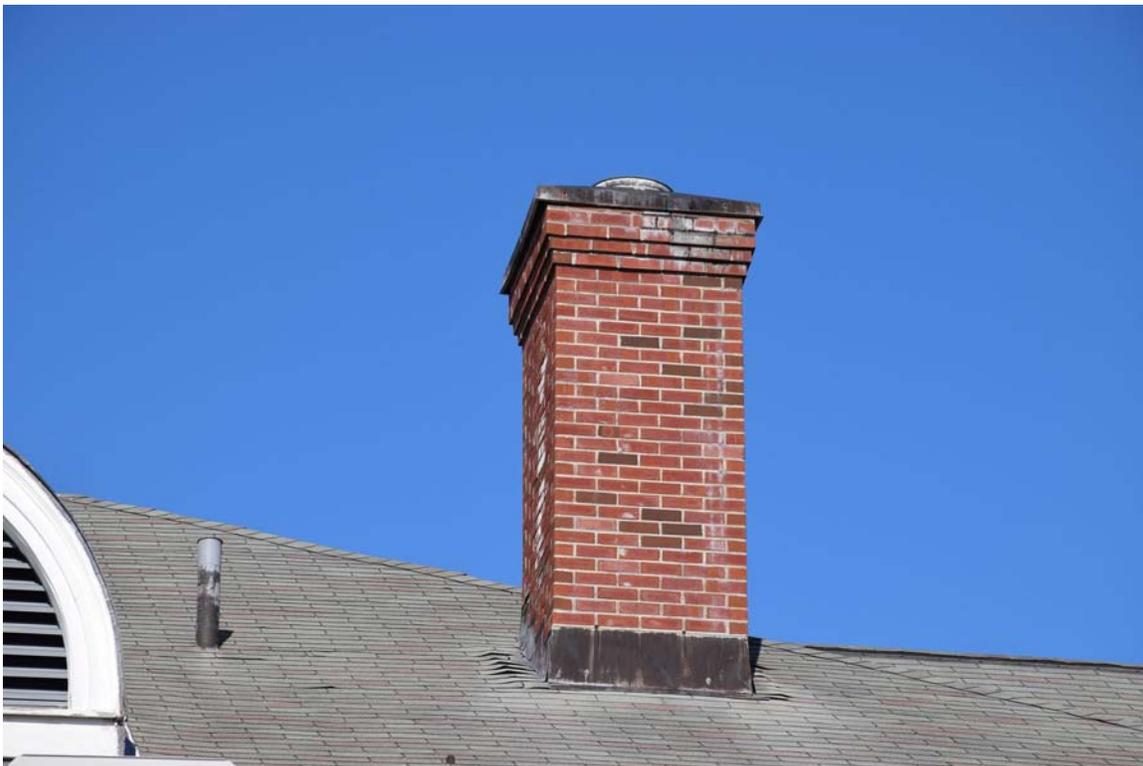
The existing brick chimney, when viewed from the ground, appears to be in good condition (see photo 29)

**Photo 29: Detail view of chimney**

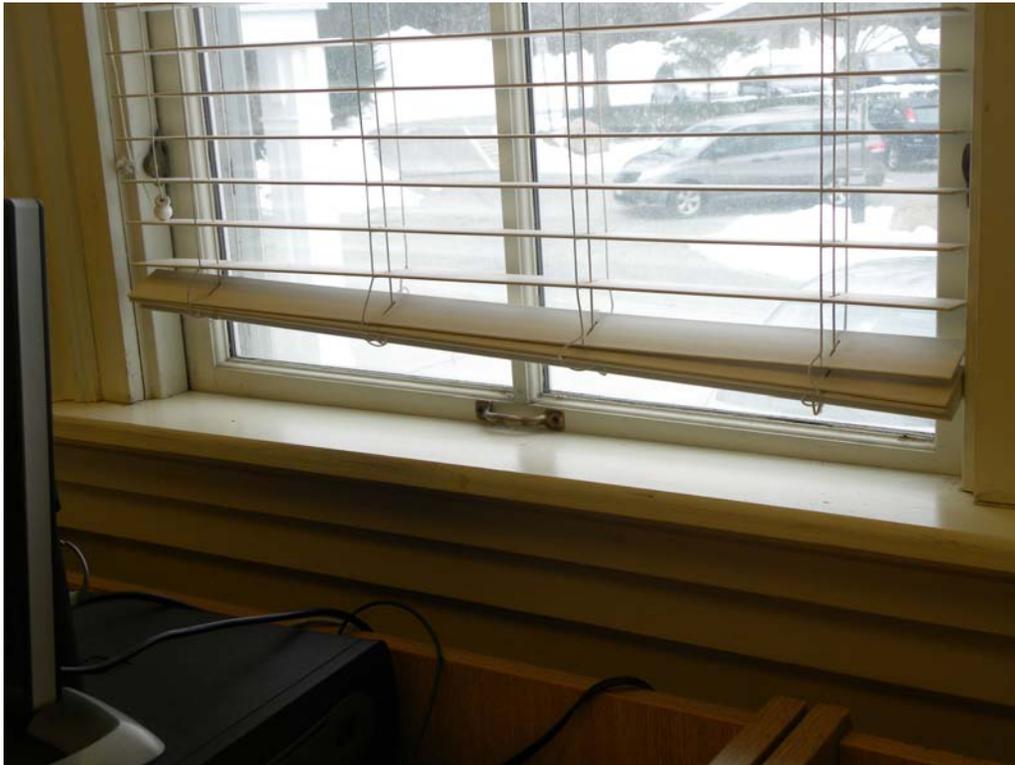
is that insulated glass in this large sized sash makes the sash very heavy. This sash is not only difficult to operate, but there is structural deflection at the window sills (see photo 30), and the bottom rail of the top sash has deflected to the point of causing seal failure in many of the insulated glass units in the bottom row of glazing in the top sash (see photo 31). The sill deflection is particularly noticeable at locations where the windows are ganged in groups of three. (see photo 32)

**Photo 30: Detail at a south window, 1<sup>st</sup> floor shows deflection at sill.**

At the insulated glass windows, glazing units should be replaced wherever there is seal failure, and a method should be developed to add structural reinforcing to the sash to reduce further overloading and deflection. Ropes or chains to the sash weights should be replaced, and additional weight could be added to counterbalance the sash and make them easier to operate. Sash should be repainted.
