# Brooks Free Library

739 Main Street  
Harwich, Massachusetts 02645

## Exterior Assessment Report

July 17, 2015

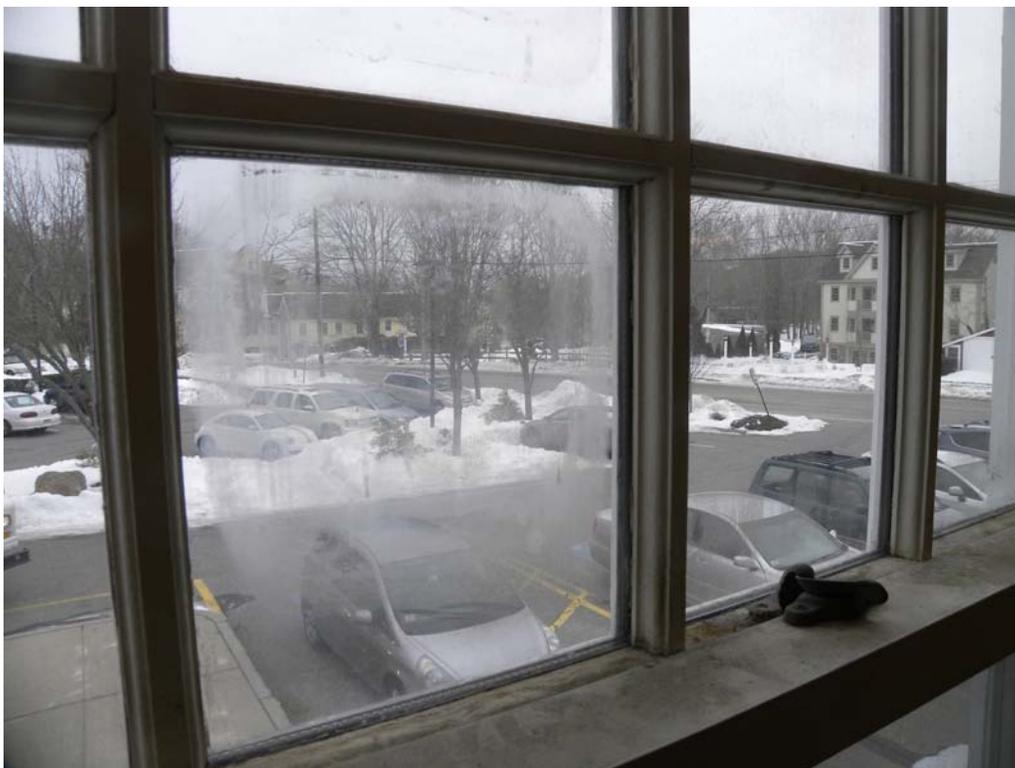
**Photo 31: Detail at a south window, 1<sup>st</sup> floor shows seal failure of insulated glazing unit (note condensation).**

At the insulated glass windows, glazing units should be replaced wherever there is seal failure, and a method should be developed to add structural reinforcing to the sash to reduce further overloading and deflection. Ropes or chains to the sash weights should be replaced, and additional weight could be added to counterbalance the sash and make them easier to operate. Sash should be repainted.

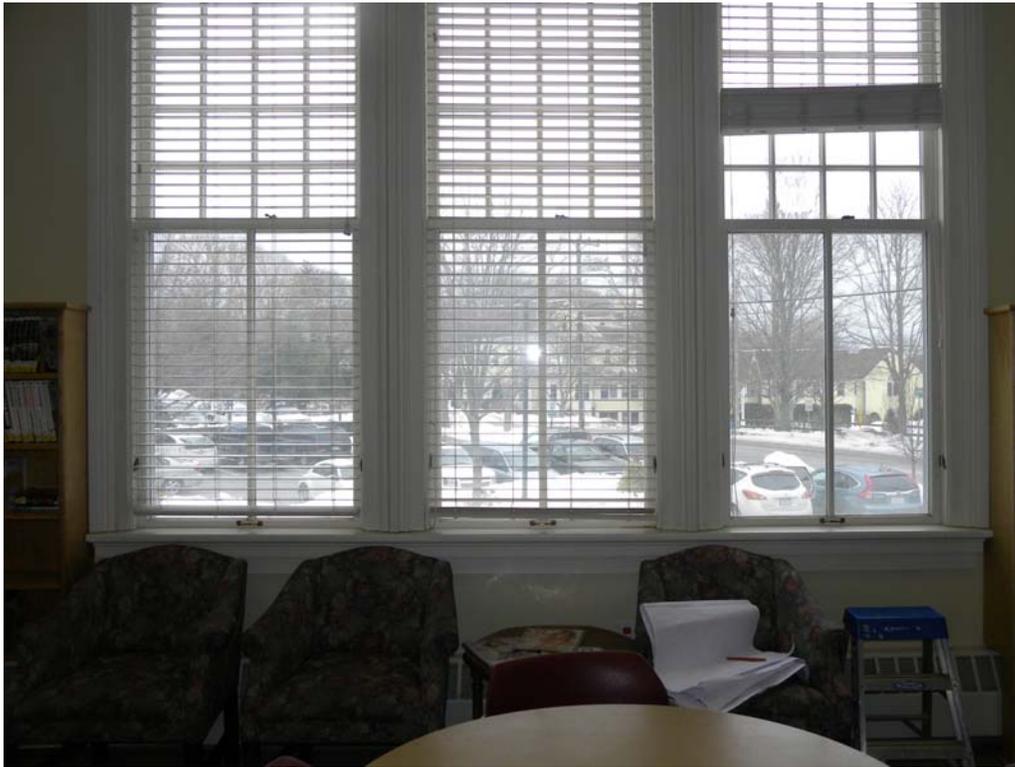
**Photo 32: Sill deflection is prevalent at ganged windows on the south, 1<sup>st</sup> floor.**

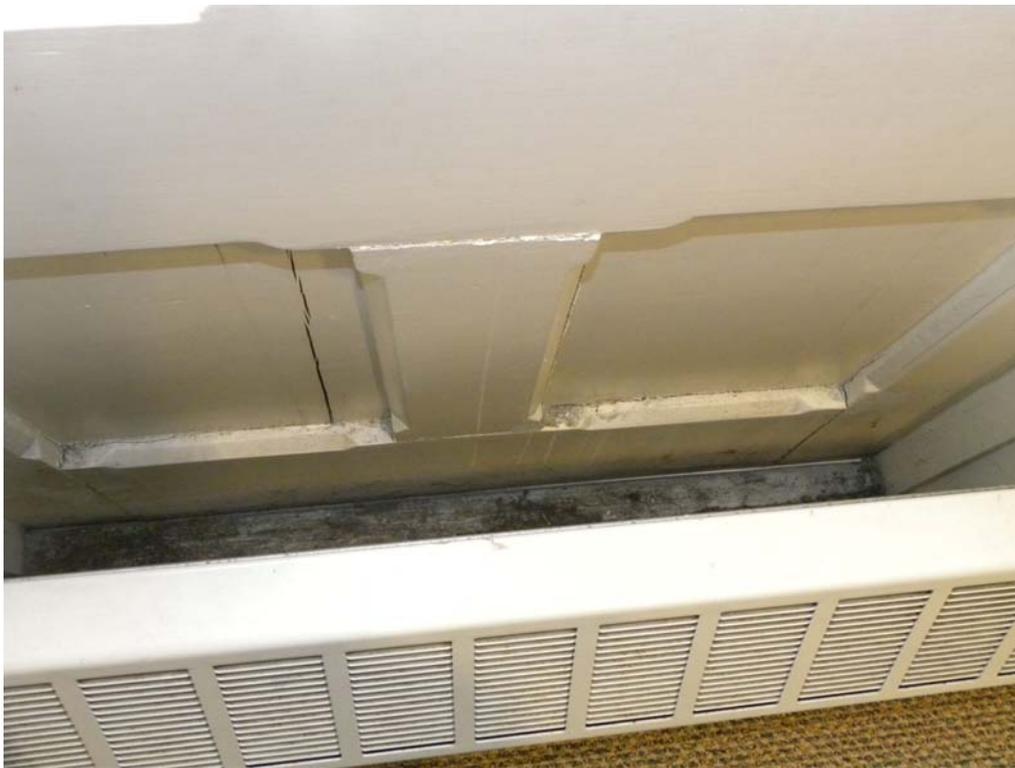
The original door at the Main Street façade of the former mercantile building was fixed in place and the hardware was removed to make it inoperable in the 1998 renovation. There is a crack in one of the bottom panels, and an evident air gap at the threshold. (see photo 33). The panel should be repaired and a door bottom weatherstrip should be added at the sill.

**Photo 33: Stationary door at North elevation has a split panel and air gap at the threshold.**

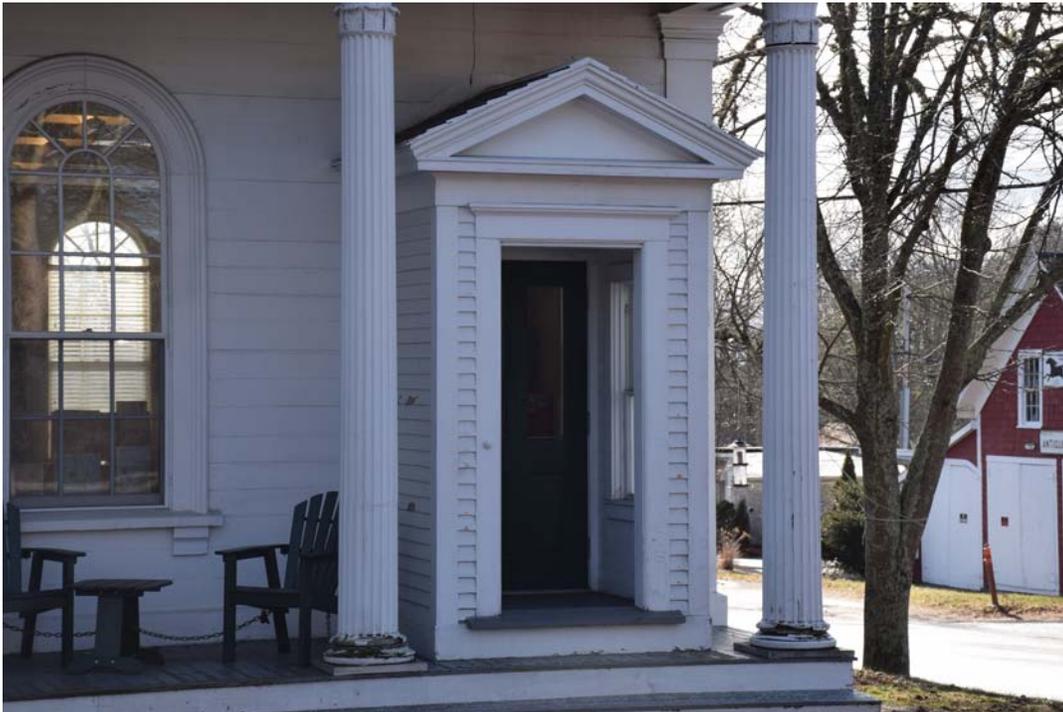
At the Main Street façade of the former Cape Cod Savings Bank building, there is an exterior vestibule installed at the West end of the building (see photo 34) This vestibule is not original to the building, but most likely evolved from the tradition of adding a removable weather vestibule each winter until at some point it was decided that it was much easier to permanently install it. It may have been in place for 75 years. The vestibule was well designed and well constructed, fits within the character of the building, and due to its protected location on the porch it is in good condition. There are compelling arguments on both sides of the issue as to whether it should stay or go, and ultimately either decision would be a logical and defensible preservation approach. As an aside, it does offer some protection and comfort against air infiltration for Children’s room during the winter.

**Photo 34: Detail view of exterior vestibule at the west end of the north elevation.**

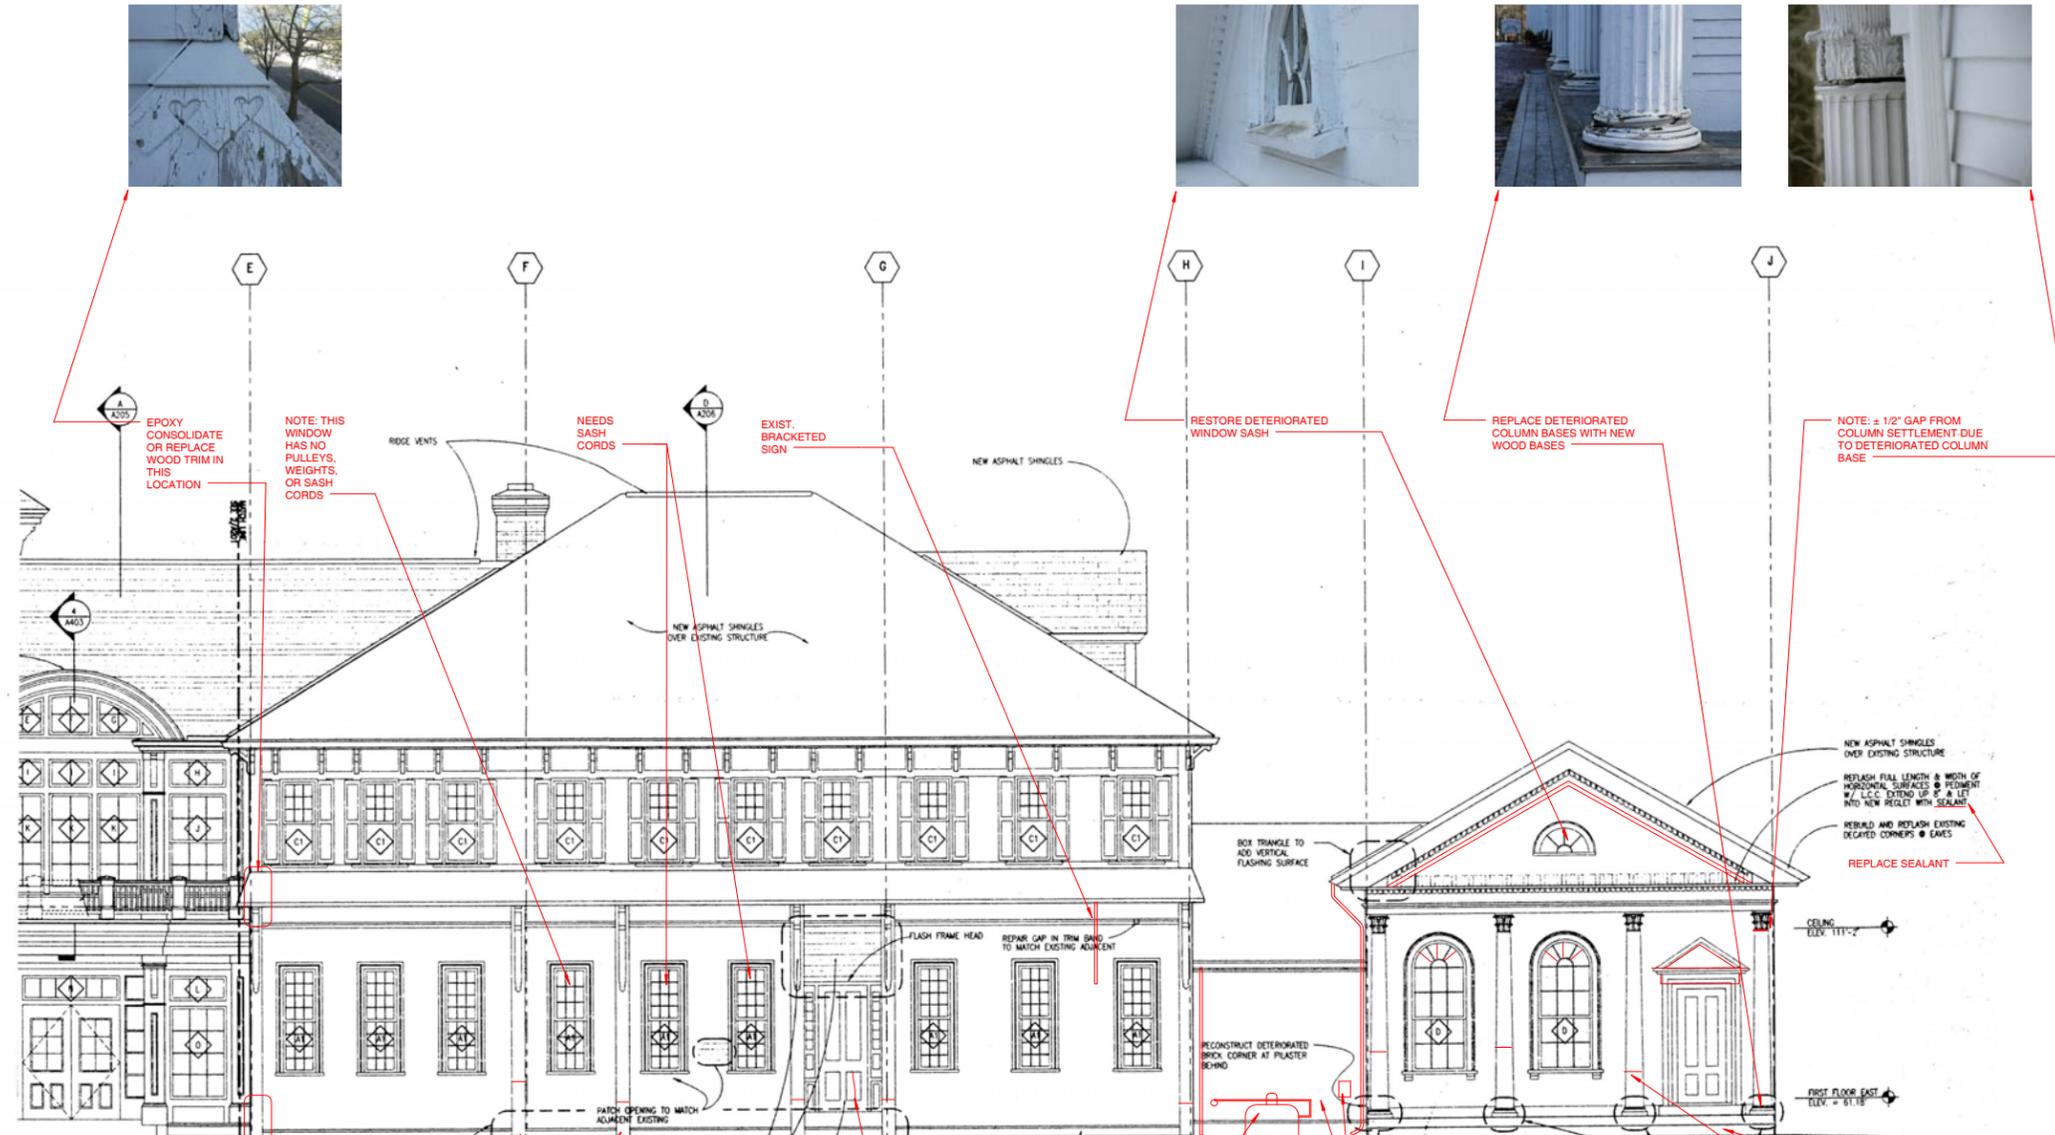
No.  
**A2.1**

NOTE: ± 1/2" GAP FROM COLUMN SETTLEMENT DUE TO DETERIORATED COLUMN BASE

EPOXY CONSOLIDATE OR REPLACE WOOD TRIM IN THIS LOCATION

RESTORE DETERIORATED WINDOW SASH

REPLACE DETERIORATED COLUMN BASES WITH NEW WOOD BASES

CUT AND REPOINT MORTAR AT BRICK FOUNDATION

REPAIR AND/OR REPLACE WATER TABLE AND ASSOCIATED CLAPBOARDS ALONG NORTH ELEVATION. POINT MASONRY BELOW

REPAIR SPLIT PANEL AT THIS LOCATION, ADD STOP TO CLOSE OPEN GAP AT THRESHOLD

REFLASH FULL LENGTH & WIDTH OF HORIZONTAL SURFACES & PROMINENT W/ L.C.C. EXTEND UP 8" & LET INTO NEW REGLET WITH SEALANT

REBUILD AND REFLASH EXISTING DECAYED CORNERS & EAVES

REPLACE SEALANT

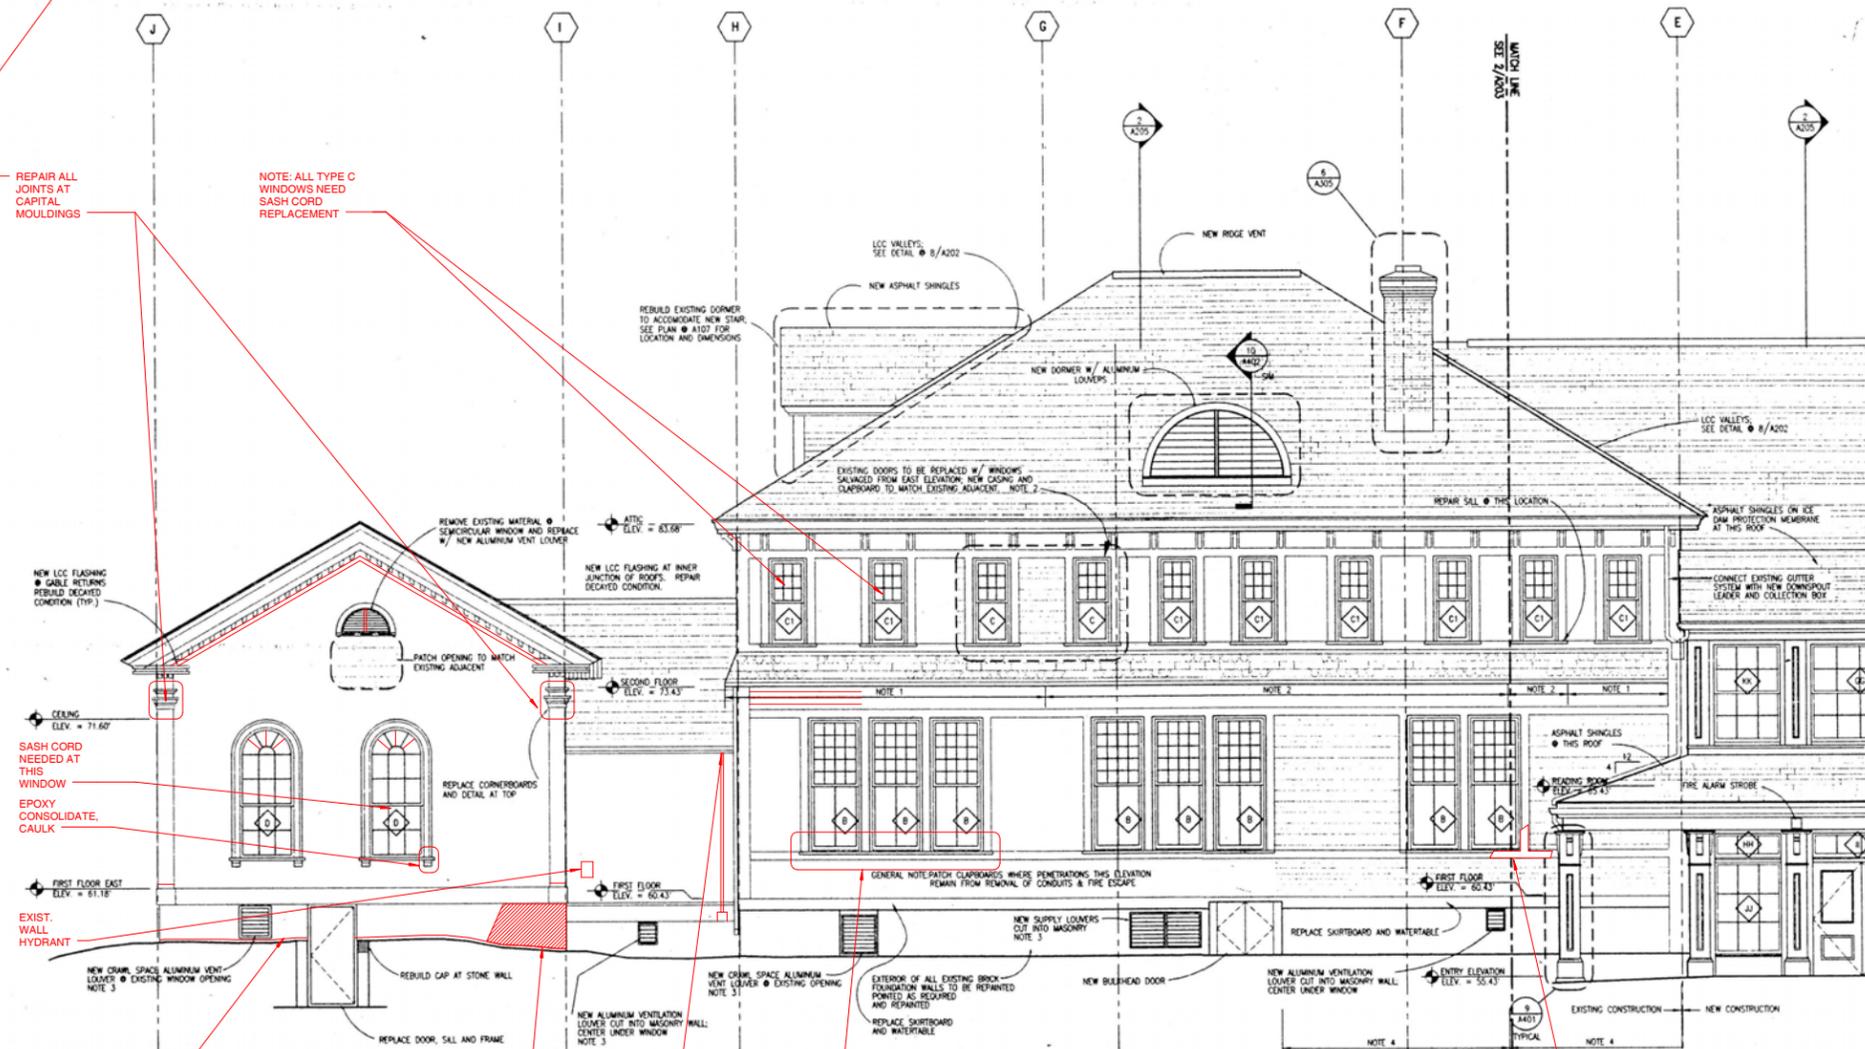
**A2.2**

NOTE: GRADE HAS ERODED IN THIS AREA. PAINT EXPOSED AREA OR RAISE GRADE

AT THE INTERIOR THERE IS DEFLECTION OF SILL DUE TO THE WEIGHT OF SASH

REPAIR ALL JOINTS AT CAPITAL MOULDINGS

NEW LCC FLASHING @ GABLE RETURNS REBUILD DECAYED CONDITION (11P)

EPOXY CONSOLIDATE, CAULK

RE-POINT BRICK FOUNDATION IN THIS AREA; PAINT

RECONNECT DOWNSPOUT AT THIS LOCATION
