**APPENDIX A**  
**HARWICH FIRE DEPT**  
**STATION 2 STUDY COMMITTEE**  
**STRUCTURAL REVIEW and PRELIMINARY OBSERVATIONS**

**January 2016**

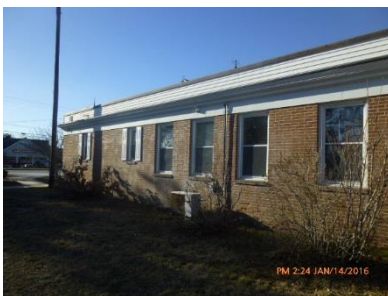
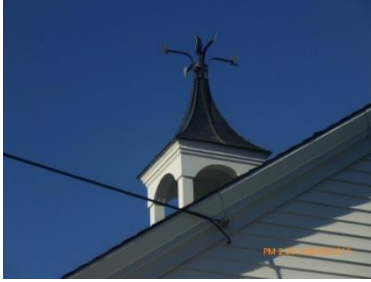
The brick work is still in excellent condition. However, there are many joints within the CMU block that are in need of some clean-up and repointing. The Hose tower that is no longer in use is a good example of the mortar deterioration. From the looks of the ceiling tiles in the room below, I believe rain water is penetrating these joints. Attention to this should be a priority before further damage occurs. Because it is no longer required it would be my recommendation to remove it and seal the roof.

The Cupola is showing signs of deterioration at the base and some weather damage. For cosmetic reasons it should be removed from the roof for repair and restoration.

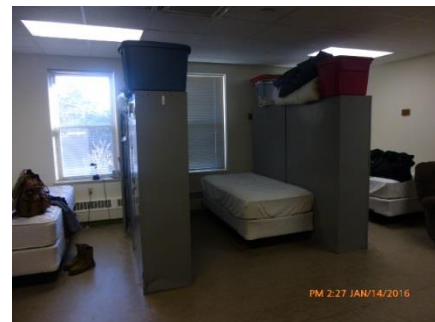
The living quarters do not offer any privacy. An open bay design with lockers to separate the sleeping area. This area is the main passageway from the front to the rear of the building. If walls were to be recommended to separate the spaces then the HVAC system would need to be addressed.

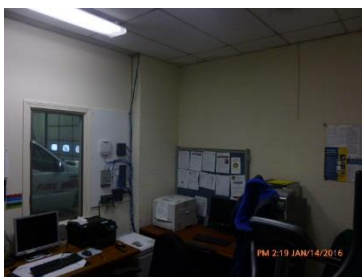
The Office space was constructed within the apparatus bay. It does not have any HVAC for exchange of air and there is no source for outside air. The door is not fire resistant and should be changed to meet building code.

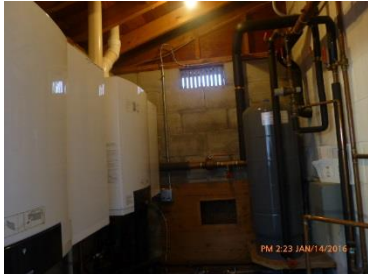
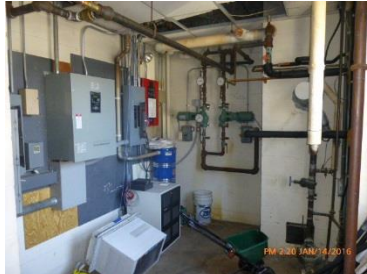
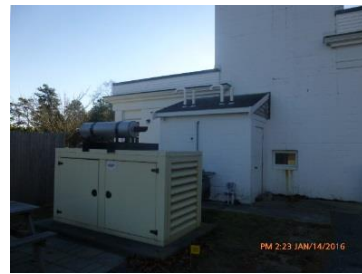
**Boiler** – High efficiency Buderous Gas fired boiler is only four years old.

**Power service** – 200 amp service. With a generator capable of handling the entire load requirement in case of emergency. The automatic switch gear for the generator was upgraded to solid state electronic controls less than a year ago.

**HVAC delivery-** Currently the only zoning for heat is within the apparatus area. The heating system is not zoned within the living and work space. This is not only inefficient but also affects comfort levels and creates hot and cold spots throughout the kitchen, lounge, office and sleeping quarters. Because the cooling system is not centralized, there is no air exchange or fresh air intake. This is only accomplished through opening doors and windows. The air conditioner is over twenty years old and has met its life expectancy.
