3 December 2020

Reference: Brooks Academy Museum
Structural Conditions Assessment Report

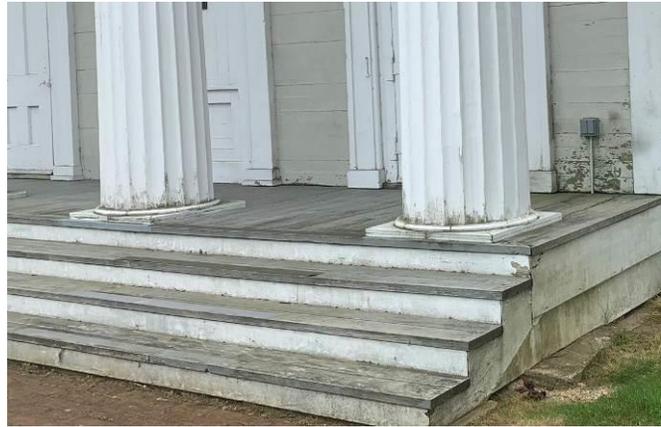
- The flat wooden column bases at the front colonnade are collecting water and causing the bottoms of the fluted columns to begin to rot.

The bases should be replaced with new ones that are slightly pitched to shed water and the bottoms of the columns should be repaired with fitted wood dutchmen.

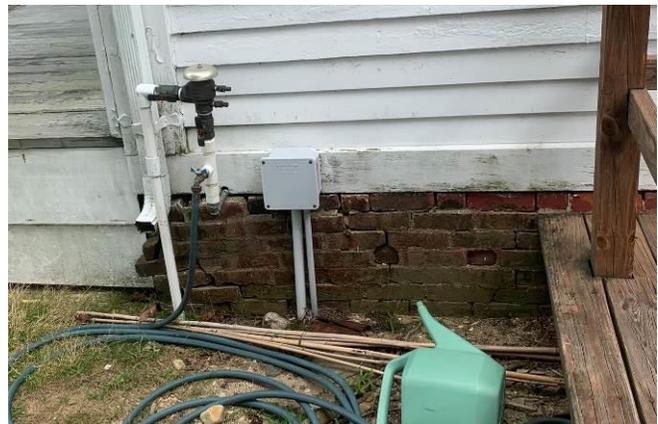
- The 1844 section's foundations are in poor condition:

- The exposed brickwork on the northern end of the west foundation is unraveling, with bricks that are loose, debonded and displaced.

- The remainder of the west foundation brickwork has eroded mortar joints and debonded bricks (that move when lightly tapped on with a hammer).

- The east foundation also has eroded mortar joints and debonded brickwork.

- The east foundation appears to have settled in several places as the brick coursing is not level.

Because of these extremely poor conditions we recommend that the east and west foundations be replaced. This would involve temporarily supporting the building structure, removing the brick above grade and stone below grade, and additionally excavating to a depth of at least four feet and constructing a new concrete footing and foundation wall on which a new masonry above-grade wall would be built. The above grade masonry would consist of grouted concrete block with an external bonded brick veneer that would incorporate as many of the original bricks as possible.

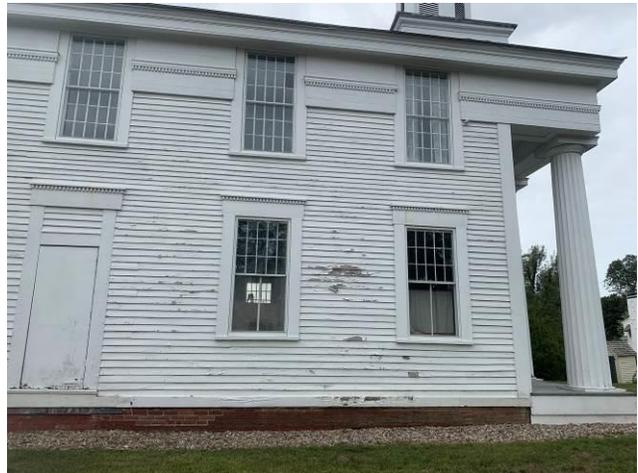
- The wood-sheathed east wall slopes toward the north and south ends in reaction to the foundation settlements that have occurred. *No attempt need be made to re-level the wall during foundation replacement as this would cause damage to interior and exterior finishes.*
- The roof ridge dips in the center however I saw no apparent damage in the attic that might have caused this condition, other than perhaps cross-grain shrinkage of the wood framing.
- The cornice molding at the base of the front pediment sags in the center. This is likely due to slippage of the wood furring that supports the cornice *and should be monitored.*

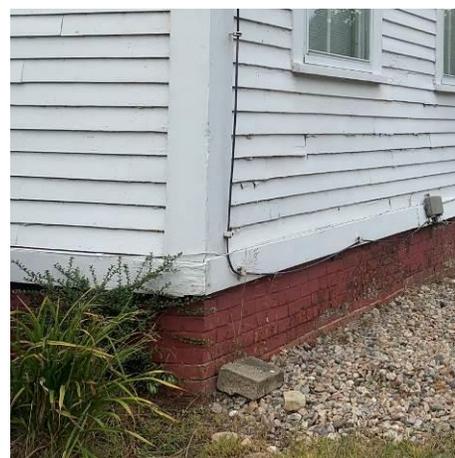
- As with the 1844 section, the 1909 section's foundations are also in poor condition:
 - The exposed brickwork dips between the northeast and southeast corners and the deeper underpinning foundation of the dug-out mechanical area, which provides a hard point of support.
 - The brickwork at the southeast corner is rotated the eastward direction.
 - The south and east walls have eroded mortar joints and debonded brick units.

- According to two test pits, the stone foundations below the brickwork consist of loose, rounded fieldstone that are dry laid in soil to a depth of only a few feet below the ground surface.

Because of their extremely poor conditions we recommend that the south and east foundations be replaced. This would be done in the same manner as described for the 1844 section.

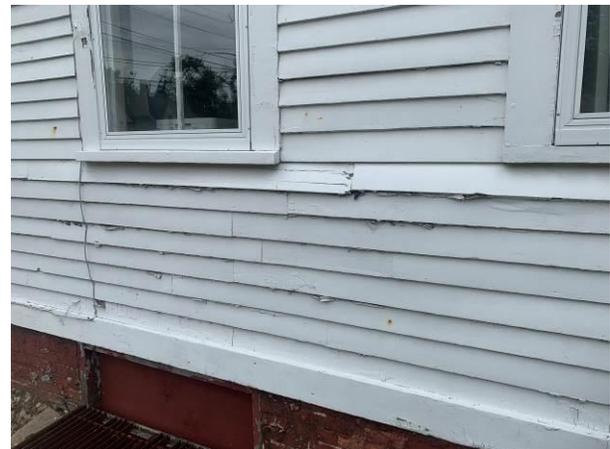
- As at the 1844 section, the supported building walls above the foundation follow the same undulating settlement patterns as the foundation.
- The wood siding on the east wall bulges outward above the mechanical areaway. This bulge could be indicative of compression in the wood framing behind the siding. Such compression could either come from rotting studs or wall plates, or localized overload as would occur if the foundations to each side of the compressed area settled downward, which they have, but the center did not. *This condition should be investigated.*

- The lower clapboards and watertable of the south wall are rotted and bulged out. The bulge might be attributable to compression in the wall's sill. *The rotted wood should be removed and replaced, and the sill investigated and repaired if needed.*

- The upper half of the south wall appears to sweep backward above the second floor, however there are no signs of movement or cracking at the interior. This may be an historical condition that has since stabilized *but should be monitored for change going forward.*

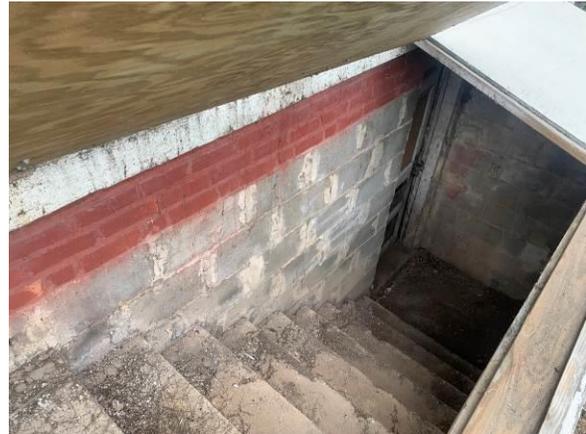
- The concrete block window wells at the west wall are in poor condition and have settled away from the main building foundation. *These should eventually be replaced.*

- There is a disused stairway to the basement in an areaway that is covered with a rickety plywood shield. *Since this is the only secondary egress from the basement, we recommend that the access be restored.*
- The roof-edge fascia atop the north wall appears to dip in two places. *These localized deflections should be investigated and monitored.*

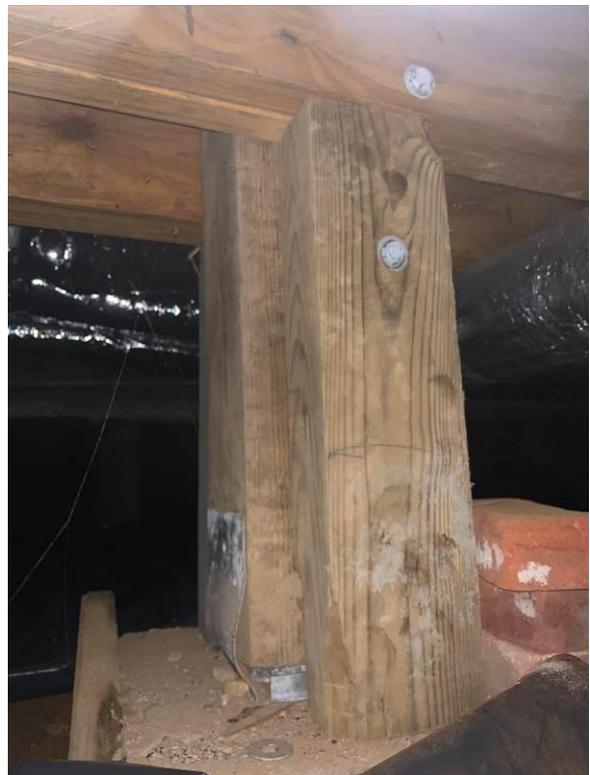
- All of the first floor framing has been extensively reinforced through sistering and posting in what is clearly an engineered solution to earlier deficiencies.
- It is not clear whether the partial height concrete block walls along the trench that leads to the mechanical space are designed as cantilever retaining walls to hold back the higher grade of the crawlspace, however no lateral movement was observed.
- The concrete footings that run along the sides of the trench rest on both the tops of the concrete block walls and the retained soil behind them, creating a condition that is prone to settlement and lateral movement of the walls. Fortunately, no such settlements or movements were observed.

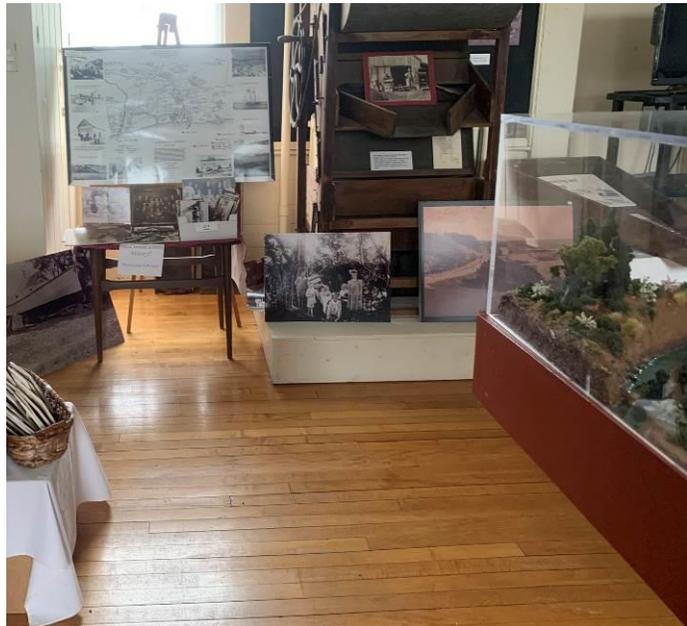
- The first floor surfaces are somewhat irregular with scattered ridges and valleys that are moderately noticeable underfoot. The elevated portions of the floor correspond to supporting girt and wall alignments within the basement with the floor joists sagging between them. *Because the joists and girts have been so extensively reinforced, other than for the specific conditions noted below one would assume that the reinforcement was done in response to the deflections and done in accordance with proper engineering practice.*

- The floor of 1844 section sags in the vicinity of the wall that divides the main Exhibit Hall from the Gift Shop. This wall supports the second floor, where there is a high point noted above it. *The sag is likely caused by the stacked second floor loads coming down on the first and should be investigated and reinforced if needed.*

- The floor of 1844 section also sags in the vicinity of the two columns toward the main Exhibit Hall's south end, along with the ceiling there. The column also support the second floor, and a high point is noted above them. *Again, the sag is likely caused by the stacked second floor loads coming down on the first framing and should be investigated and reinforced if needed.*

- There is a heavy concentration of file cabinets against the west wall of the Marketing and Research room that has caused the floor to dip and the wall to crack, and appears to be beyond the intended capacity of the reinforcement below it. *The files should be relocated to the basement slab or the floor construction should be analyzed and additionally reinforced as needed.*

- There is some disturbance in the wall and ceiling finishes around the mechanical chase against the east exterior wall. *This may relate to rot or other damage within the chase and should be investigated.*

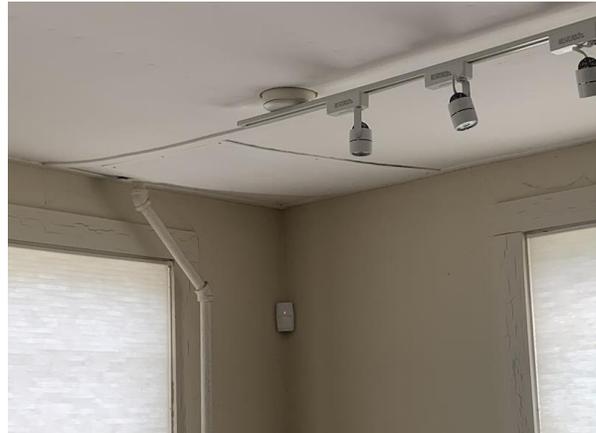
- The ceiling of the Meeting and Research room sags in the southwest corner, where a piece of plywood appears to have been added. *The ceiling attachment to the second floor should be reviewed and reinforced as needed.*
- The ceiling of the Meeting and Research room also sags along the west edge where it has been dragged down with the west wall.

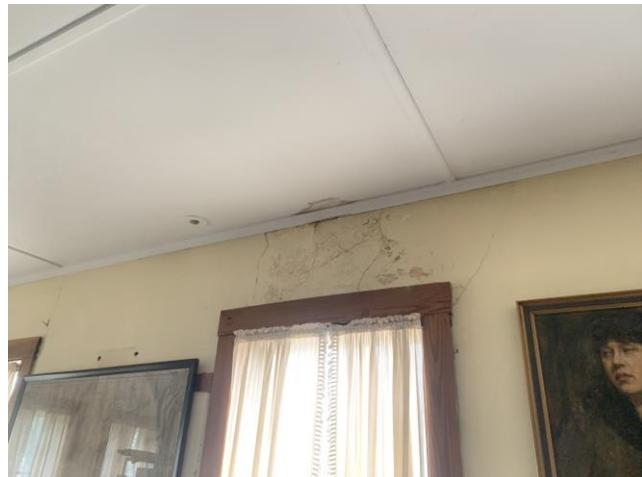
- Like the first floor, the second floor has localized dips and ridges that generally correspond to supporting walls below. The deflections are within a normal ranges for the construction type.
- There is water related plaster damage on the south wall of the 1909 section *that should be investigated as to its source.*

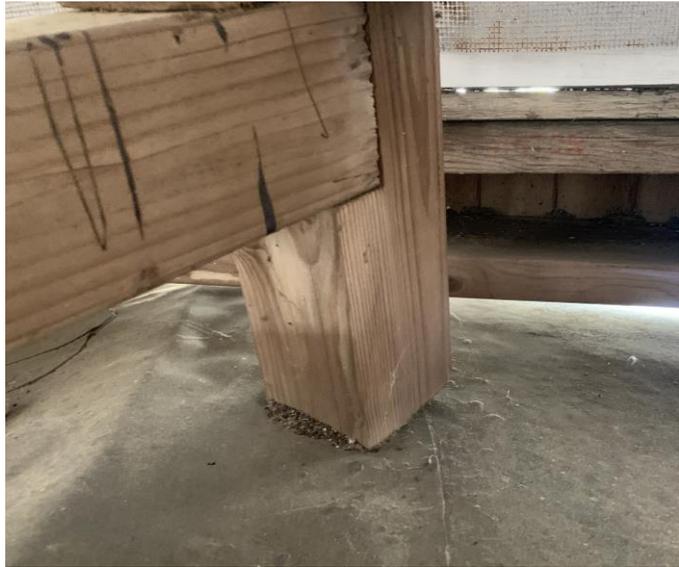
- The rafter pair at the intersection of the 1844 and 1909 sections is discolored at the ridgeline, possibly by fungus, *and should be checked for rot.*
- The wooden posts that frame the cupola land on the sloping roof covering of the belfry with 90-degree cut ends and not hold-down connections. This puts undue stress on the roofing system and will eventually cause it to tear, and the lack of restraint diminishes the resistance of cupola structure to wind loads. *Properly seated and anchored post-base connections should be installed.*
