**BOARD OF WATER & WASTEWATER COMMISSIONER'S**  
**MEETING AGENDA\***  
**Harwich Water Department, 196 Chatham Road, Harwich MA**  
*Thursday, March 23, 2023*  
*11:30 a.m.*

**MINUTES**  
**HARWICH WATER DEPARTMENT**  
**BOARD OF WATER/WASTEWATER COMMISSIONERS**  
Thursday, March 9, 2023  
11:30 a.m.

### Pleasant Lake Water Storage Tank

HARWICH WATER DEPARTMENT  
PLEASANT LAKE TANK 2022 ANNUAL INSPECTION

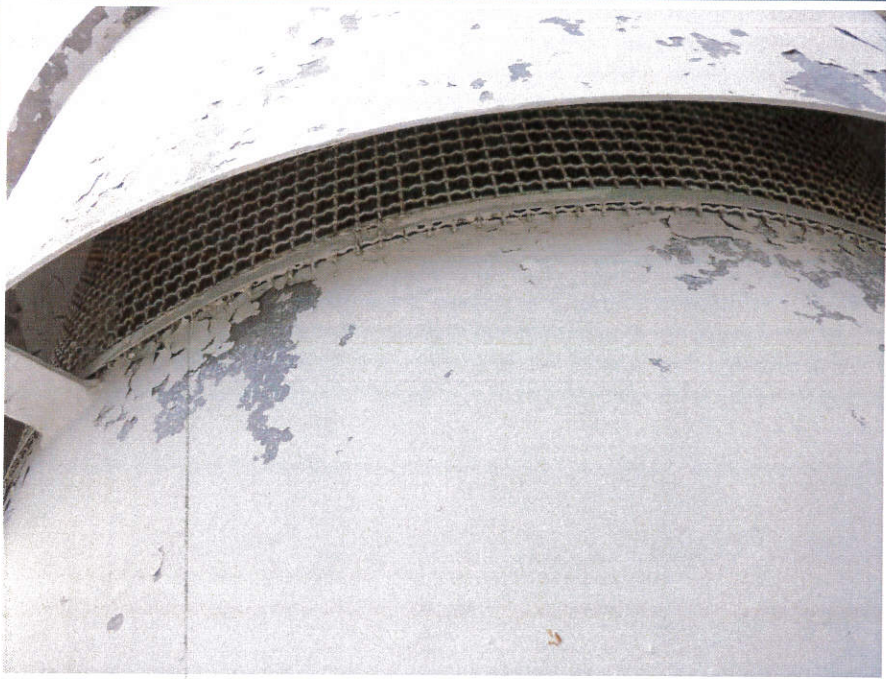
<b>Photo No. 1</b>

<b>Photo Date:</b> 11/15/22	
<b>Site Location:</b> Pleasant Lake Tank	
<b>Description:</b> Final Screen	
<b>Photo By:</b> MBK

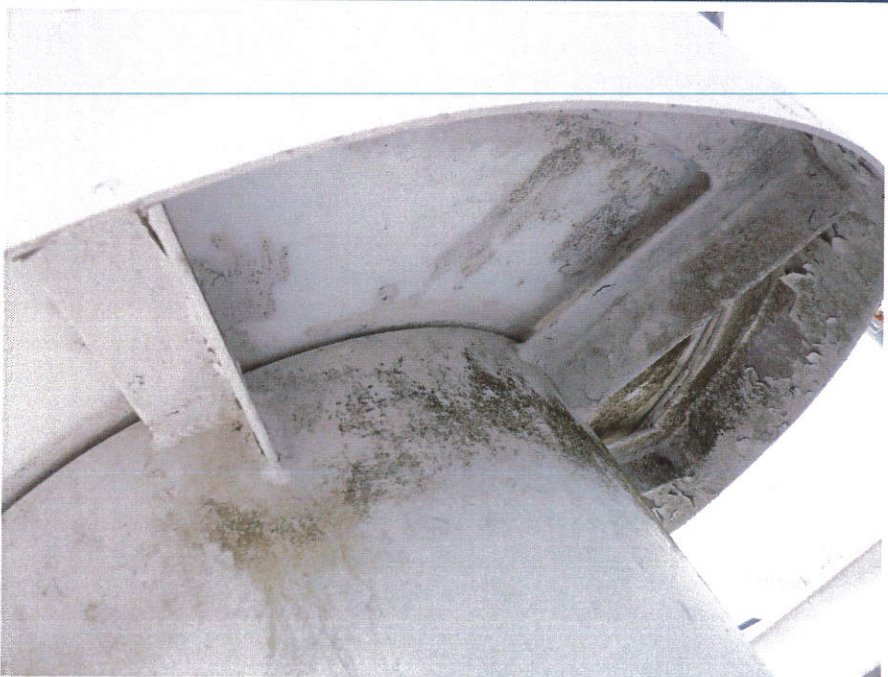
<b>Photo No. 2</b>

<b>Photo Date:</b> 11/15/22	
<b>Site Location:</b> Pleasant Lake Tank	
<b>Description:</b> Final Vacuum Pallet	
<b>Photo By:</b> MBK

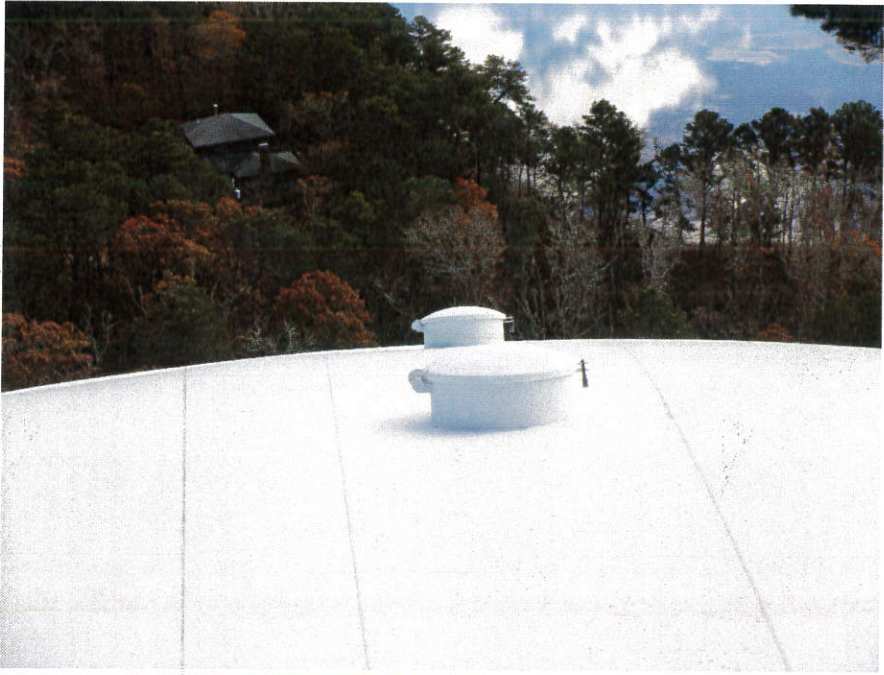
<b>Photo No. 3</b>

<b>Photo Date:</b> 11/15/22	
<b>Site Location:</b> Pleasant Lake Tank	
<b>Description:</b> Roof hatches	
<b>Photo By:</b> MBK

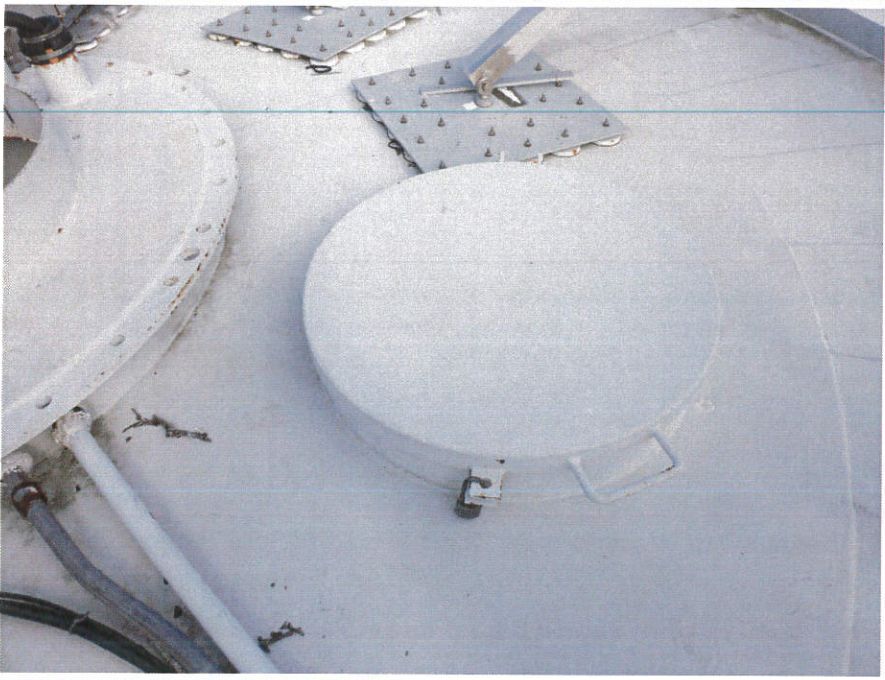
<b>Photo No. 4</b>

<b>Photo Date:</b> 11/15/22	
<b>Site Location:</b> Pleasant Lake Tank	
<b>Description:</b> Roof hatch	
<b>Photo By:</b> MBK

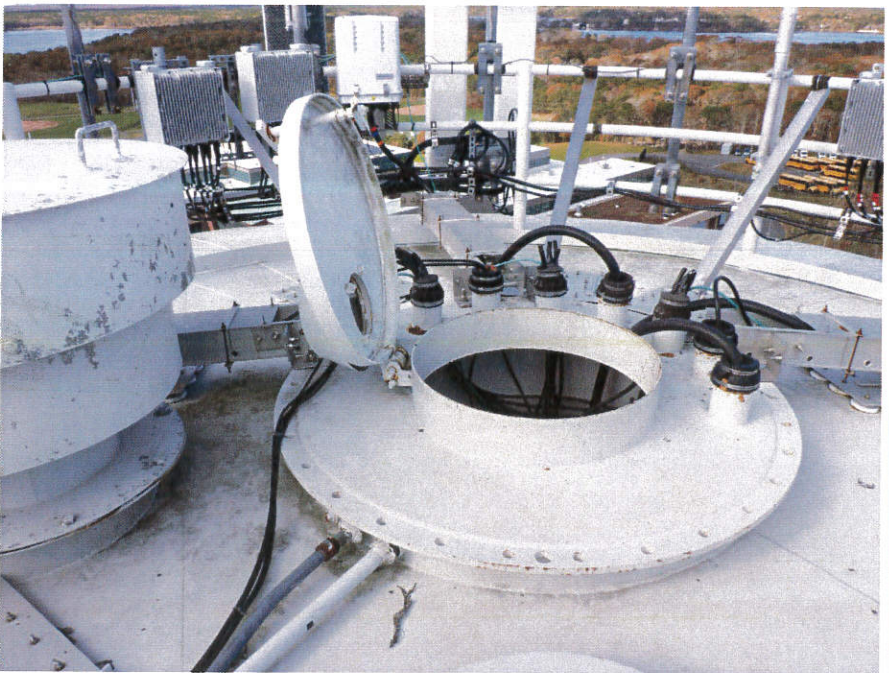
<b>Photo No. 5</b>

<b>Photo Date:</b> 11/15/22	
<b>Site Location:</b> Pleasant Lake Tank	
<b>Description:</b> Roof hatch	
<b>Photo By:</b> MBK

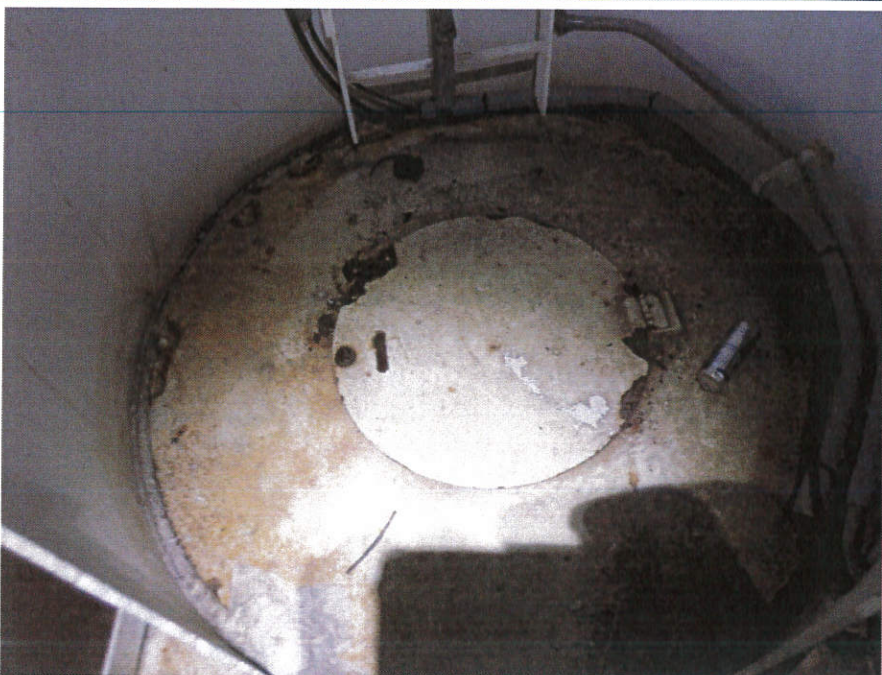
<b>Photo No. 6</b>

<b>Photo Date:</b> 11/15/22	
<b>Site Location:</b> Pleasant Lake Tank	
<b>Description:</b> Bowl access floor	
<b>Photo By:</b> MBK

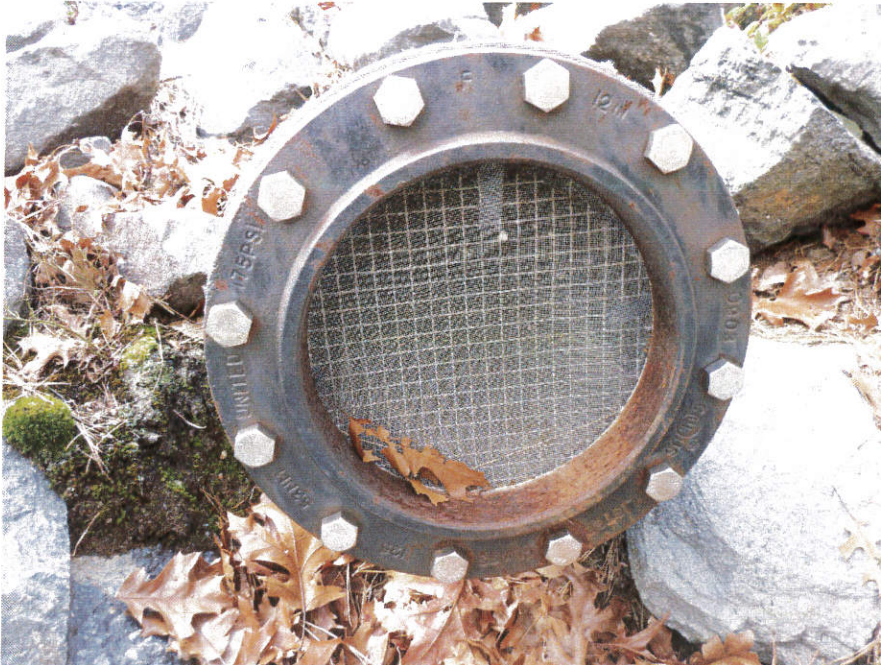
<b>Photo No. 7</b>

<b>Photo Date:</b> 11/15/22	
<b>Site Location:</b> Pleasant Lake Tank	
<b>Description:</b> Overflow screen	
<b>Photo By:</b> MBK

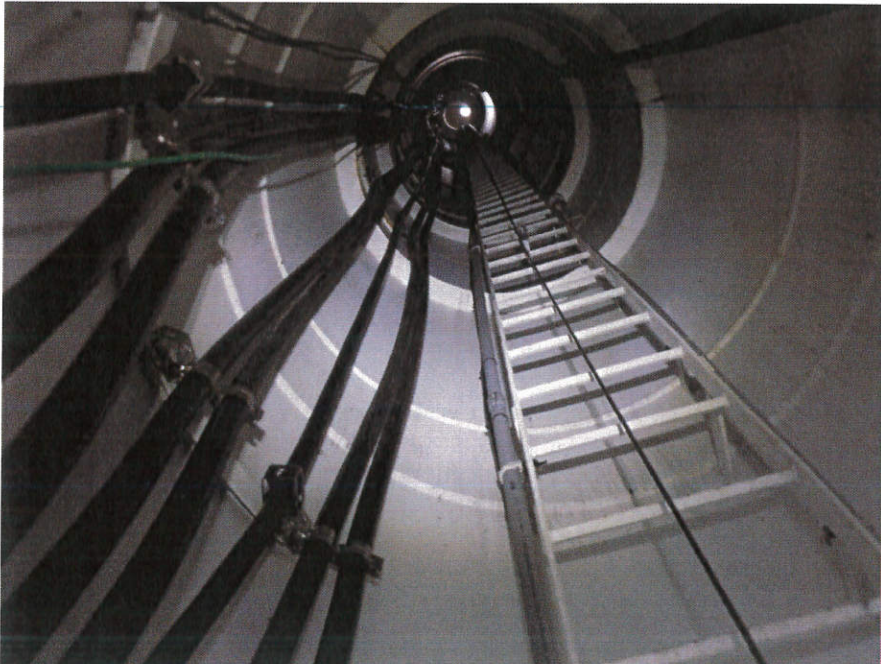
<b>Photo No. 8</b>

<b>Photo Date:</b> 11/15/22	
<b>Site Location:</b> Pleasant Lake Tank	
<b>Description:</b> Bowl access ladder	
<b>Photo By:</b> MBK

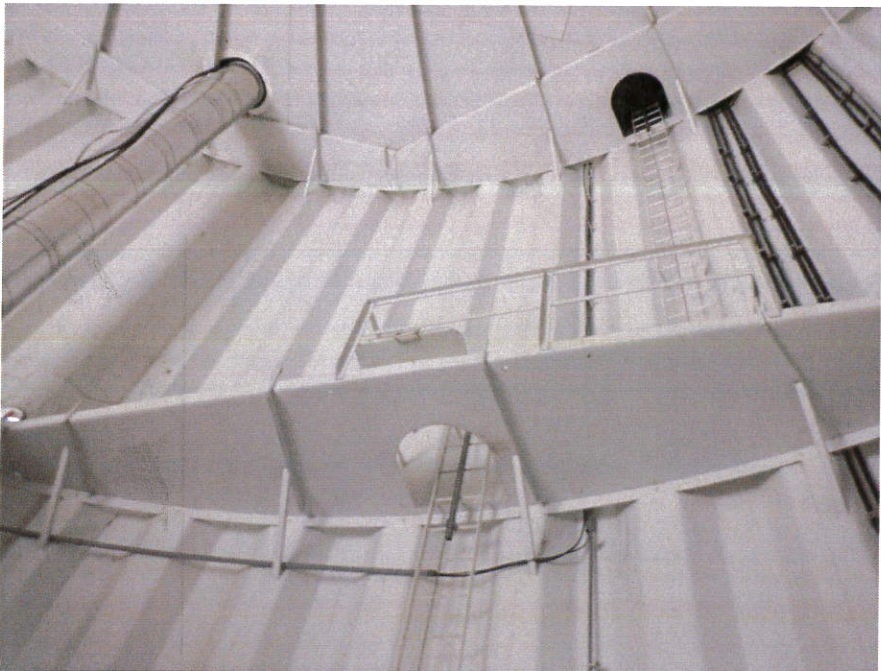
<b>Photo No. 9</b>

<b>Photo Date:</b> 11/15/22	
<b>Site Location:</b> Pleasant Lake Tank	
<b>Description:</b> Interior column	
<b>Photo By:</b> MBK

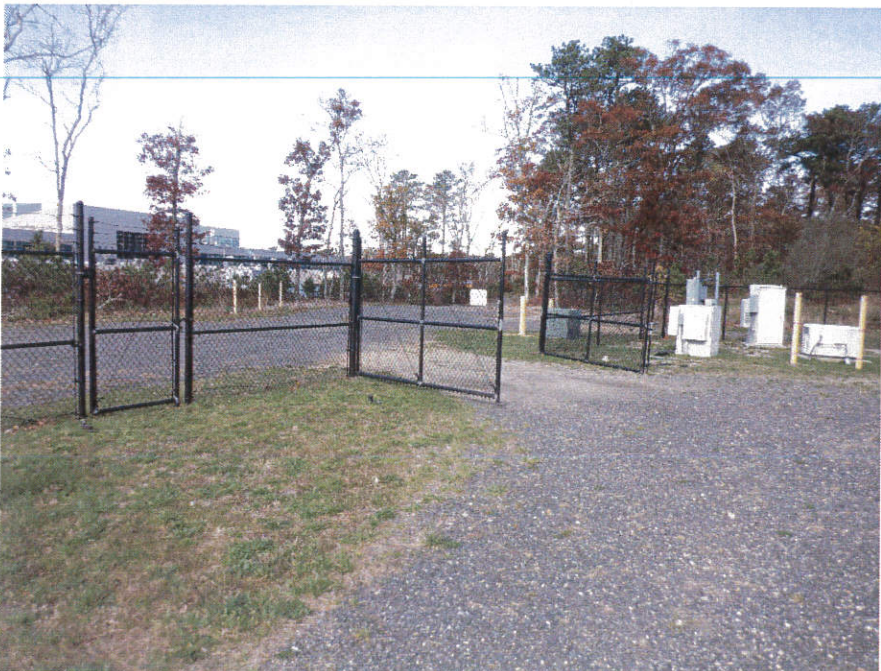
<b>Photo No. 10</b>

The site has a chain link fence which is in good condition, with locked gates, both of which are in good condition. The access roadway has a locked gate that is in good condition.

<b>Photo Date:</b> 11/15/22	
<b>Site Location:</b> Pleasant Lake Tank	
<b>Description:</b> Site fence	
<b>Photo By:</b> MBK

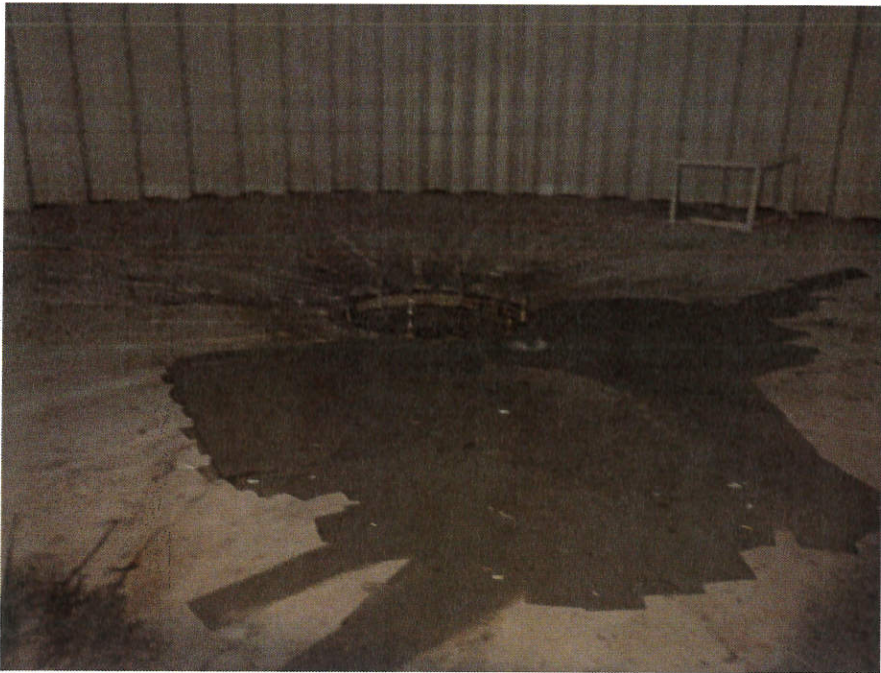
<b>Photo No.</b> 13

<b>Photo Date:</b> 11/15/22	
<b>Site Location:</b> Pleasant Lake Tank	
<b>Description:</b> Interior column	
<b>Photo By:</b> MBK

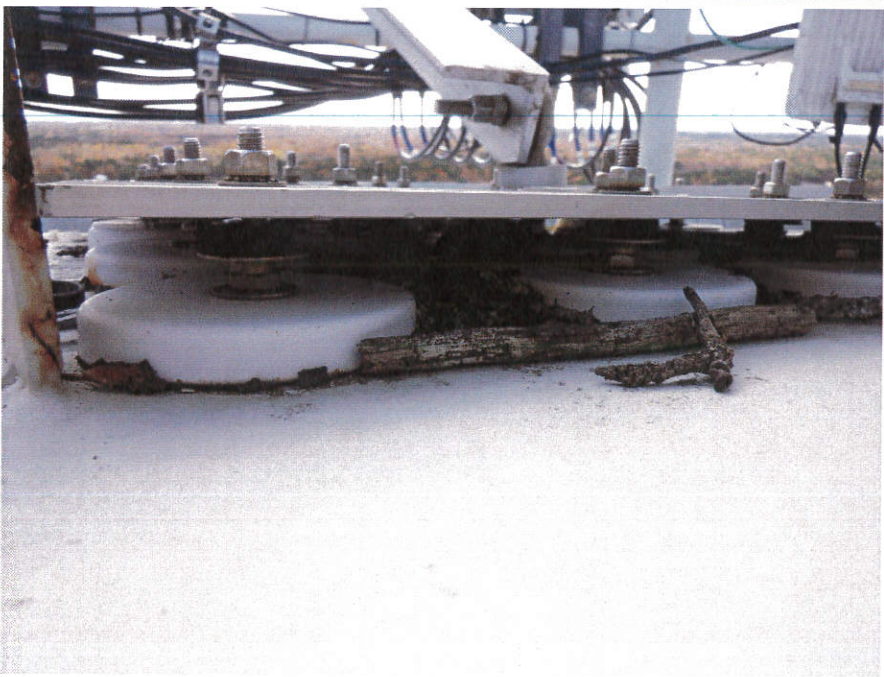
<b>Photo No.</b> 14

<b>Photo Date:</b> 11/15/22	
<b>Site Location:</b> Pleasant Lake Tank	
<b>Description:</b> Antenna magnets	
<b>Photo By:</b> MBK

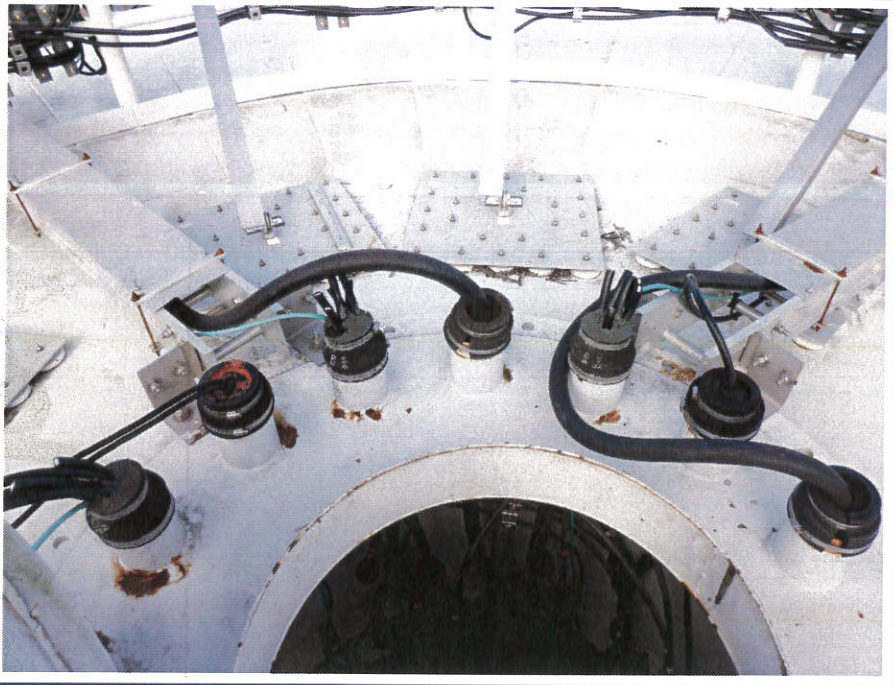
<b>Photo No.</b> 15

<b>Photo Date:</b> 11/15/22	
<b>Site Location:</b> Pleasant Lake Tank	
<b>Description:</b> Antenna cables	
<b>Photo By:</b> MBK

- a. Annual inspection completed by Haley Ward. We recommend:
  - i. Replace five (5) light bulbs in the interior column and access tube.
  - ii. Communication equipment rubber boot seals on the roof at the access tube have deteriorated. Not expected to be a major issue, but equipment owners could be notified.

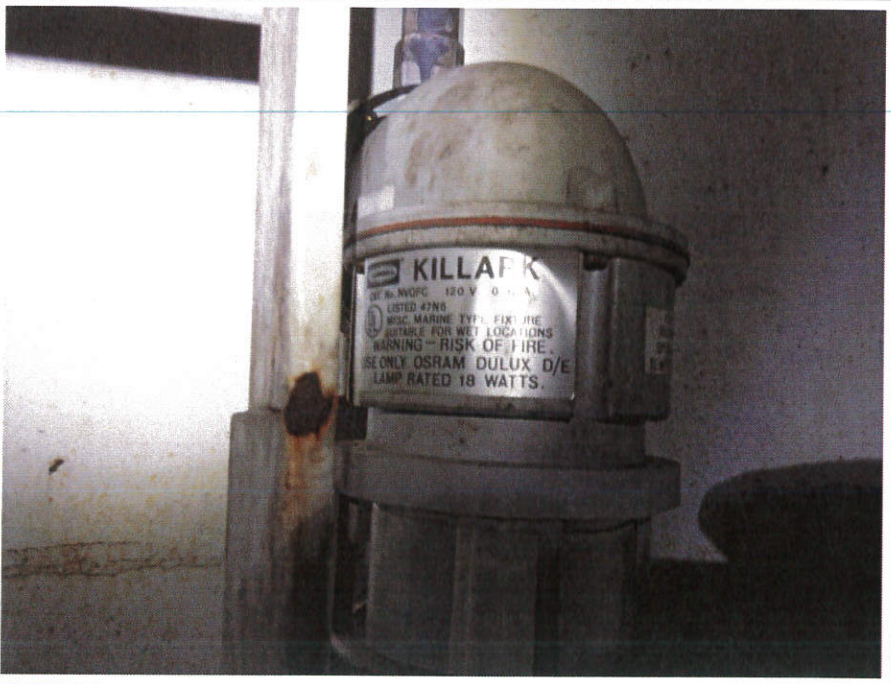
<b>Photo No.</b> 16

<b>Photo Date:</b> 11/15/22	
<b>Site Location:</b> Pleasant Lake Tank	
<b>Description:</b> Light fixture needs bulb replacement	
<b>Photo By:</b> MBK

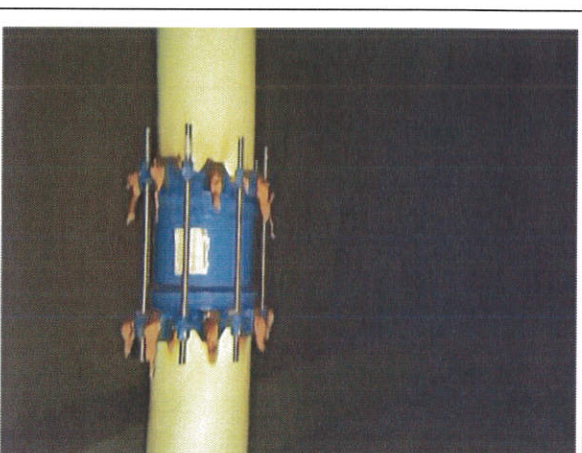
18) Repair clamp on inlet pipe 9:32

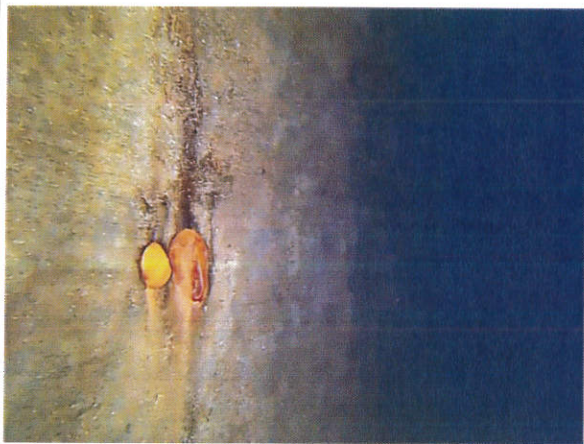
19) Isolated corrosion cells on shell 10:51

- a. No action recommended from full inspection; tank in good working order and in compliance with DEP guidelines and OSHA standards.
- b. Monitor isolated interior corrosion cells from assumed exposed steel. These are not uncommon, but should be further investigated in the next full inspection, by 2027. Per CorrTech's report, these are not actionable at this time.

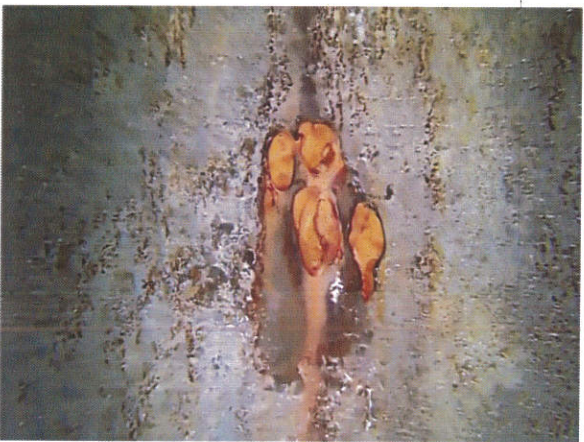
20) Close up of corrosion cells on shell  
11:17

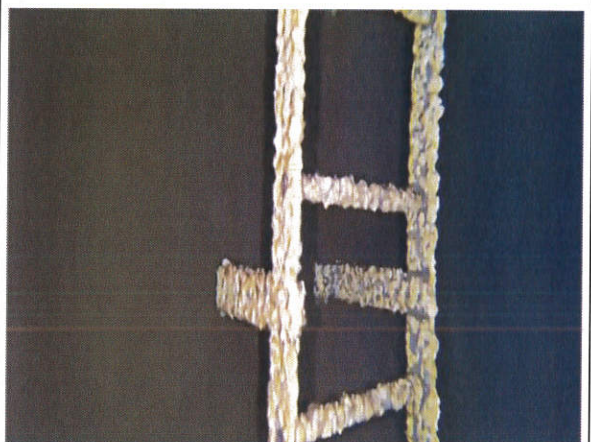
23) Widespread corrosion on interior ladder  
16:55

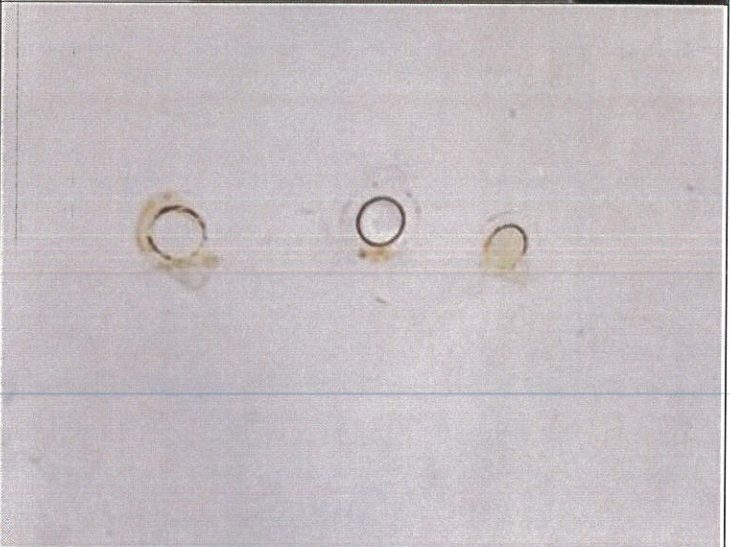
2.	View of glue failures on tank shell

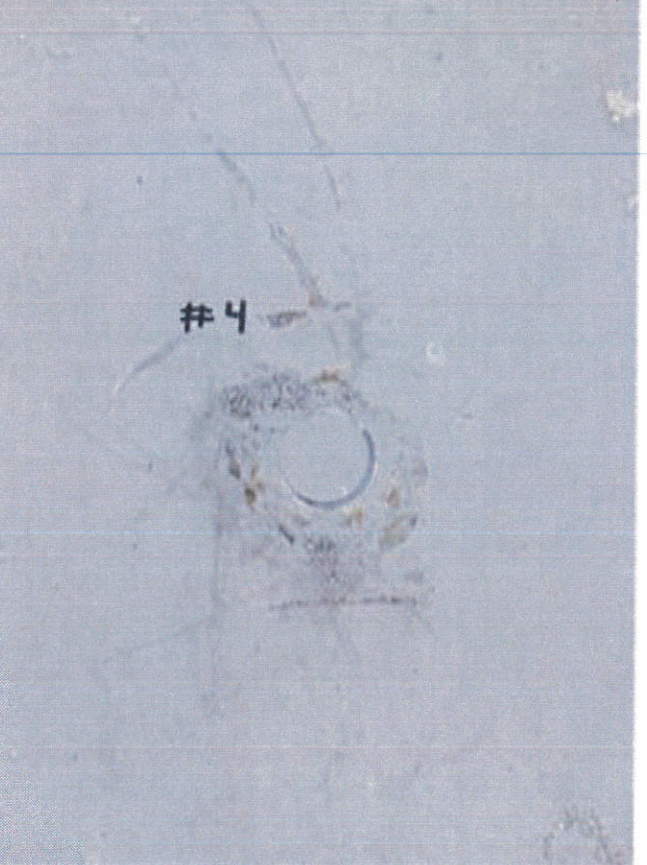
A photograph showing a circular dolly with a blue center and a yellow base, mounted on a light-colored, textured roof surface. The number "#4" is handwritten in black marker above the dolly. The surface appears clean and ready for testing.
4.	Glue failure on roof after ASTM D4541 adhesion test

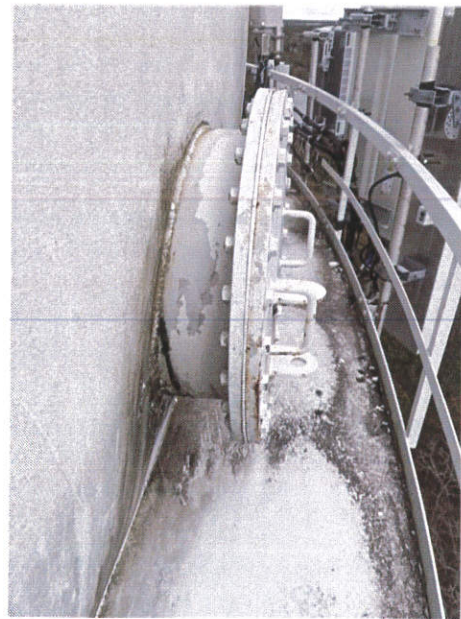
13) Clockwise view of balcony with mildew staining

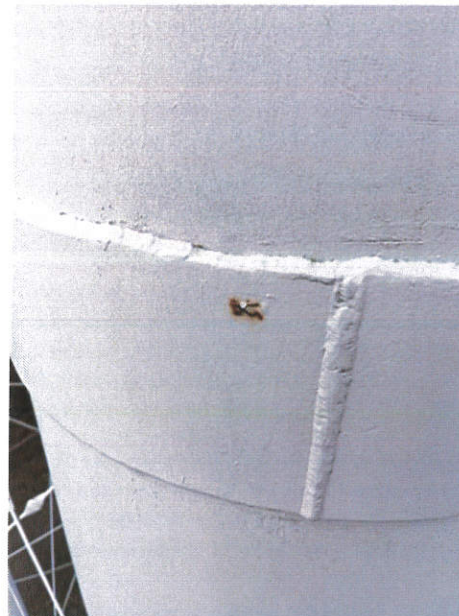
16) View of bowl underside with some surface rust

1. Rt. 39 Tank
  - a. No immediate action recommended.
  - b. We understand the intent is for this tank to be replaced in FY31 and not to pursue rehabilitation until that time.
  - c. Monitor the condition of the top tower rods, cylinder rods and erection rods, along with the clevises, pins and connecting plates. Monitor the underside of the bowl's bleed through corrosion. Per CorrTech's report, nothing is

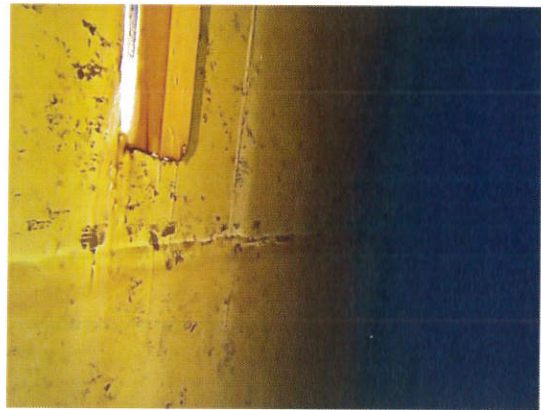
23) Edge corrosion has started at bottom of stiffener beam 4:46
