Town of Harwich Road Safety Audit Route 39 (Orleans Road) at Pleasant Bay Road

July 29, 2016

Prepared by the Cape Cod Commission in cooperation with the Town of Harwich and MassDOT Highway Division, Traffic Safety, and District 5 Offices.

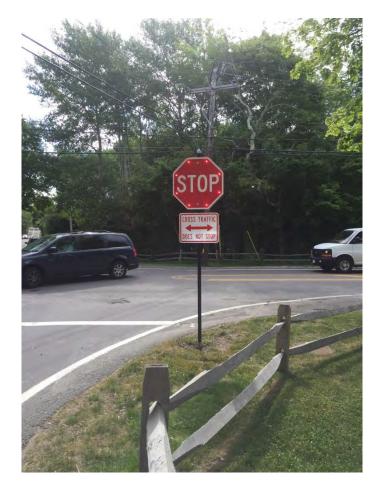
Figure 1 - View from Pleasant Bay Road looking east, showing LED stop sign

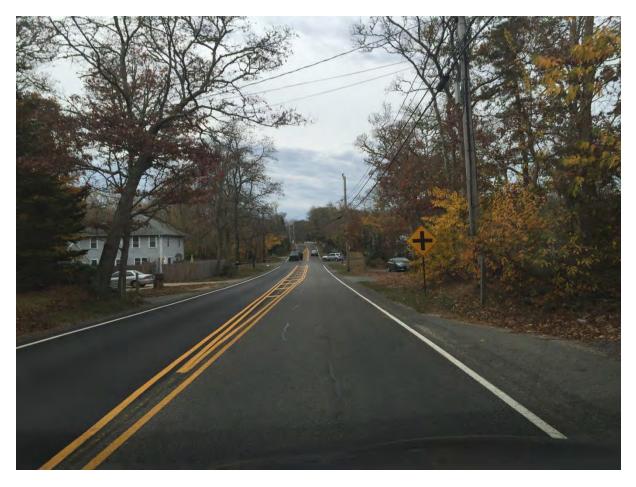
Figure 4 - View looking south, showing newly installed painted median

Team members also discussed the recently installed painted median, as shown in Figure 4 and Figure 9, and potential adjustments to it. Town staff noted that early feedback on the painted median (installed in November 2015) has been positive.

The installation of the painted median seems to give drivers on Pleasant Bay Road an impression that they are crossing a major road and that they should proceed with care. The effect on Route 39 drivers is less clear. While it certainly makes drivers take note of the intersection, it is unclear if it has slowed vehicle speeds.

One potential adjustment to the painted median would be to narrow the painted median and move the edge lines in, increasing the shoulder width. This would push Route 39 drivers away from the edge of roadway, allowing drivers on Pleasant Bay Road to stop a bit closer to Route 39 and improving sight lines.

Move edge lines in and narrow painted median

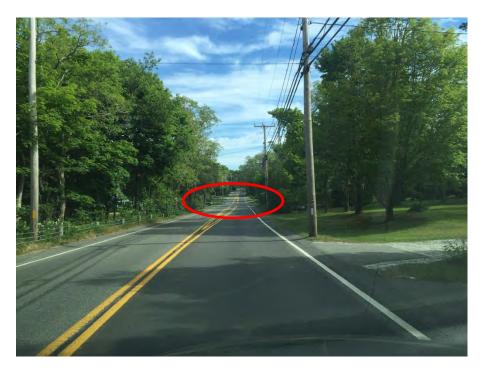
Obstructions on the southwest and southeast quadrant of the intersection are restricting the ability of drivers traveling north on Route 39 to see vehicles potentially crossing their path from Pleasant Bay Road. Figure 5 shows the view of a driver traveling northbound on Route 39 approximately 360 feet south of the intersection. This is the approximate distance required for a driver traveling 45 mph to identify a potential conflict and safely stop. Trees on the west side of Route 39 and hedges on the east side of Route 39 are **limiting drivers'** ability to see potential crossing vehicles.

Figure 5 - View looking north from Route 39 approximately 360 feet south of the intersection (intersection circled in red)

Remove trees and hedges to the south of the intersection that are currently obstructing sight lines

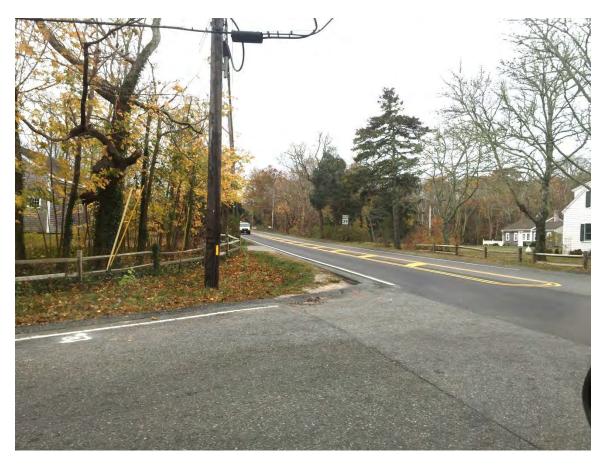
Figure 6 shows the view of a driver traveling westbound on Pleasant Bay Road looking south on Route 39. The hedges on the east side of Route 39 obstruct the view of oncoming traffic. Assuming vehicles on Route 39 are traveling 45 mph, a driver turning left out of Pleasant Bay Road should be provided clear sight lines to see vehicles 500 feet south down Route 39. The current available sight distance is less than 500 feet.

Figure 6 - View looking south down Route 39 from the Pleasant Bay Road eastbound

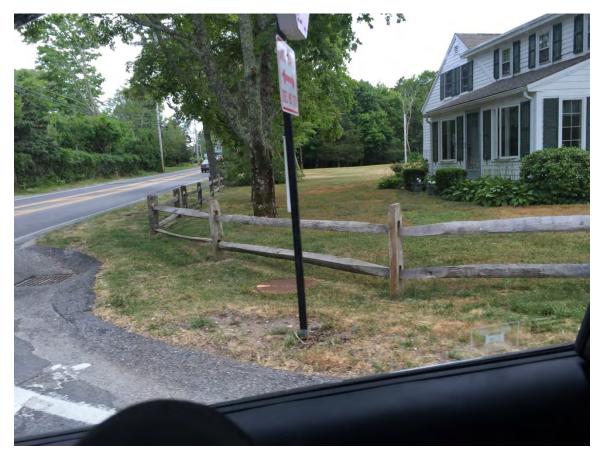
Figure 7 shows the view of a driver traveling eastbound on Pleasant Bay Road looking south on Route 39. The trees on the west side of Route 39 obstruct the view of oncoming traffic. Assuming vehicles on Route 39 are traveling 45 mph, a driver turning left out of Pleasant Bay Road should be provided clear sight lines to see vehicles 500 feet south down Route 39.

Figure 7 - View looking south down Route 39 from the Pleasant Bay Road westbound

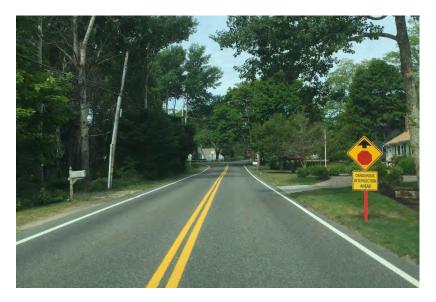
Another obstruction noted was a tree on the north side of the westbound Pleasant Bay Road approach partially blocking the view of the LED stop sign as shown in Figure 8. This obstruction partially obscures the LED stop sign when drivers are more than 300 feet from the intersection. From 300 feet in, the LED stop sign is fully visible. The advanced stop signage is visible from well beyond 500 feet of the intersection.

Given that the sign is visible well advanced of the intersection, censuses was that removing this tree would not have a significant safety benefit. Adding a supplemental stop sign on the left sign of the road, as discussed in the next section of the report, would likely have a greater safety benefit.

Figure 8 – Pleasant Bay Road westbound approach showing partially obscured stop sign

Install secondary (left side) stop signs on Pleasant Bay Rd westbound approach

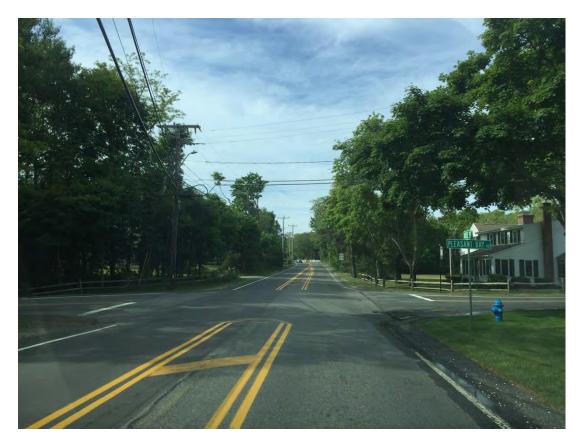
The placement of stop lines and stops signs at both Pleasant Bay Road approaches was discussed extensively by team members. Moving the stop lines closer to Route 39 encourages drivers to stop closer to Route 39 providing for better sight lines. However, moving the vehicles closer to Route 39 also presents issues for vehicles, particularly large trucks, turning onto Pleasant Bay Road.

Proper placement depends in large part on the degree to which vegetation is removed within the intersection sight triangles. As such, the placement of the stop lines and stop signs should be reassessed after such changes to the intersection are made.

Figure 9 – Looking south on Route 39, showing stop line placement on Pleasant Bay Road

Review stop sign and stop line placement

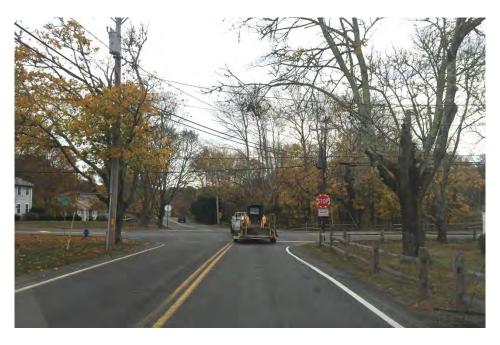
Team members discussed making improvements to the Pleasant Bay approaches to ensure drivers are aware that they will be required to stop at the intersection. Improvements to, that end that have been completed by Town staff to date, include the installation of stop ahead signage and flashing LED stop signs as shown in Figure 11. Additional potential improvements discussed include installing a secondary (left side) **stop sign eastbound approach and installing "Stop Ahead" pavement markings on both** Pleasant Bay Rd approaches. It was noted that any pavement markings placed in the travel lanes should use an application technique designed to maintain skid resistance, particularly in consideration of motorcyclist and bicyclists.

Figure 11 – Looking east on Pleasant Bay Road, showing LED stop sign

Install "Stop Ahead" pavement marking on both Pleasant Bay Rd approaches

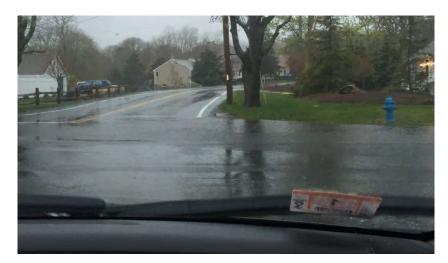
While the intersection appeared to generally be well-designed for drainage, a team member noted seeing some ponding during a recent heavy rain event. This ponding is shown in Figure 13.

Figure 13 - Looking west, showing ponding during heavy rain event

Clean/repair catch basin as necessary

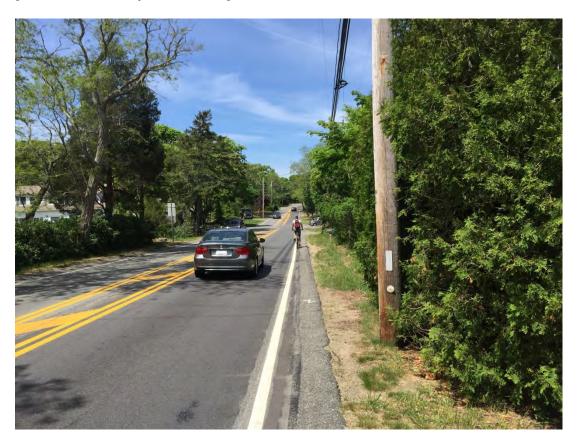
While this intersection does not typically experience a high level of pedestrian or bicyclist activity, it was acknowledged that it is an important route for some non-motorists. Figure 15 shows a bicyclist traveling north on Route 39.

Figure 15 – Bicyclist traveling north on Route 39

There is no dedicated accommodation for pedestrians or bicyclists at the intersection and very little shoulder on the approaching roadways. While many team members expressed a desire to safely accommodate non-motorists, they recognized that isolated improvements at this intersection may not be of particular value. In the event that a geometric change is made to this intersection, consideration should be given to improving bicycle and pedestrian accommodation.
