Summary of Findings: 5 Bells Neck ESA Phase 2

**PHASE II
ENVIRONMENTAL SITE ASSESSMENT**

5 Bells Neck Road
Map 10 Parcel G1
West Harwich, MA 02671
Project #BEA10-10288

BENNETT ENVIRONMENTAL ASSOCIATES, INC.

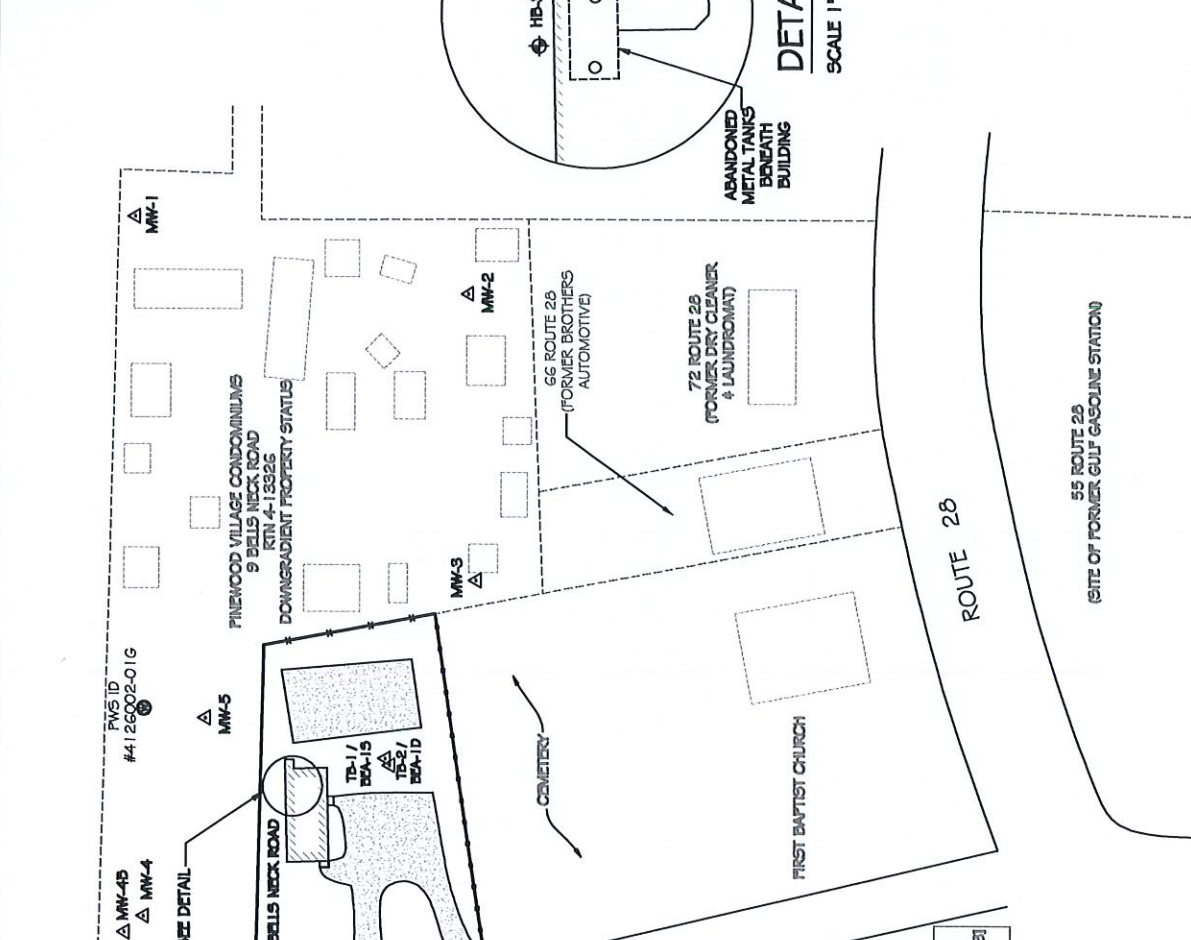
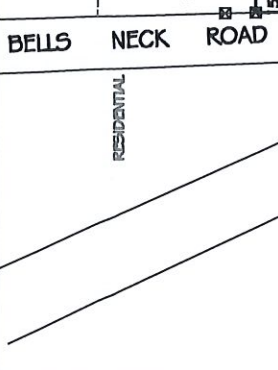
SKETCH PLAN

FORMER DRY CLEANER
 13 HALL STREET - KTN 4-12932
 CLASS C-1 RAO
 0.40 MILES SW (++)

FORMER DRY CLEANER
 CORNER OF DIVISION STREET & ROUTE 28
 (PER SAC ENG. REPORT DATED MARCH 2008)
 0.30 MILES SW (++)
