# CRANBERRY VALLEY GOLF COURSE

## CART PATH MASTER PLAN

### ***SUMMARY OF PATH MODIFICATION RECOMMENDATIONS***

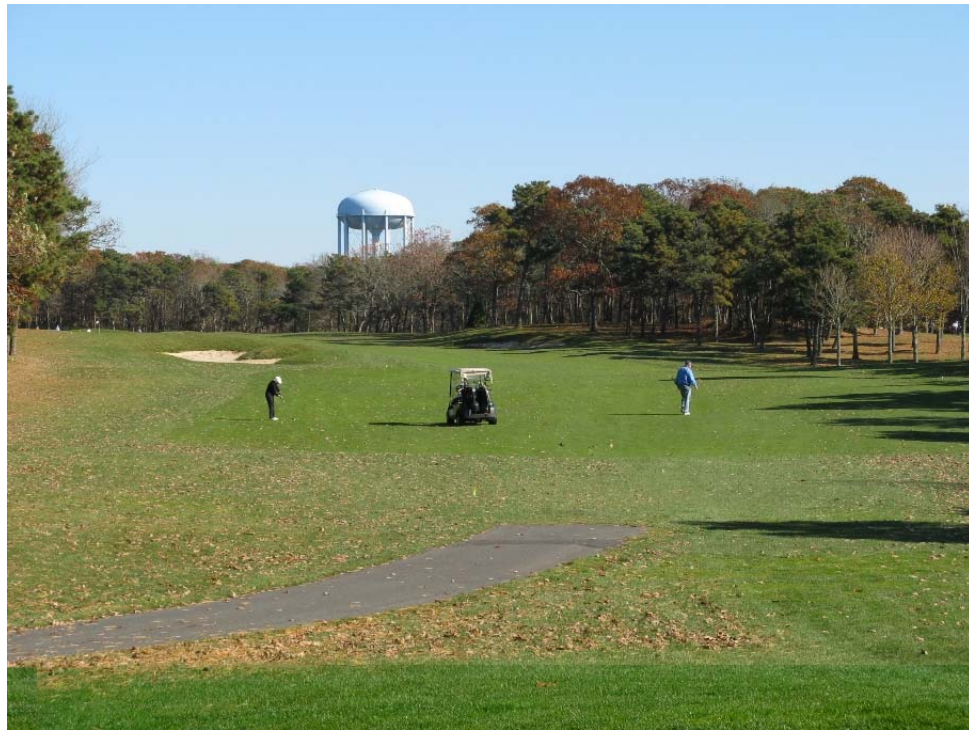
- The problem with the path at #2 tee is that it ends directly in front of the tee, resulting in weak and flattened turf directly in the line of view from the tee. This ruins the visual character of the hole. We have proposed removing the end of the path and shifting the end to the right side of the hole near the start of the fairway. In this configuration, although carts can still leave the path directly in front of the tee, carts can egress along the width of the hole, resulting in less concentrated wear. The course can at times restrict egress to the end to reduce wear in front of the tee

*Avoid path endings directed at middle of fairway, such as here on Hole #2*

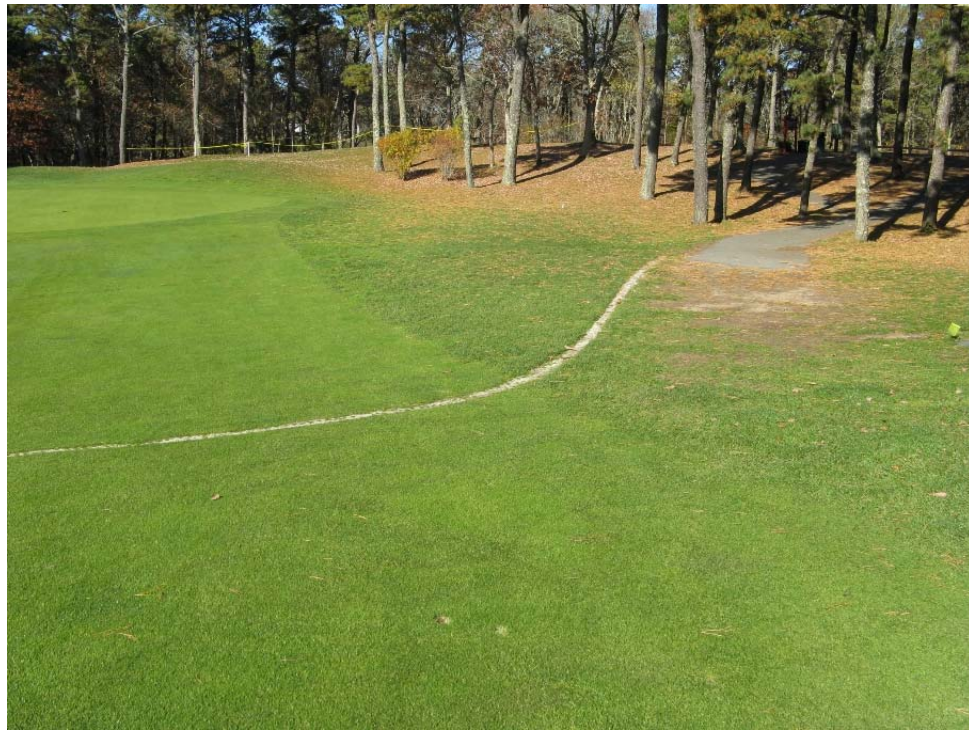
*The use of a line across the approach helps preserve turf near green but causes excessive wear at start of path*

- The angle and location of the path beginning to the right of the green directs carts to the same point of the fairway, creating poor turf conditions and depressions. The end of the path should be eliminated and the path extended about 175 feet behind and along the tree edge. Consider expanding the fairway right after extending the path.

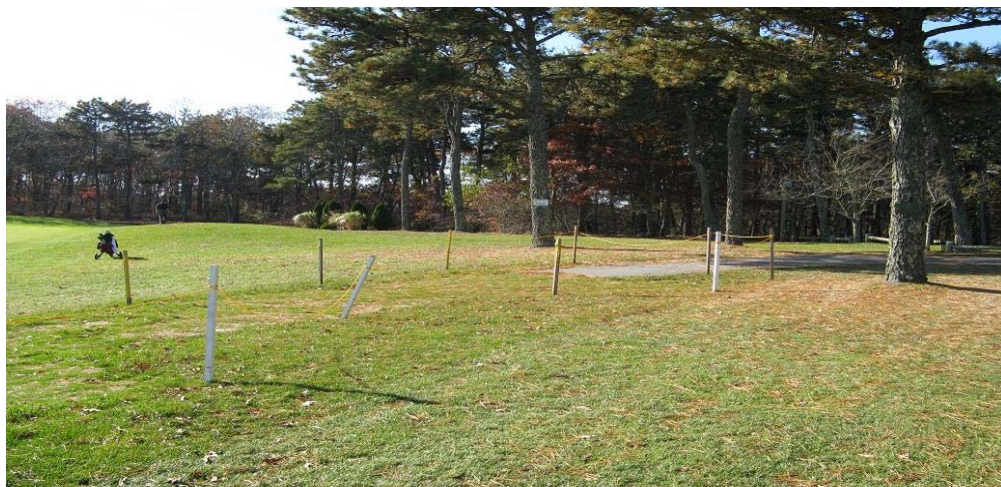
*Consider extending path on #8 to turn-around right of green*

- We have also proposed extending the path to the right side of the green. The current end of path funnels all foot traffic onto the front right of the putting surface. The large number of handicap carts already drives to the right of the green. Extending the path and adding a turn-around will vary and improve the access.

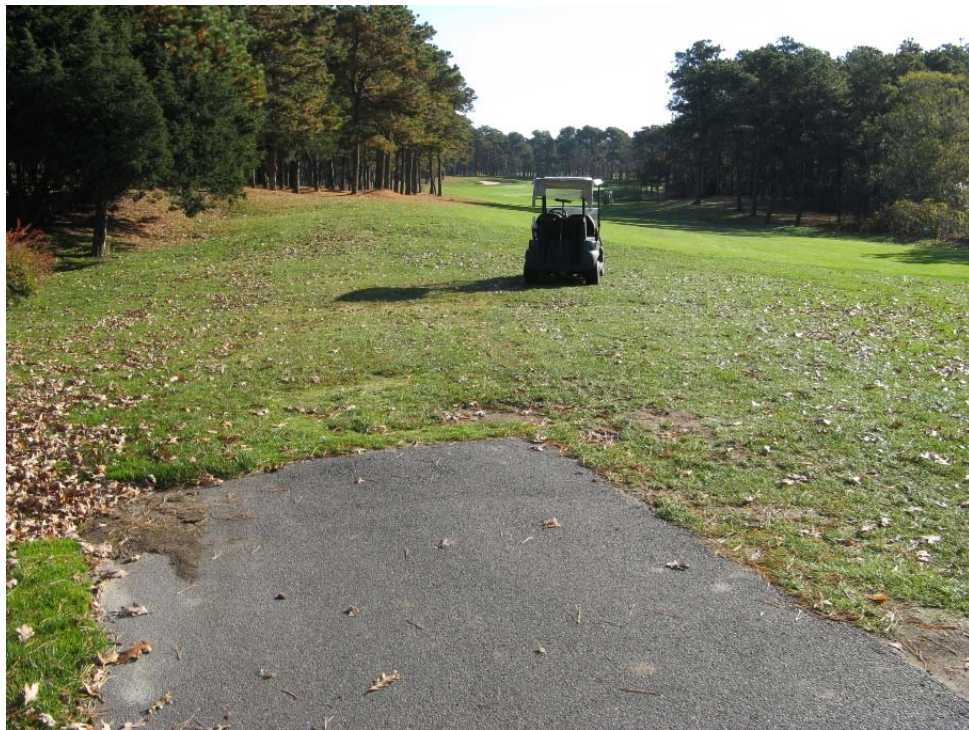
- The cart path on the tenth hole is one of the more difficult ones to figure out. Players currently drive off the end of the tee path directly toward the fairway, creating worn turf and compacted ground near the start of the fairway. All carts leave the path at the same location rather than at different points. My initial advice is to gently curve the end of the path so players drive off at different locations.
- The fairway and hole corridor on #10 is very narrow. Carts are concentrated in a small, shaded area. The proximity of hole #13 to the left, and wetlands to the right, make expansion and shifting of the path to the outside of the hole problematic. A path between 10 fairway and 13 green should be avoided.

*Turf conditions on the narrow 10<sup>th</sup> hole would be improved with a continuous path*

- With the existing path to the right of #10 green, and the difficulty with setback from 13 green on the left, it would seem logical to continue the path down the right side, but this area is protected from development because of wetlands. At other courses, we have received permission to install timber pile supported boardwalks across wetlands for use by carts and thought this might be the best solution here. A path on the right will also require removal of several trees and the filling of a hollow where soil was formerly removed.
- It seems many carts currently go to the left of the green, and there is a maintenance path just into the trees on this side that could easily be upgraded. If construction of the path modifications to the right is not feasible, I recommend removing a few trees and paving this path as an alternate access to the green.

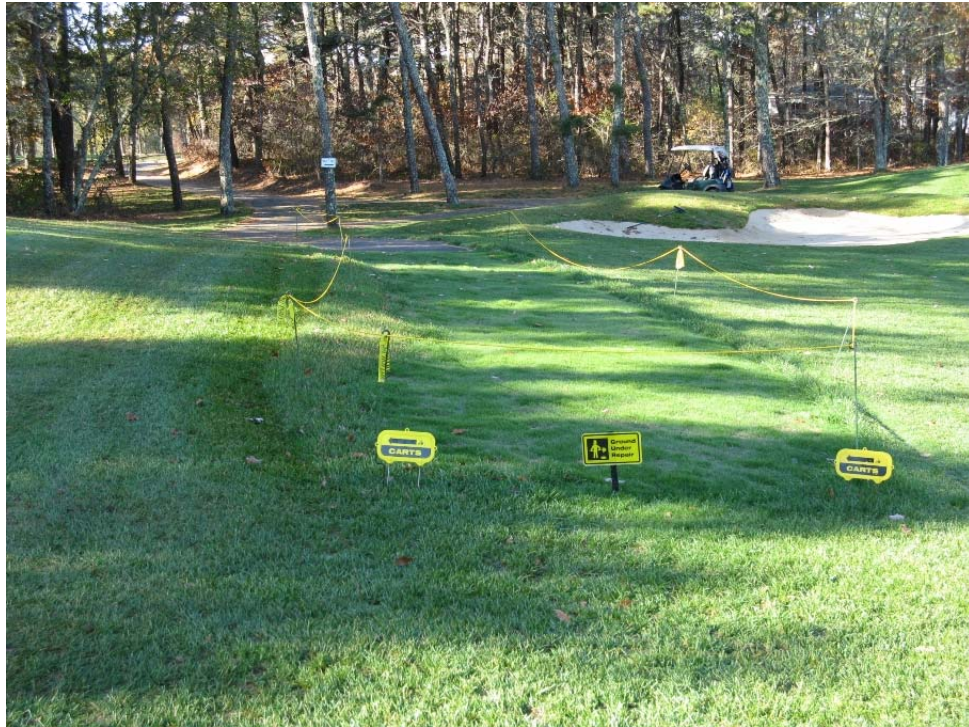
- The current greenside path provides no access options, resulting in a significant worn area extending into the fairway at the end of the path. The problem area is compounded by an adjacent burial area. The plan shows the path being extended about 250 feet toward the tee to greatly improve the potential access points. A few trees may require removal to facilitate path development and the irrigation main will need to be avoided.

*Eliminating worn areas, such as here on #12, are a constant battle*

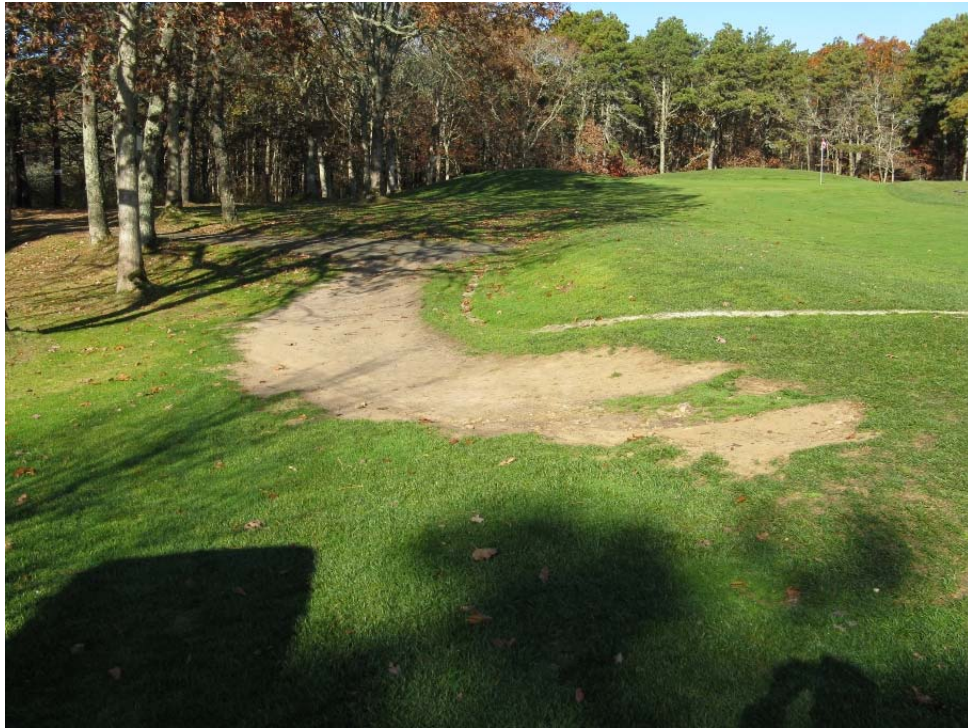
*The beginning of path at #14 green must be extended to alleviate barren area*

- Widen path between tees to improve access for emergency vehicles.
- Consider adding new path between tees to left side of fairway. If not installing continuous path, this addition is likely not required. The path is shown to continue along the right side of the hole, with several trees requiring removal.
- Due to limited access to the end, the path at the green should be extended about 150 feet to eliminate the barren area at the current end.

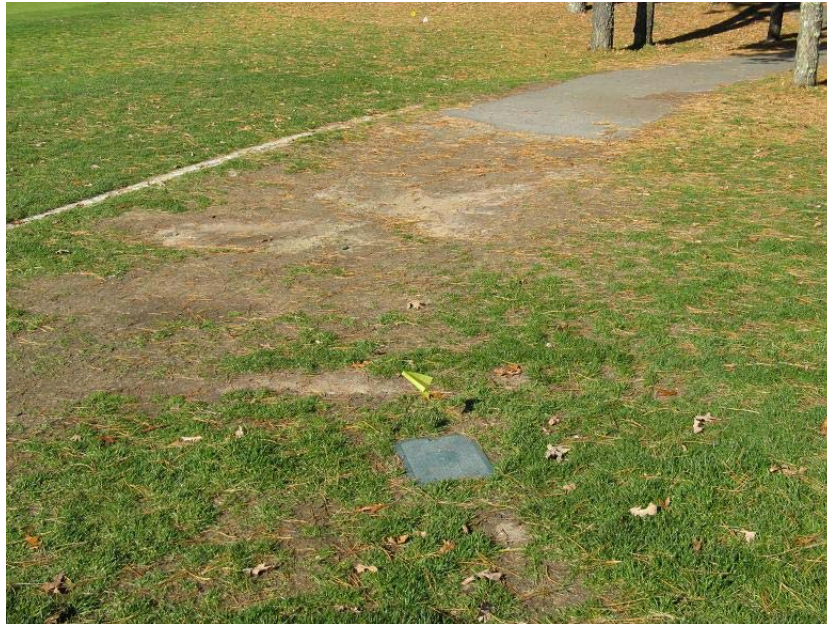
*Be mindful of irrigation installation and burial areas when routing new paths*

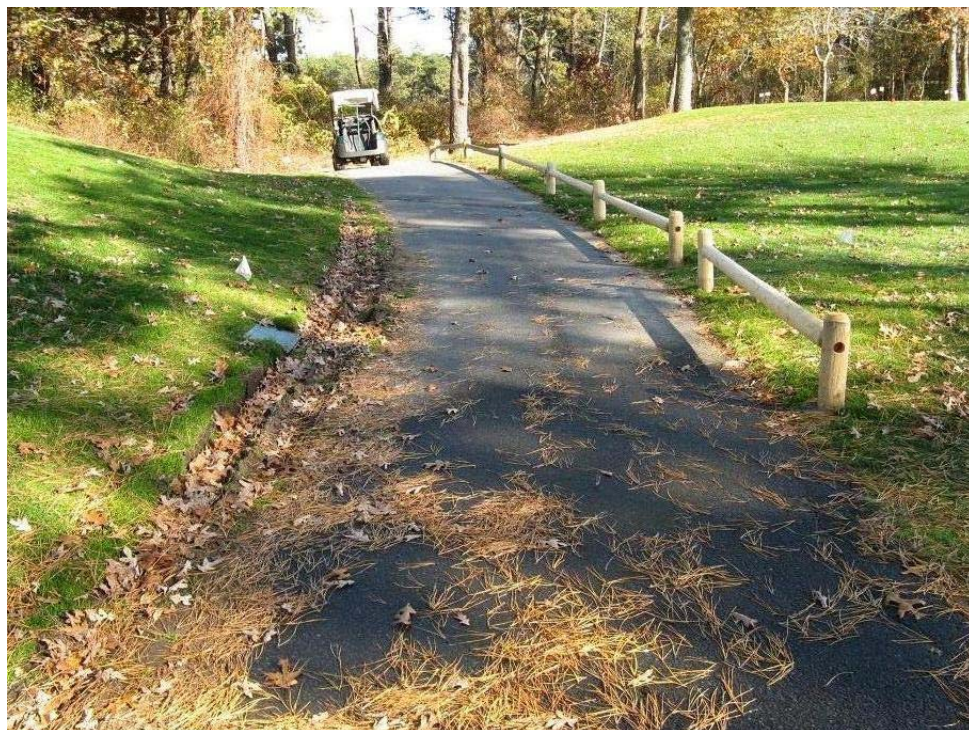
*The path between tees on Hole #1 is too narrow, resulting in ruts along edge*

- We discussed improving emergency access to the front nine of the golf course. It seems that the best access to these holes is through the first tee. The existing path between the tees is too narrow for the wheel base of emergency vehicles and should be widened to better accommodate them.

Consideration was given to improving the ability to access the course with emergency vehicles. A high priority of this work should be widening the path between the tees on Hole #1 and continuing this path up the left side of the first hole and across #4 so emergency vehicles can better access the front nine holes. Most of the emergency access path utilizes maintenance paths in the woods between the holes. Upgrading of these paths by widening, grading and adding of base material will be necessary in some locations.
