Town of Harwich  
HDHC  
RE: 24 Freeman Street Harwich Port

December 14, 2022

CEC Project No: C22028.01

**RE: Existing Structural Conditions Assessment  
24 Freeman Street, Harwich Port, MA**

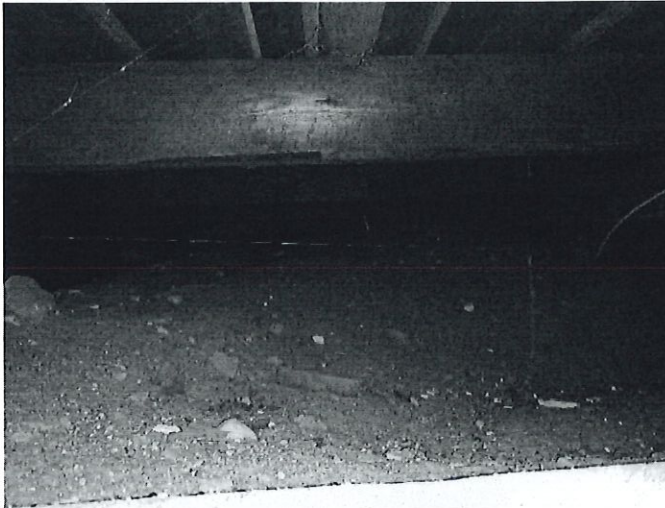
The first-floor framing appears to be in fair condition throughout, with an area of failed members in the living room area. Access to review these failed members was found via a hole in the floor. The members were found to have failed and were resting on the crawlspace floor below. There also appears to be a beam failure closer to the front chimney. In review of the members from the full basement, they appeared in relatively sound condition, with the exception of some members with deterioration at the bearing ends and one member that was found to be augmented and repaired. Some shoring was found to be supporting some floor framing elements in this area. Access to review the sill beams was limited, but due to the elevation of the grade relative to these members, deterioration is likely. The integral foundation support system for the first-floor beams is scattered and appears to be somewhat random at the crawlspace elevation. This is most likely due to reinforcing done over the years to supplement inadequate floor joist members. Floor slopes were present throughout the first floor, indicating the member sizes are likely undersized for their current use. To remedy the floor slopes, the floor system would require substantial replacement and/or augmentation.

Photo 1: Framing at crawlspace

While portions of structure appear to be currently stable, much of the foundation and framing are in need of augmentation/replacement to remain stable and to extend the useful life of the building. When a new foundation structure is provided, a new first floor framing system would be recommended in conjunction. The existing internal footing supports would not allow for a simple interior support system and would require many supports randomly placed throughout the interior. Given this assessment, much if not all the structural elements of the building superstructure will need to be augmented to provide a complete load path and to ensure that the members meet the requirements of the Code. Given the extensive scope of structural replacement and/or augmentation, which would essentially involve all the structural elements in the building, any renovation in place option may be onerous when considering other reconstruction options. The Code requires that any new structural elements, or elements that are augmented meet the Code for new construction. Given the condition of the structure and the Code requirements, CEC believes that a replacement of the structure in its entirety is likely warranted.

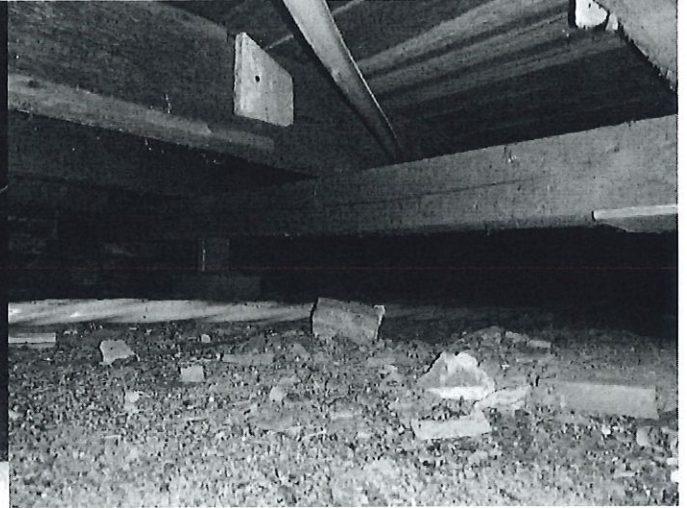
Photo 2: Exterior wall and support at crawlspace

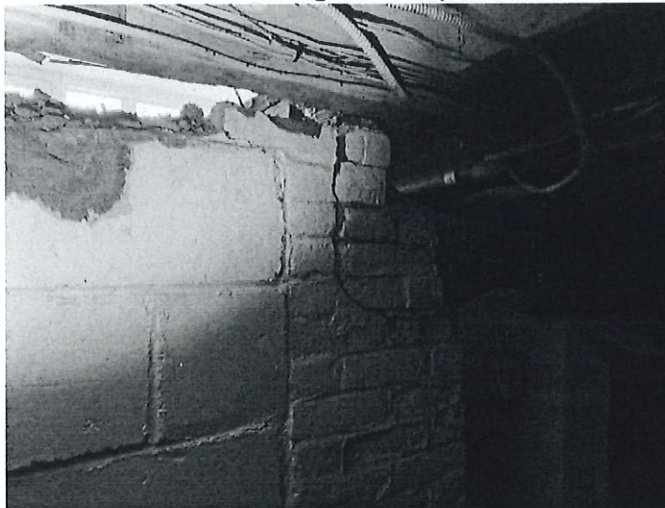
The structure is a two-story residence with an attached garage. The foundation system is combination of a crawl space and a full basement, with a concrete slab-on-grade at the garage. The foundation appears to mostly be a combination of brick and concrete masonry unit (CMU) block. The crawl space is brick foundation walls extending at unknown amount below grade. The basement area appears to have brick at the top of the wall with CMU below. This is likely due to the addition of the basement to the existing structure at some point. It is assumed that there is a footing supporting the CMU wall, but this could not be confirmed during this assessment. There is a concrete slab on grade at the basement, with natural subgrade at the crawlspace.

Photo 3: Brick wall and CMU wall

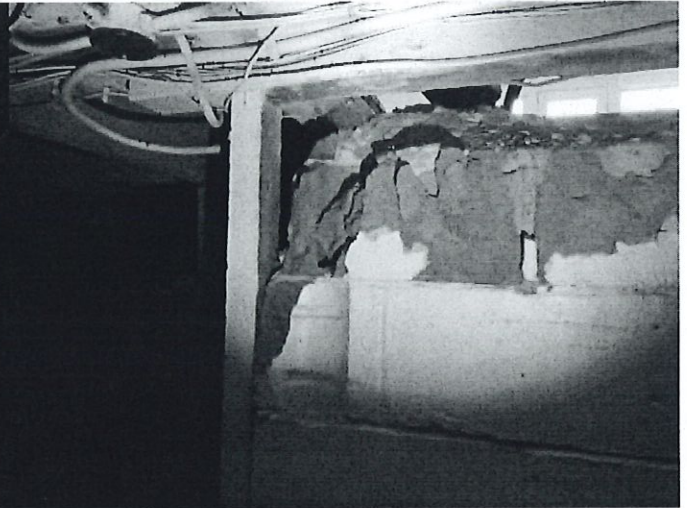
Photo 4: CMU wall with framing above

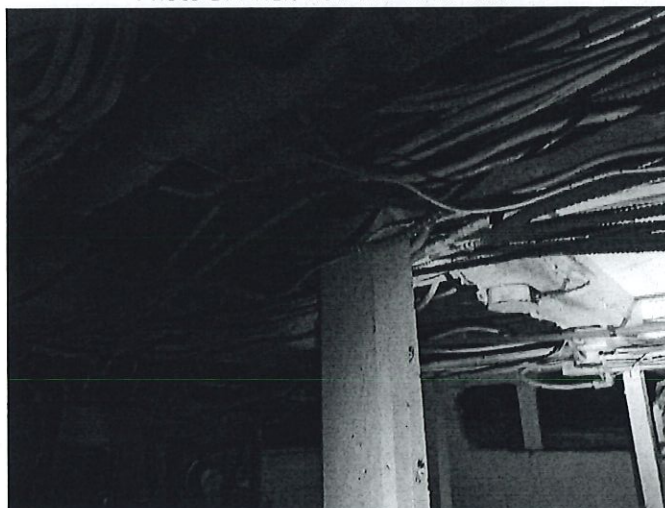
Photo 5: First floor support post

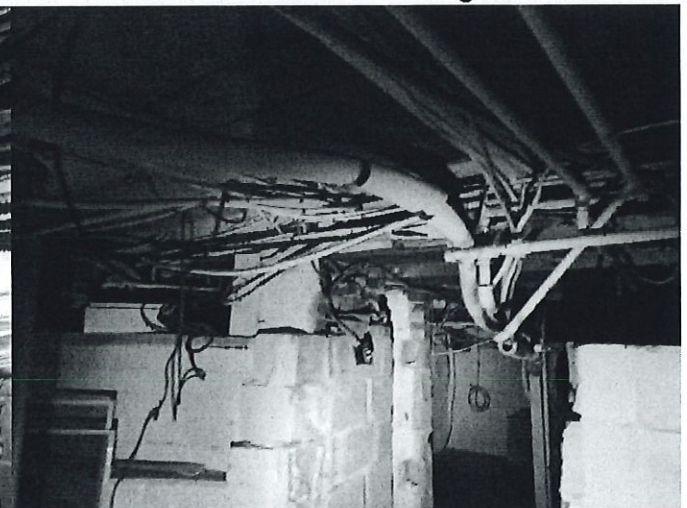
Photo 6: First floor framing and floorboards
