**Resource Assessment  
to Evaluate Ecological & Hydrodynamic Responses  
to Reinstalling a Water Control Structure  
in the Muddy Creek Dike**

**University of Massachusetts Dartmouth  
School for Marine Science and Technology**

**Applied Coastal  
Research & Engineering**

***DRAFT FINAL REPORT - REVISED –NOVEMBER 2008***

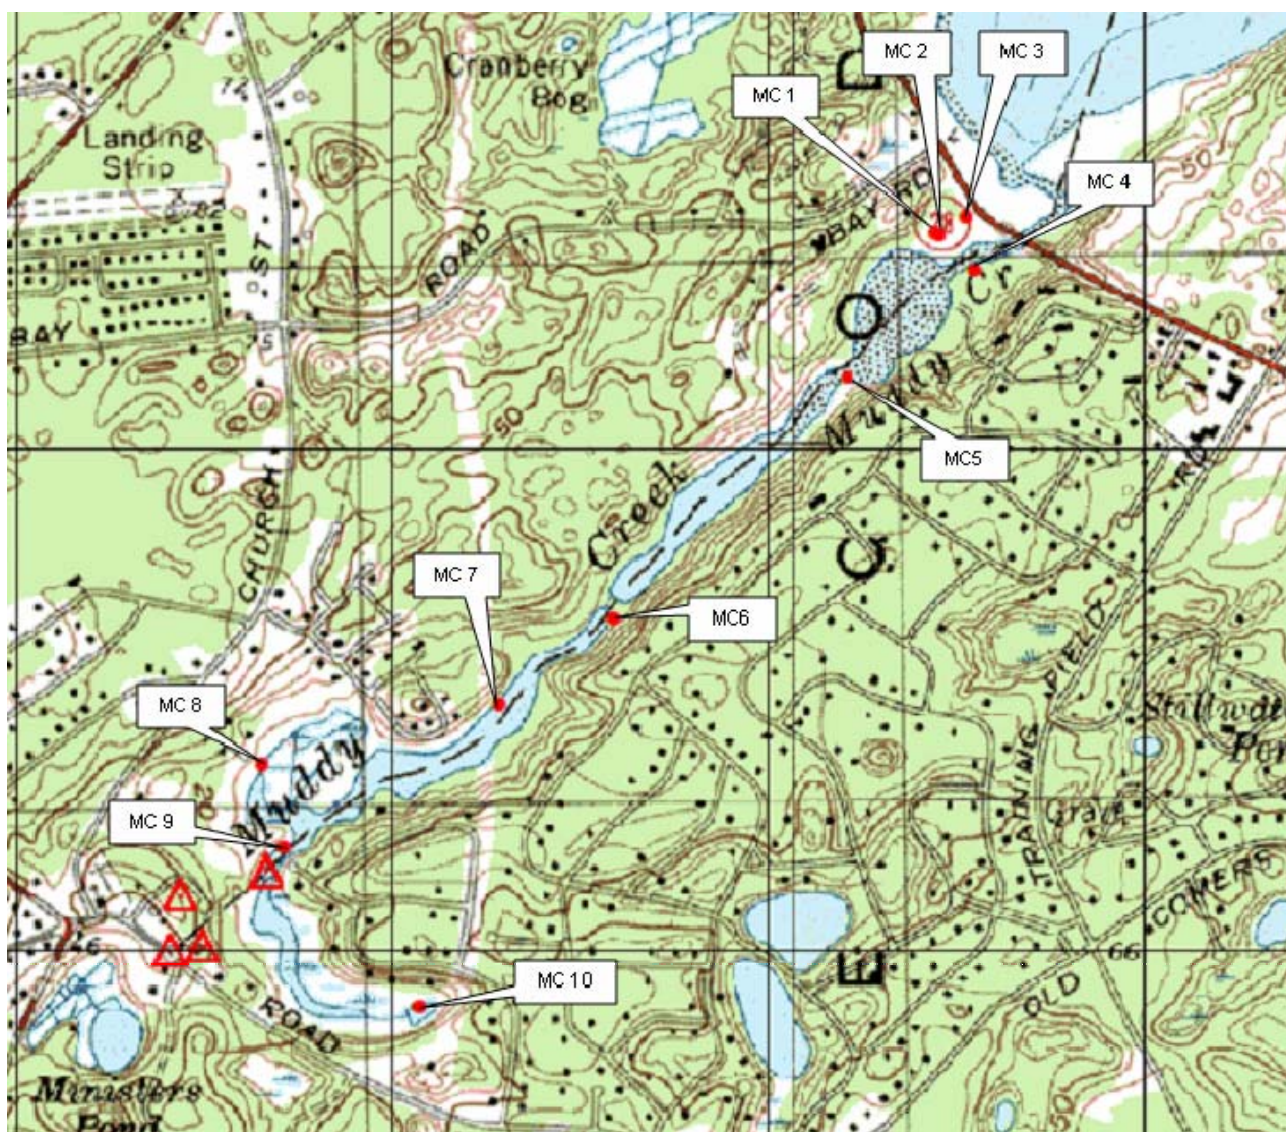
Figure 4 Locations of sediment core sites (red dots labeled MC 10) for determining porewater salinities of wetland areas within the Muddy Creek System. Red triangles show locations of benchmarks.

A total of ten wetland sites were sampled, 5 above and 5 below the dike site (Figure 4, Table 1). Sediment cores (6.5 cm inside diameter) were taken from each site and cut into 5 cm sections to allow assay of the 0-5 cm, 5-10 cm and 10-15 cm depths within the root zone. Pore waters were extracted and analyzed for salinity based upon specific conductivity measurements at the SMAST Analytical Facility.

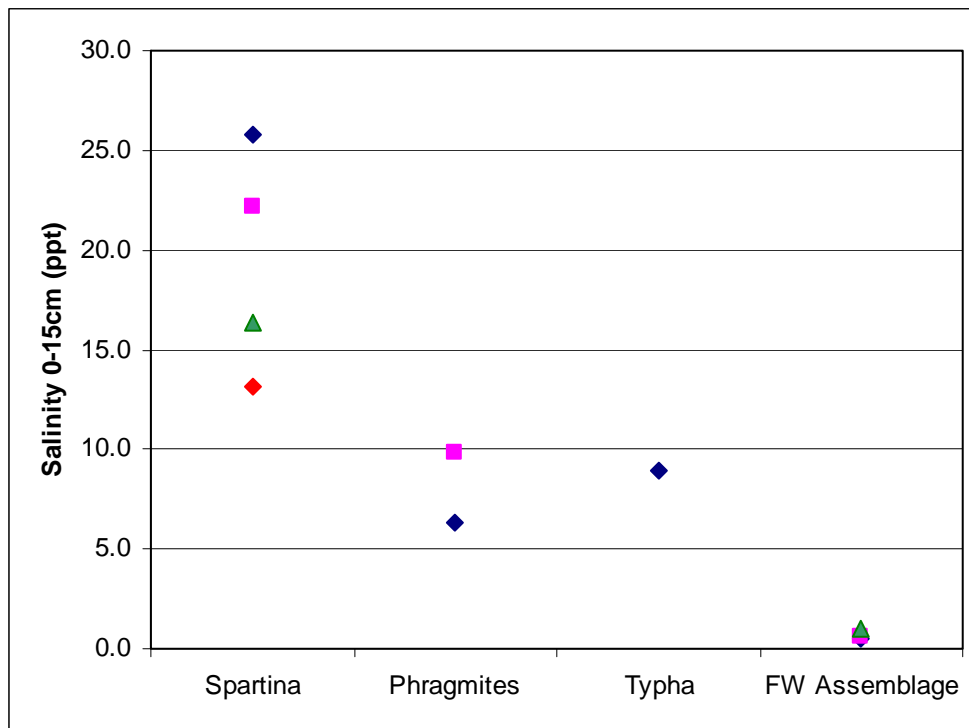
Figure 5. Average salinities (0-15cm) from core survey (Figure 4). It appears that salt marsh plants dominated at mean salinities >10 ppt, Typha and Phragmites at brackish conditions and the large freshwater assemblage areas at <1 ppt. The data show the same pattern in both upper and lower Muddy Creek sites.

Lower Muddy Creek sites with salinities >10ppt were generally supportive of salt marsh vegetation, while more brackish sites were dominated by *Typha* and *Phragmites* (Figure 5). Salinities at the 0-5cm depth range ranged from 32.8 to 18.1 ppt in *Spartina* dominated areas, 9.4 ppt in *Phragmites* and 13.4 ppt in *Typha* areas, respectively (Table 2). Salinities at the 5-10 cm interval were generally lower than surface values and ranged from 26.3 to 15.8 ppt for *Spartina*, 7.2 ppt for *Phragmites* and 7.5 ppt for *Typha* (Table 2). Values at the 10-15 cm depth interval were generally lower than either 0-5 cm or 5-10 cm depth intervals, ranging from 26.3 to 15.2 ppt for *Spartina*, 2.5 ppt for *Phragmites* and 6.0 ppt for *Typha* (Table 2). The *Typha* site (MC-3) showed a steep salinity gradient with depth and most likely was supported by freshwater from below, as this is a relatively high salinity for a *Typha* marsh.. The *Phragmites* sites (MC-2 and in the upper Creek, MC-7) showed similar salinities, and were brackish, typical of this species.

Average salinities (0-15 cm) were highest in *Spartina* dominated areas with *Phragmites* and *Typha* occurring in more brackish environments and with fresh water assemblages restricted to areas where sediment salinities were approximately 1.0 ppt or less (Figure 5).

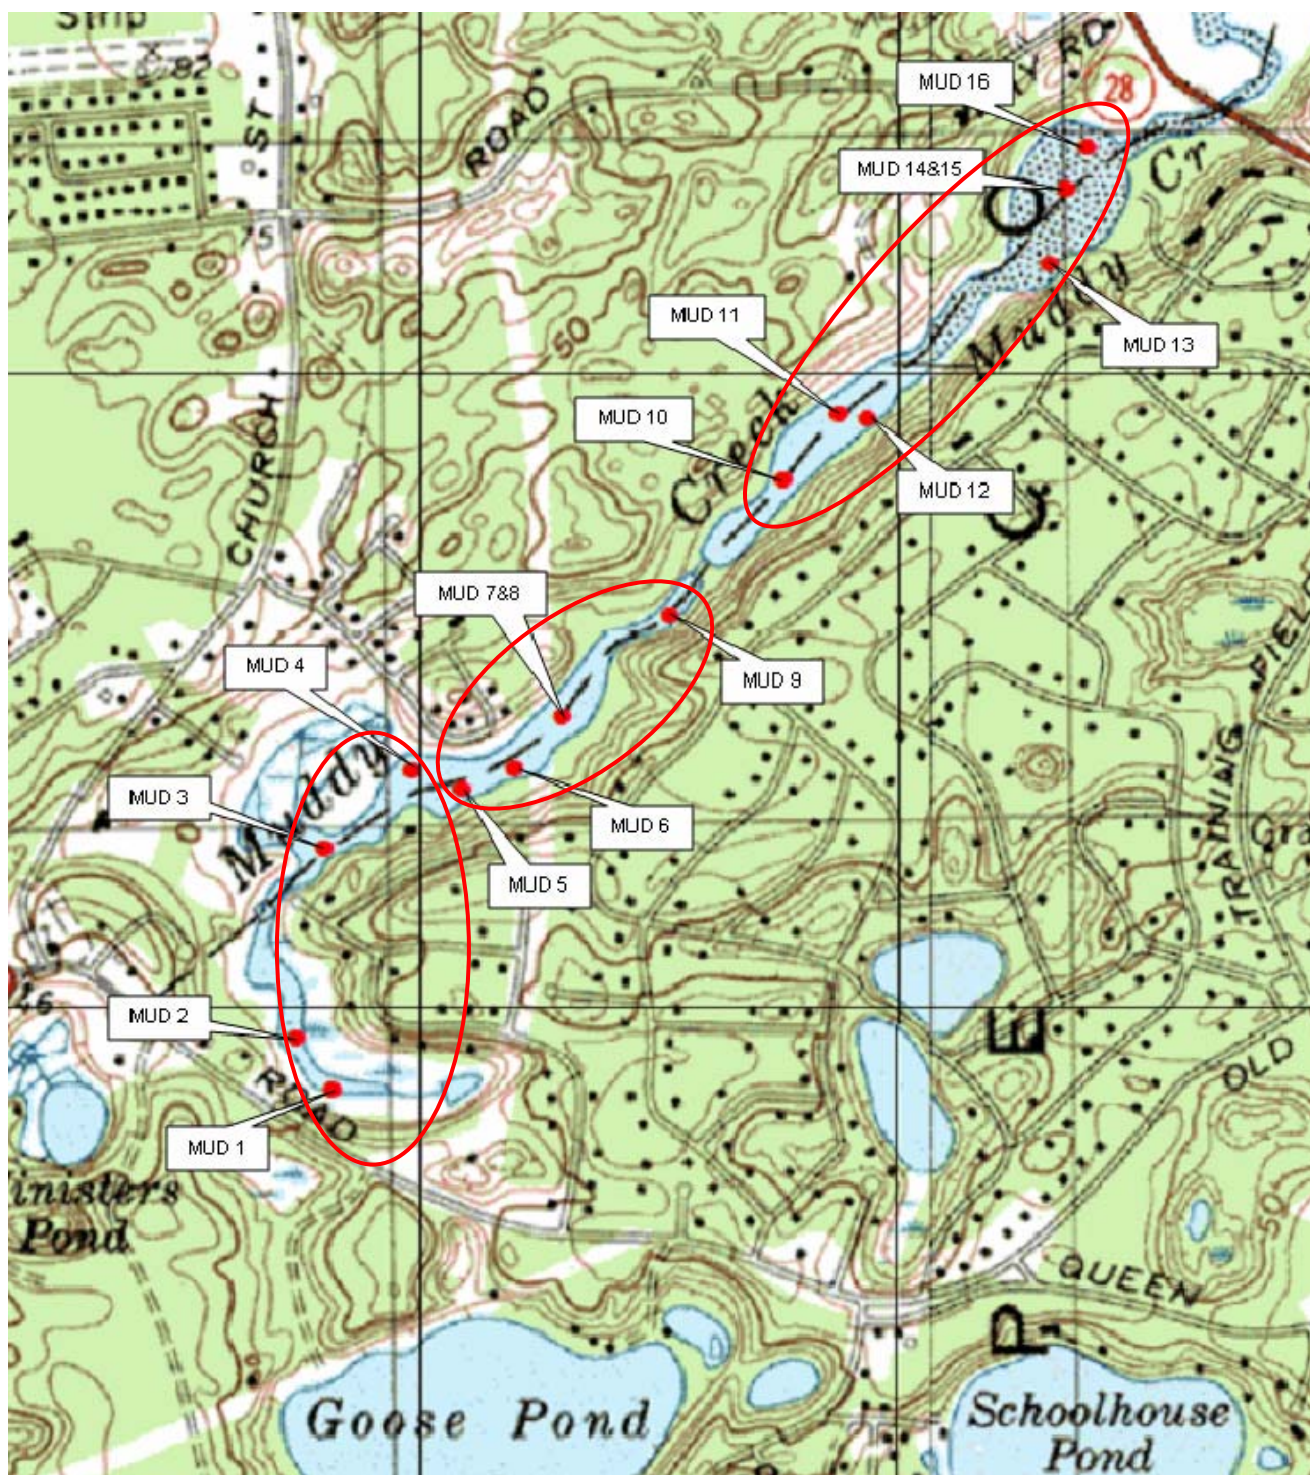
Figure 9. Locations of core sampling sites for measurement of sediment-watercolumn nitrogen exchange during July 2008 throughout the Muddy Creek Estuary. Circles enclose similar basin characteristics.

In order to determine the contribution of sediment regenerated nutrients to primary production during the summer, 16 sediment cores (15 cm inside diameter) were collected by SCUBA divers (Figure 9, Table 11)<sup>2</sup>. Cores were maintained at in situ temperatures during transport to the field laboratory (private residence) and throughout the incubation. Bottom water from each site was collected and filtered to replace headspace water of each core prior to the start of incubation. The headspace of each core was continuously mixed and periodic 60 ml samples withdrawn (volume replaced with filtered water), filtered into acid-leached polyethylene bottles and held on ice for analysis. Analysis followed the protocols detailed in the QAPP for the MEP. Flux rates were determined by linear rates of change of total dissolved nitrogen over the time course of the incubations.

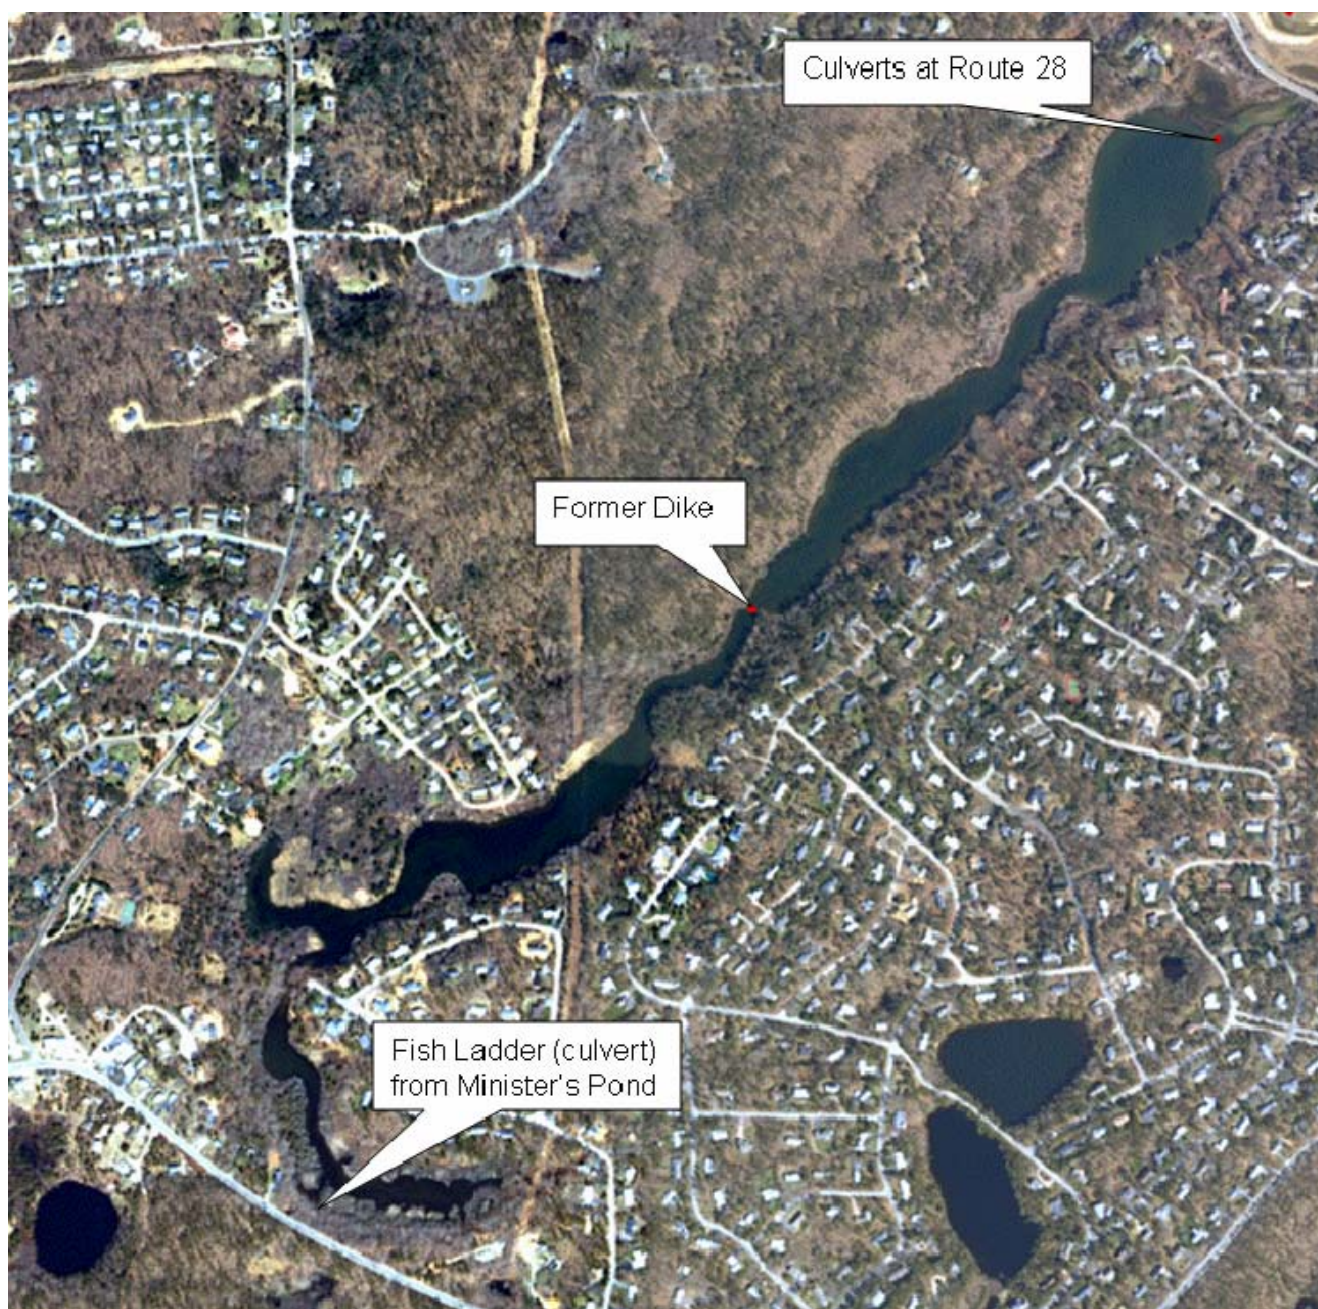
Figure 12 Anadromous fish runs, Muddy Creek. The fish runs relate to the present (culvert at Rt. 28 and Minister's Pond fish ladder) and historical (dike) restrictions to fish passage. Source, MassGIS.

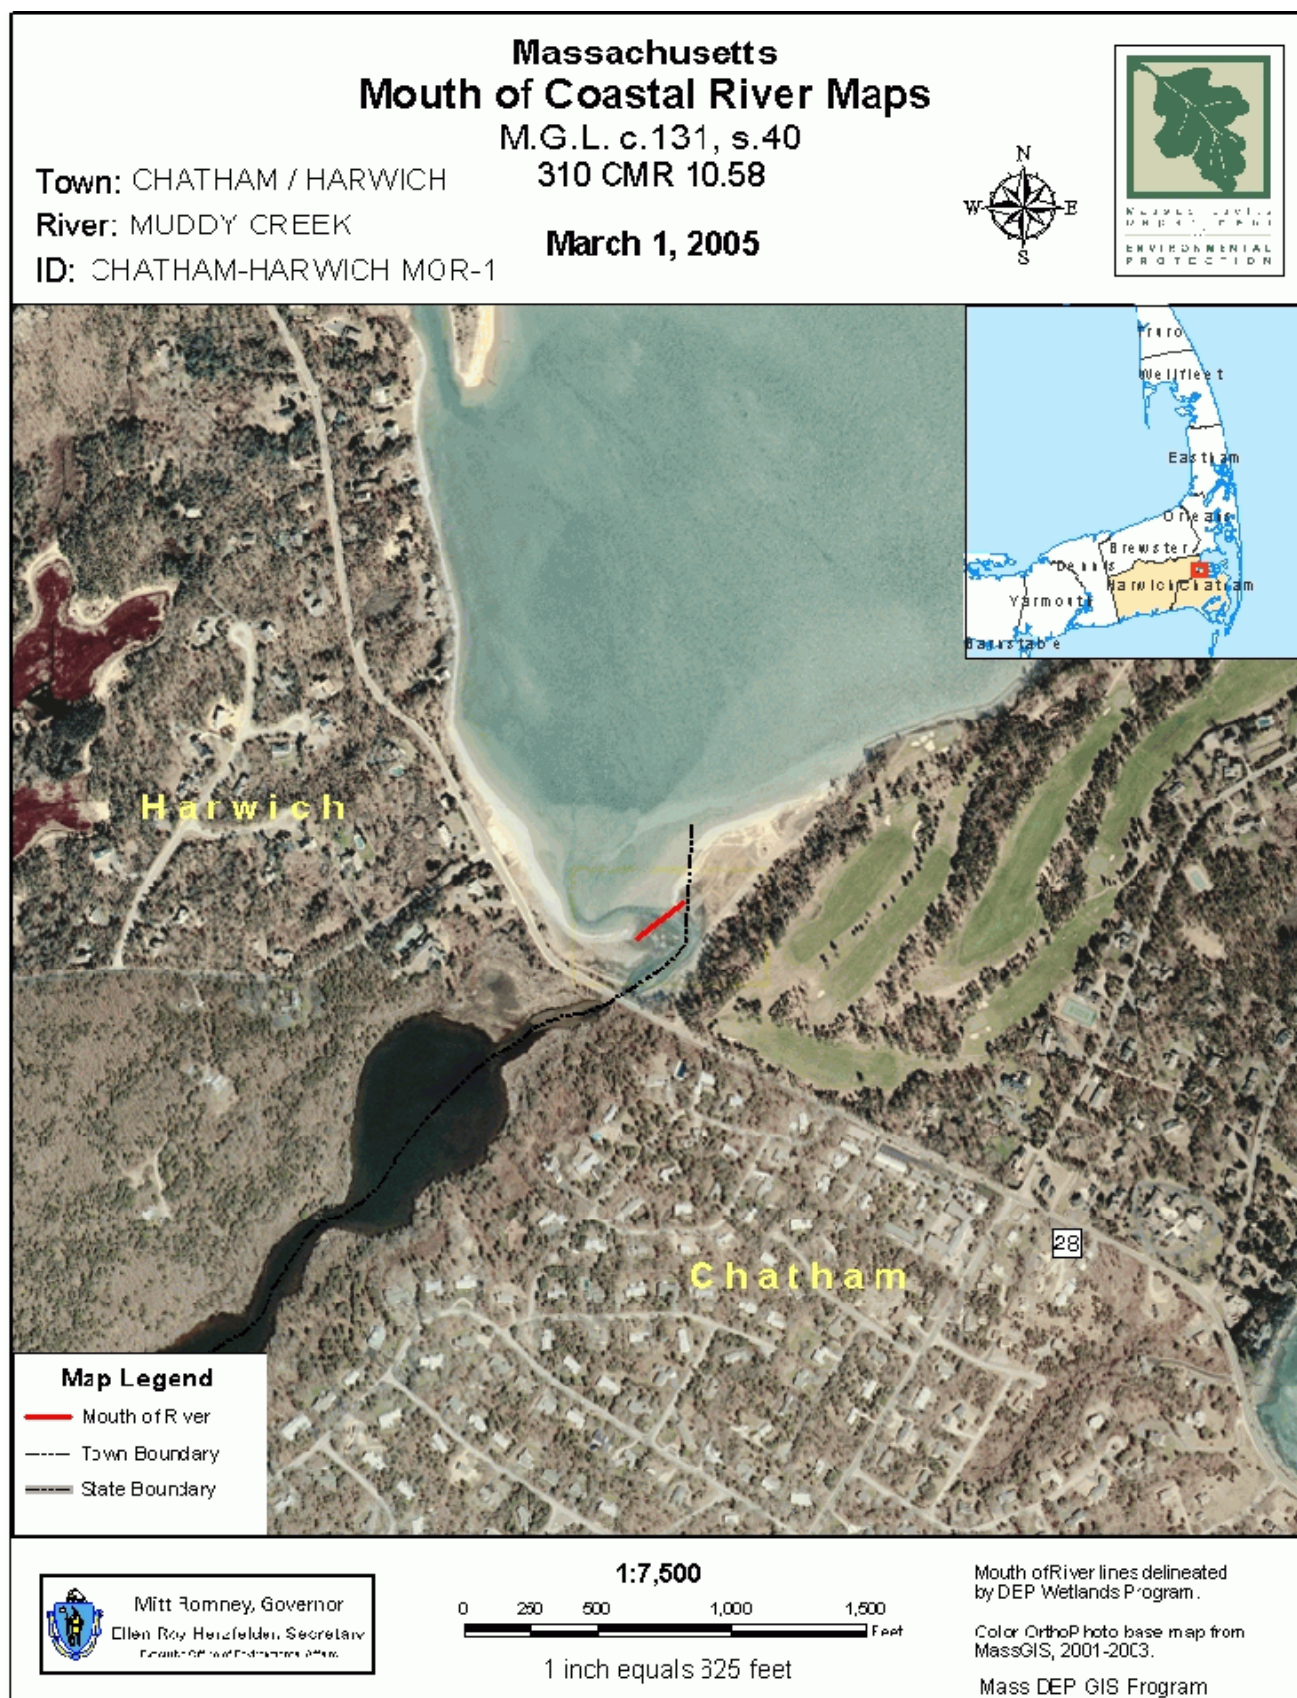
Figure 15 Mouth of a coastal river as designated by MassDEP under the Massachusetts Rivers Act. The Red Bar represents the furthest extent of the coastal river (drown river valley estuary), the performance standards of the Act apply to the river reach inland of the mouth.
