Section 5

Assessment of Freshwater Ponds

5.2 Pond Health Assessment

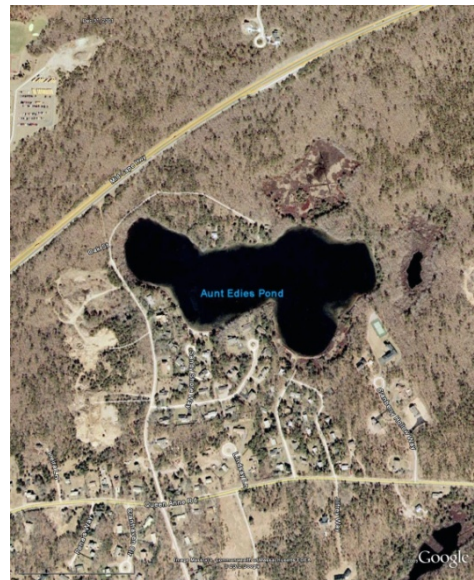
Satellite Image of Aunt Edies Pond, Harwich, MA

Aunt Edies Pond is categorized as a shallow, mesotrophic pond. The Harwich Ponds Report states that the average TSI for Aunt Edies Pond is classified as mesotrophic, but the data variability for all indicators spans across oligotrophic and eutrophic categories. The northern, upgradient shoreline of Aunt Edies Pond has fewer than five housing units. The pond's westernmost edge is approximately 300 feet from Route 6, and road runoff may be a source of contamination. In addition, the WQMTF developed a fact sheet for Aunt Edies Pond and identified two abandoned cranberry bogs.

At one point in time in either the late 1980's or early 1990's, the Sandy Shore Association limed Aunt Edies Pond in an attempt to improve the pond's water quality. The residual impact of liming is difficult to quantify without information before and after the lime application. The pond water quality is not improving with reports of milfoil infestation and nuisance algal blooms.

- 18 out of 18 DO measurements were greater than the state DO threshold of 5 mg/l for shallow, warm-water ponds.
- Total phosphorus concentrations were within the mesotrophic range. Average phosphorus concentrations at the pond bottom were higher compared to surface readings, indicating that bottom sediments may be an additional nutrient source.
- The average Secchi depth reading was 7 feet, which is approximately the total depth of the pond.

- Though concentrations of chlorophyll-a at any depth did not exceed 16 µg/l, the Ecologic Memo states that Aunt Edies Pond chlorophyll-a measurements did indicate a diminished water quality for recreational use because of concentrations averaging 7 µg/l compared to 4 ug/l in previous years. However, true data trends could not be identified due to the limited number of samples.

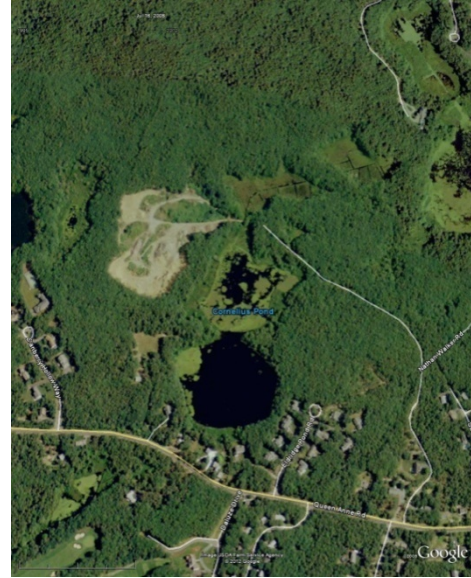
Satellite Image of Cornelius Pond, Harwich, MA

The Harwich Ponds Report categorized Cornelius Pond as a shallow, oligotrophic pond based on the average TSI for chlorophyll-a, but stipulated that Cornelius Pond had a large TSI range across the typical indicators. The Ecologic Memo categorized Cornelius Pond as a eutrophic pond based on a mean TSI from chlorophyll-a, total phosphorus, and Secchi disk measurements.

The shoreline of Cornelius Pond is relatively undeveloped with all residential units on the southern, downgradient edge of the pond. Limiting development in the northern, upgradient area will help protect the water quality of Cornelius Pond. Based on an orthophotographic survey, there appear to be two bogs that are directly connected via a culvert or channel into the northern section of the pond. There also appears to be a slag or sediment dump location to the northwest of the pond. Historic orthophotography also reveals persistent algal blooms.

- 5 out of 14 DO measurements were greater than the state DO threshold of 5 mg/l for shallow, warm-water ponds.
- Total phosphorus concentrations were elevated and were within the eutrophic range.
- The average Secchi depth reading was 3 feet, which does not satisfy the state water clarity swimming standard.
- Average concentrations of chlorophyll-a did not exceed 16 µg/l. The 2006-2008 dataset did contain recorded measurements at the surface that exceeded 16 µg/l, which are likely due to existence of algae.

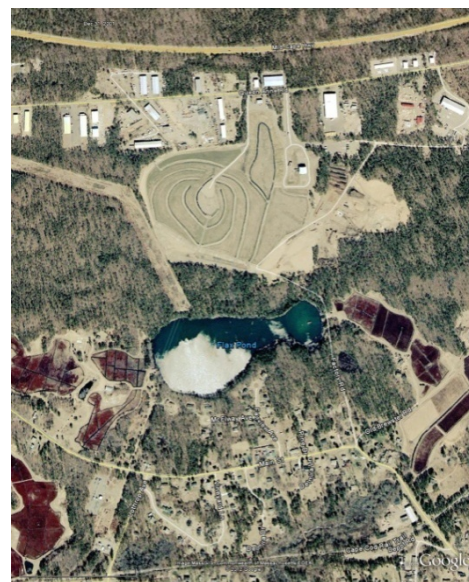
Satellite Image of Flax Pond, Harwich, MA

Samples for Flax Pond were taken on both the western and eastern portions of the pond. The western portion of the pond is deeper than the eastern portion of the pond. Discrete data were summarized separately for each monitoring location and analyzed separately in the Ecologic Memo. The Harwich Ponds Report categorized Flax Pond as a deep, oligotrophic pond based on the average TSI for chlorophyll-a, but stipulated that there was a large TSI range across the indicators. The Ecologic Memo categorized Flax Pond as a mesotrophic pond based on an average calculated TSI.

Flax Pond is connected on both the western and eastern sides for irrigation of nearby cranberry bogs. Historic orthophotography of the pond shows evidence of algal blooms. The area north of the pond is a capped landfill. In the mid-1990s, the Town initiated a project to restore Flax Pond after it was identified that leachate from the landfill and septage lagoons were impacting the pond's water quality. Water quality in Flax Pond has improved since the 1990s, but monitoring data for Flax Pond indicates that it still has some significant water quality concerns.

- 33 out of 75 DO measurements were greater than the state DO threshold of 6 mg/l for deep, cold-water ponds. Low DO measurements and non-detect readings were at depths of 13 feet and greater indicating an anoxic pond bottom.
- Total phosphorus concentrations were generally elevated and were within the mesotrophic range. Certain years of data exhibited higher total phosphorus concentrations at the pond bottom.
- The average Secchi depth reading was 10 feet, which makes the pond's clarity suitable for swimming.
- Average concentrations of chlorophyll-a did not exceed 16 µg/l. The Ecologic Memo determined that there was an outlier measurement in 2003 and that concentrations over time taken in the surface waters (between 2001-2005) were consistently less than 10 µg/l. The 2006-2010 dataset supports that finding.

- The Ecologic Memo indicated that Flax Pond East was undergoing a statistically significant decreasing trend of total phosphorus concentrations. Interpretation of the 2006-2010 dataset indicates insignificant fluctuation in total phosphorus concentrations.

- The average Secchi depth reading was 5 feet, which makes the pond's clarity suitable for swimming.
- Concentrations of chlorophyll-a at any depth did not exceed 16 µg/l.

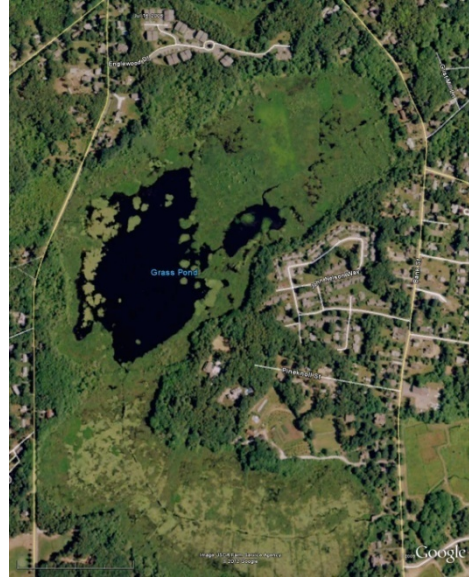
Satellite Image of Grass Pond, Harwich, MA

The Harwich Ponds Report and the 2008 Ecologic Memo categorized Grass Pond as a shallow, eutrophic pond, whereas the 2011 Ecologic Memo categorized the pond as mesotrophic. Flow from Grass Pond feeds the Bank Street Bogs Nature Preserve, which is a parcel preserved by the Harwich Conservation Trust. There is a small housing development to the north of the pond and a denser housing development to the west. Based on an orthophotographic survey, there appears to be at least one abandoned bog that is directly connected to the pond via a culvert or channel in the southern section of the pond. A second bog/marsh borders the northern edge of the pond. The pond's westernmost edge is approximately 100 feet from a minor arterial road, Forest Street. Road runoff may also be a source of contamination. Surface water from Grass Pond flows through a series of bogs and marshes until it reaches Saquatucket Harbor.

- 5 out of 8 DO measurements were greater than the state DO threshold of 5 mg/l for shallow, warm-water ponds.
- Total phosphorus concentrations were elevated in Grass Pond and were within the eutrophic range. The Ecologic Memo stated that Grass Pond has consistently elevated total phosphorus concentrations but because of the limited number of measurements, a statistical trend could not be identified of improving or worsening water quality. The discrete 2007-2010 data does include measurements that were taken at the outlet and at locations where the sample depth was not recorded.

- Only one Secchi depth measurement was reported in the 2007-2010 data set at a depth of 4.4 feet, which just meets the 4 foot pond clarity threshold for swimming.

- There were two measurements of chlorophyll-a that were exceptionally high and were likely taken during a period of elevated algal activity. All other measurements at any depth did not exceed 16 µg/l.

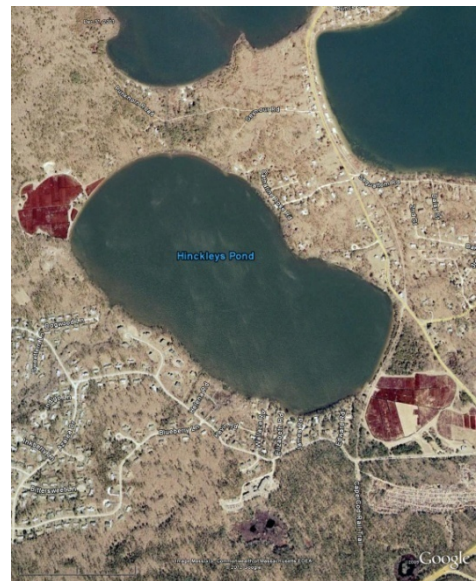
Satellite Image of Hinckleys Pond, Harwich, MA

Hinckleys Pond was categorized as a deep, borderline eutrophic pond. Hinckleys Pond is surrounded by medium to high density residential units. It is also bounded by two active cranberry bogs and is less than 100 feet from Route 124. Recently, the water quality in Hinckleys Pond has degraded. In 2009, Hinckleys Pond was closed when state and local officials determined that toxic cyanobacteria algae were found and that concentrations were five times the allowable level. During the fall of 2011, a diagnostic assessment was performed specifically for Hinckleys Pond and its watershed (Evaluation of Hinckley's Pond, Harwich, Massachusetts,

Draft March 2012, by Water Resource Services in Conjunction with CDM Smith). The purpose of the study was to understand nutrient sources and to recommend actions to mitigate adverse impacts of excess phosphorus to improve the pond's water quality. The evaluation determined that the largest source of phosphorus is internal.

- 64 out of 106 DO measurements were greater than the state DO threshold of 6 mg/l for deep, cold-water ponds. Low DO measurements and non-detect readings were at depths of 16 feet and greater indicating an anoxic pond bottom.
- Total phosphorus concentrations were elevated and were within the eutrophic range. There was evidence of a trend of internal recycling of phosphorus due to elevated concentrations in deeper waters.
- The average Secchi depth reading was 5 feet with a minimum measurement of 2 feet demonstrating poor water clarity. The readings were consistently at or below the swimming standard.
- Average concentrations of chlorophyll-a did not exceed 16 µg/l. However, there were 14 measurements of chlorophyll-a concentrations greater than 16 µg/l.

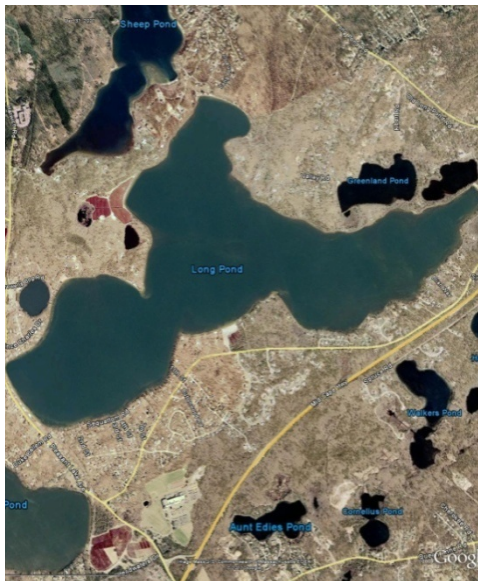
Satellite Image of Long Pond, Harwich, MA

Long Pond was categorized as a deep, mesotrophic pond and is split by the Town boundary between Brewster and Harwich. It is surrounded by medium-to-high density residential development and is less than 100 feet from Route 124 and Long Pond Drive. A cranberry bog is located on the northwestern edge of Long Pond.

Long Pond was treated with alum in the fall of 2007 because of degrading water quality. The limited available water quality data since the alum treatment suggest that the water quality has not returned to the highly impacted condition prior to the pond treatment, but it also suggests that elevated phosphorus levels are still present in the pond. The *Treatment Summary for Phosphorus Inactivation in Long Pond* (AECOM, 2009) provides water quality monitoring data for the year following the alum treatment. The phosphorus data during this year are ambiguous. After the initial drop in phosphorus levels in the month following the treatment, AECOM (2009) reports “the pattern that arose after October 2007 was unexpected. In essence, TP and DP [dissolved phosphorus] increased gradually between October 2007 and April 2008, with TP reaching levels similar to those of the upper layer from September 2007 in April and May 2008. DP levels did not recover to pre-treatment levels, but did increase to more than half the pre-treatment concentration.” While the overall pond water quality has improved, additional data is needed to understand the efficacy of the pond treatment and in which category to place Long Pond.

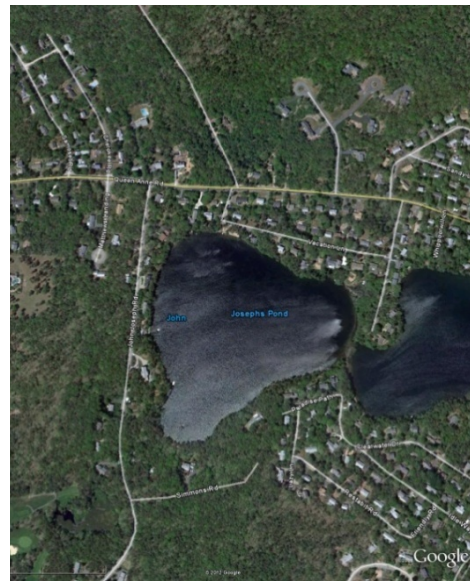
Satellite Image John Josephs Pond, Harwich, MA

John Joseph Pond was categorized as a deep, mesotrophic pond in the Brewster Pond Report. It is the second largest pond of four ponds in the Great Sand Lake pond system. It is directly connected on its eastern border to Bucks Pond. According to the USGS topographic map for the area, John Joseph and Bucks Ponds are at the same water surface elevation. This entire Great Sand Lake system is surrounded by medium-to-high density residential development with a network of minor roads. As mentioned above regarding Bucks Pond, John Joseph Pond was also studied in detail in June 2007 and identified as an area requiring phosphorus load reduction to improve water quality.

- 137 out of 197 DO measurements were greater than the state DO threshold of 6 mg/l for deep, cold-water ponds. Low DO measurements and non-detect readings were at depths of 16 feet and greater indicating an anoxic pond bottom.
- Total phosphorus concentrations were elevated and were within the mesotrophic range.
- The average Secchi depth reading was 18 feet, which makes the pond’s clarity suitable for swimming.
- Average concentrations of chlorophyll-a did not exceed 16 µg/l.

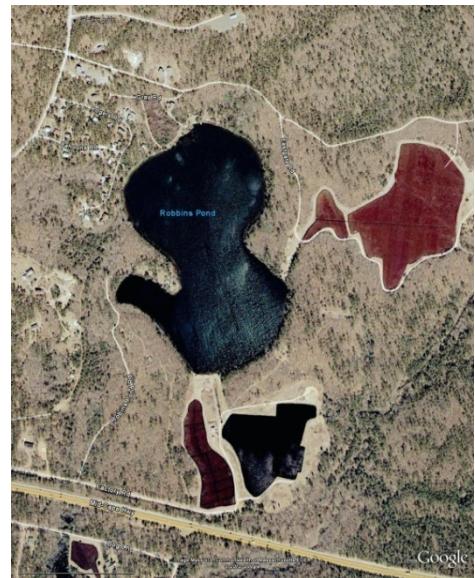
Satellite Image of Robbins Pond, Harwich, MA

Robbins Pond was categorized as a shallow, mesotrophic pond. It has a relatively undeveloped shoreline with less than ten houses within a 300-ft buffer surrounding its shoreline. There is a large cranberry bog to the west and a smaller bog to the south of the pond. There appears to be no direct

connection from either bog to Robbins Pond, but water from the pond may be used as irrigation. Historic orthophotography also indicates that nuisance algal blooms do occur in Robbins Pond, especially in the thumb-like feature where mixing is limited.

- 23 out of 24 DO measurements were greater than the state DO threshold of 5 mg/l for shallow, warm-water ponds.
- Total phosphorus concentrations were elevated and were within the mesotrophic range. The Ecologic Memo indicates that Robbins Pond exhibited an increasing trend of annual average phosphorus in 2010 compared to data in 2000-2008. Inspection of the data indicates that the samples for total phosphorus taken in 2010 were primarily at depth whereas the average from past years included surface samples.
- The average Secchi depth reading was 7 feet, which makes the pond's clarity suitable for swimming.
- There was one measurement of chlorophyll-a concentration that was above the 16 µg/l threshold. All other measurements did not exceed 16 µg/l.

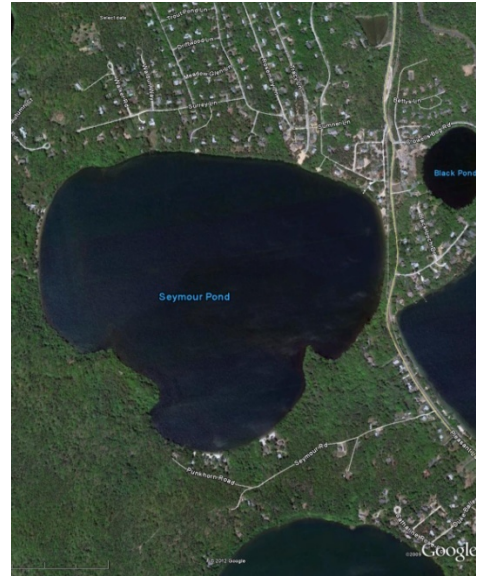
Satellite Image of Seymour Pond, Harwich, MA

Seymour Pond was characterized as a deep, mesotrophic pond. The northeastern, upgradient watershed has a medium-to-high level of residential units with a network of minor streets. It is also less than 100 feet from Route 124. Seymour Pond is split by the Town boundary between Brewster and Harwich. The Brewster Ponds Report performed a detailed individual pond assessment for Seymour Pond and developed a water budget to account for flows entering and exiting the pond. They also performed a detailed phosphorus budget to determine the sources and magnitude of phosphorus loading.

The Brewster Ponds Report identified Seymour Pond as an impaired water body from analysis of PALS data from 2001-2007.

- DO measurements show decreasing concentrations with increasing depth and regular anoxic conditions during the summer months. Based on average DO concentrations, the bottom 16 feet of the pond was less than the state DO threshold of 6 mg/l for deep, cold-water ponds.
- Total phosphorus concentrations were within the mesotrophic range. The average deep total phosphorus concentrations were three times greater than surface concentrations indicating that there is phosphorus regeneration from sediments.
- The average Secchi depth reading was estimated to be 9 feet, which makes the pond's clarity suitable for swimming. However, the Brewster Ponds Report carefully reviewed historic Secchi depth readings and suggested that clarity and water quality conditions are worsening.
- Average concentrations of chlorophyll-a do not exceed 16 µg/l.

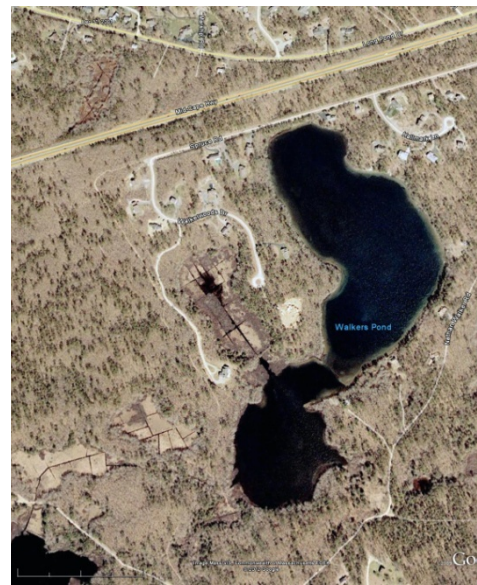
Satellite Image of Walkers Pond, Harwich, MA

The Harwich Ponds Report and the 2008 Ecologic Memo characterize Walkers Pond as a deep, oligotrophic pond, whereas the 2011 Ecologic Memo has characterized it as a mesotrophic pond. The Ecologic Memo states that Walkers Pond experienced nuisance algal blooms in 2007. The exact cause of the blooms was never determined. Historic orthophotos also show evidence of persistent algal blooms.

The shoreline of Walkers Pond has approximately ten housing units within a 300-ft buffer from the water's edge. The northern area upgradient of the pond is low-to-medium density residential since residential units also surround Long Pond, which is just north of Walkers Pond. The pond's northernmost edge is less than 100 feet from Spruce Road and approximately 300 feet from Route 6. Road runoff from both roads may be a source of contamination. Based on an orthophotographic survey, there appears to be at least one bog that is directly connected to the pond via a culvert or channel in the southern section of the pond. There also appears to be another smaller bog that is connected to the west of the southern section of the pond.

- 50 out of 83 DO measurements were greater than the state DO threshold of 6 mg/l for shallow, warm-water ponds.
- Total phosphorus concentrations were within the mesotrophic range.
- The average Secchi depth reading was 14 feet, which makes the pond's clarity suitable for swimming.
- Concentrations of chlorophyll-a at any depth did not exceed 16 µg/l.

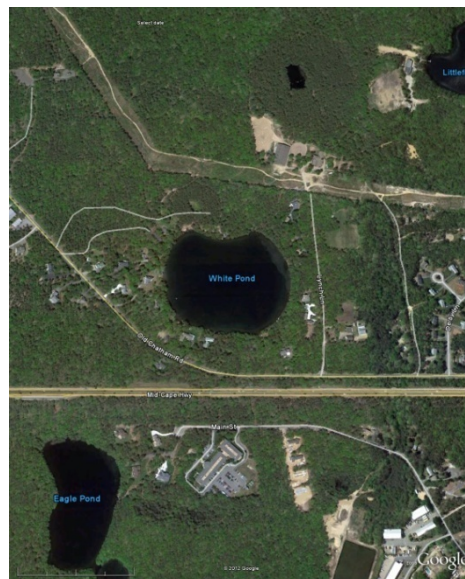
Satellite Image of White Pond, Harwich, MA

The Harwich Ponds Report and the 2008 Ecologic Memo categorized White Pond as a deep, oligotrophic pond, whereas the 2011 Ecologic memo categorized the pond as mesotrophic based on an additional two years of data showing an increasing trend of total phosphorus. The shoreline of White Pond has approximately fifteen housing units within a 300-ft buffer from the water's edge. The northern area upgradient of the pond is relatively undeveloped except for a large horse stable approximately 500 feet from the water's edge.

- 9 out of 17 DO measurements were greater than the state DO threshold of 6 mg/l for deep, cold-water ponds.
- Total phosphorus concentrations were low and according to the Ecologic Memo, exhibiting an increasing trend within the past two years. The range of concentrations was within the oligo-mesotrophic range.
- The average Secchi depth reading was 17 feet, which makes the pond's clarity exceptional for swimming.
- Concentrations of chlorophyll-a at any depth did not exceed 16 µg/l.

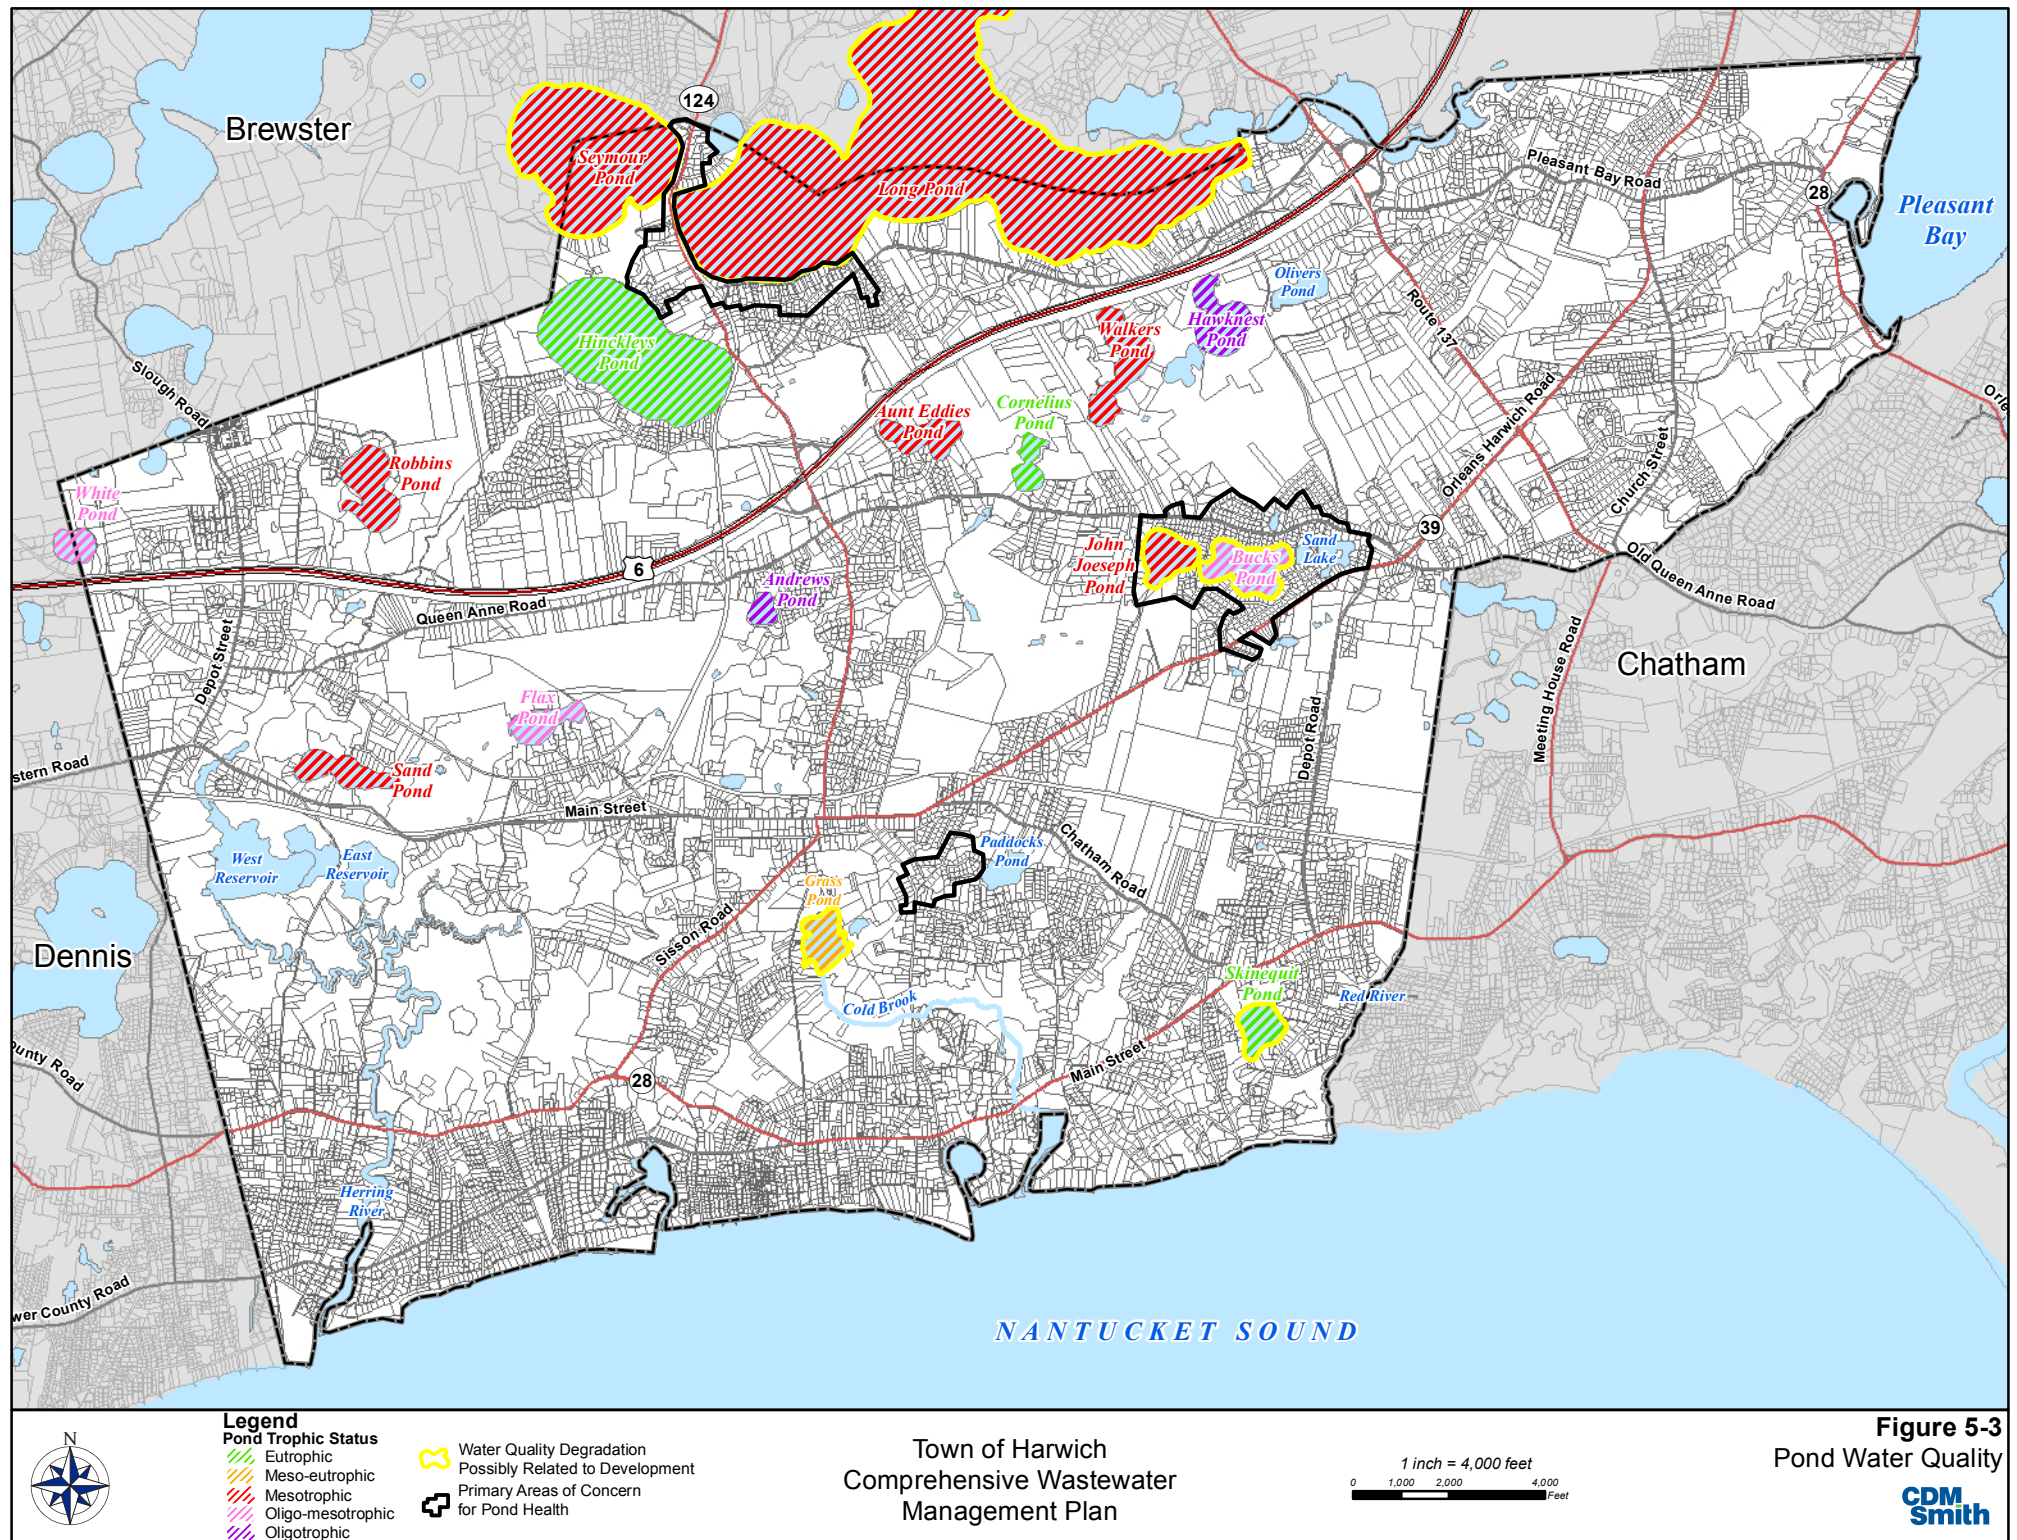
The highlighted ponds in Table 5-4 should be examined more closely to determine if providing sewers within the watersheds and thus removing septic system effluent phosphorus inputs would be appropriate to reduce degradation. Figure 5-3 presents several of the larger ponds in Harwich based on their trophic status.
