**Final Technical Memorandum
Muddy Creek Wetland Restoration
Chatham and Harwich, Massachusetts**

Cape Cod Conservation District

February 2012

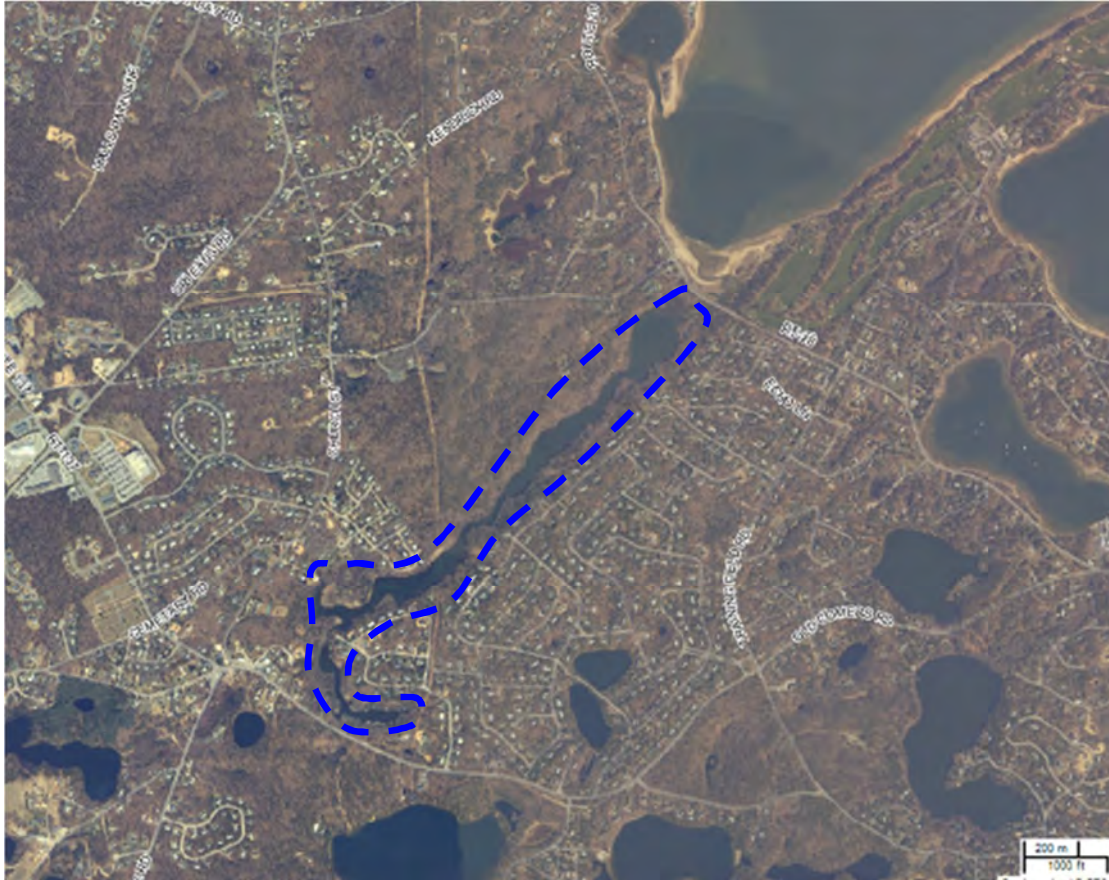
Figure 1 - Aerial of Project Study Site (MA GIS)

Muddy Creek is a tidal river and sub-embayment of the Pleasant Bay estuarine system. The municipal boundary between the Towns of Chatham and Harwich runs along the center of the majority of the Creek. As shown in *Figure 1* below, Muddy Creek is bounded by the earthen embankment supporting Route 28 at its downstream limit, sparse residential development and protected undeveloped properties to the north in Harwich, and relatively sparse residential development to the west in Chatham, and moderately dense residential development to the south in Chatham.

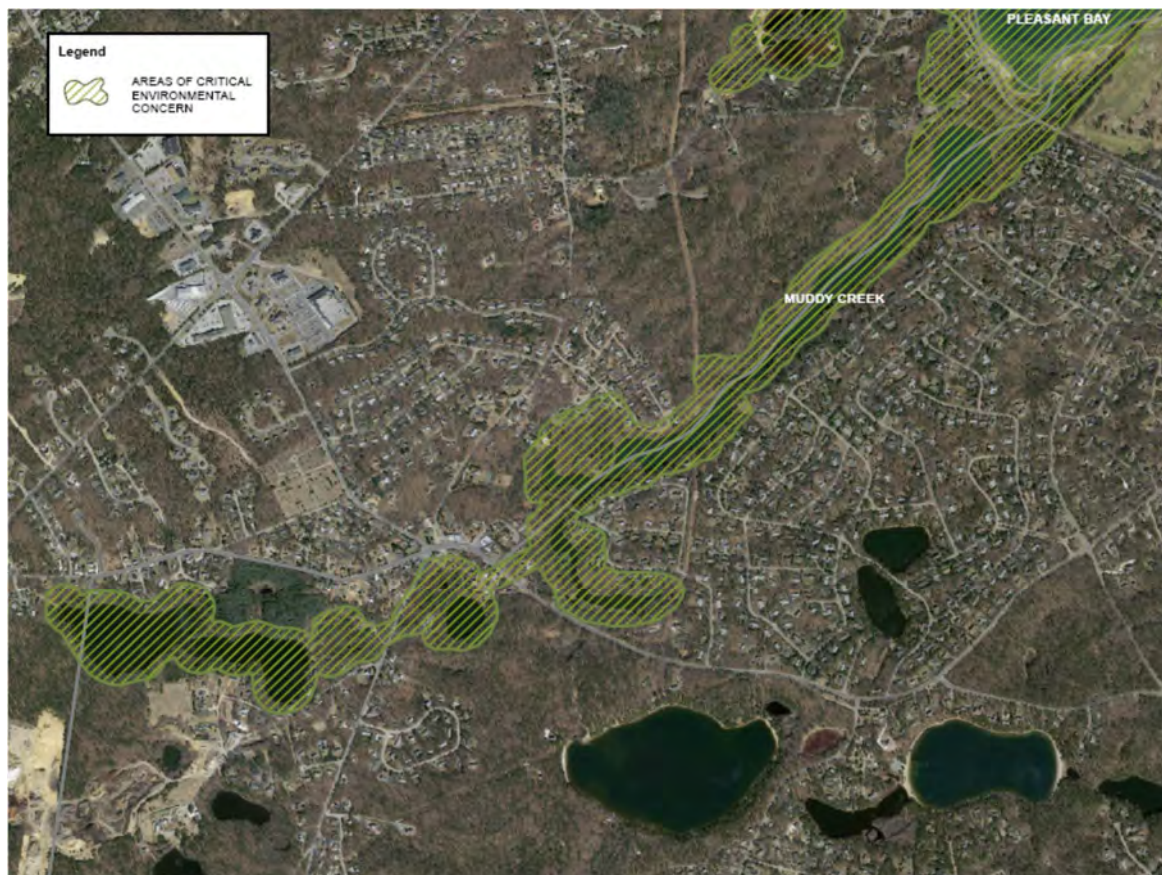
Figure 2 – Areas of Critical Environmental Concern (MA GIS)

Pleasant Bay is a state designated Area of Critical Environmental Concern (ACEC), and Muddy Creek is located within the ACEC boundary (see *Figure 2* below). The four towns that share the watershed of Pleasant Bay (Orleans, Chatham, Harwich and Brewster) formed the Pleasant Bay Alliance (PBA) to implement the locally and state-approved resource management plan for the ACEC and the Pleasant Bay watershed. Over the past two years the PBA has been exploring alternatives to improve water quality, the health of vegetative communities, and fish passage and shellfish communities in Muddy Creek as part of its overall goal of improving the natural environment and the public's use and enjoyment of Pleasant Bay in general.

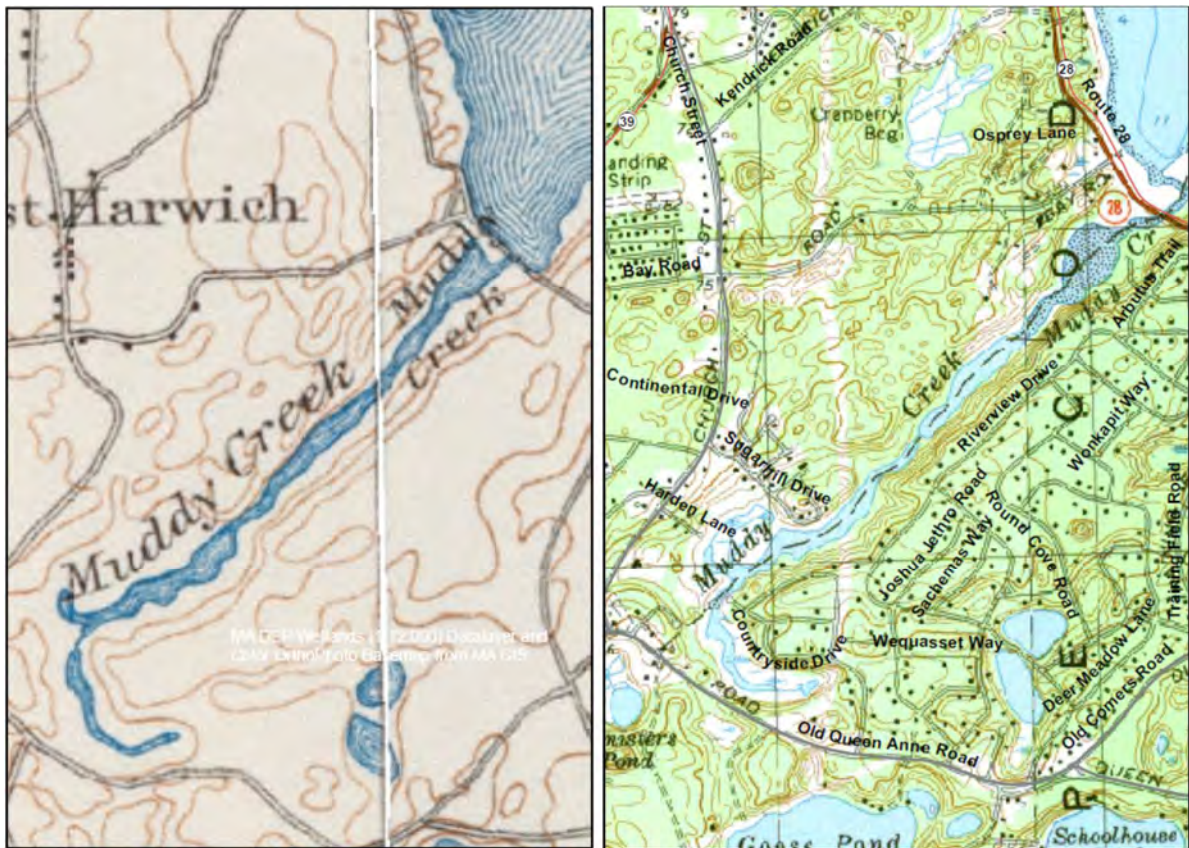
Figure 3 - Comparison of Hydrologic Modifications by Development between the 1890s (left image) and 1960s (right image).

Muddy Creek has undergone significant hydrologic changes due to anthropogenic influences over the last 200 years. Side by side topographic maps in *Figure 3* below illustrate those changes. From this figure, roadways bordering Muddy Creek can be seen as they currently exist and historically existed, however a number of additional branching roads have been constructed encroaching on the forested upland areas surrounding this waterbody.

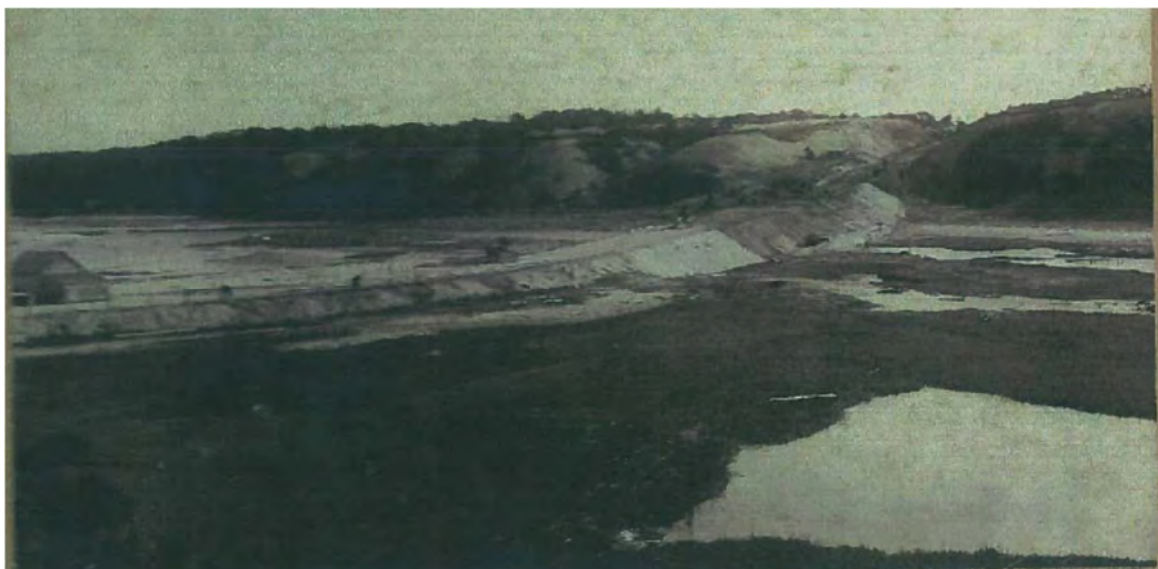
Figure 5 – Historic Photo of Earthen Fill Placement at Orleans Road (Route 28) over Muddy Creek Facing South Toward Chatham, circa 1900

The bridge was eventually replaced in the 1900's with an earthen dike and single culvert which reportedly failed to provide adequate flushing into the upstream cove (see *Figure 5* below).

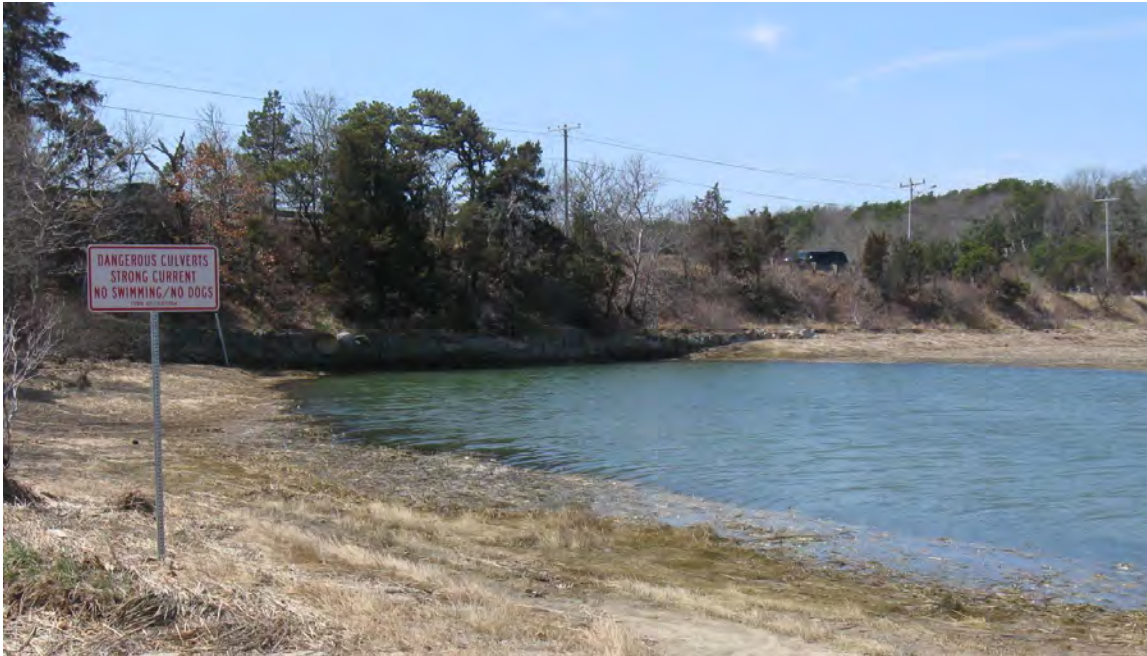
Figure 6 – Photo of Earthen Embankment and Culverts at Orleans Road/Route 28 Crossing over Muddy Creek Facing West Toward Harwich (April 15, 2011).

The single culvert was replaced in the 1930s with the current double stone culverts, each equipped with manually controlled tide gates. Anecdotal accounts recall that the gates were typically blocked and for a number of years were only partially open (Buckley, 2011), after which the gates were eventually removed. A current photograph of the embankment and culverts is provided as *Figure 6* below.

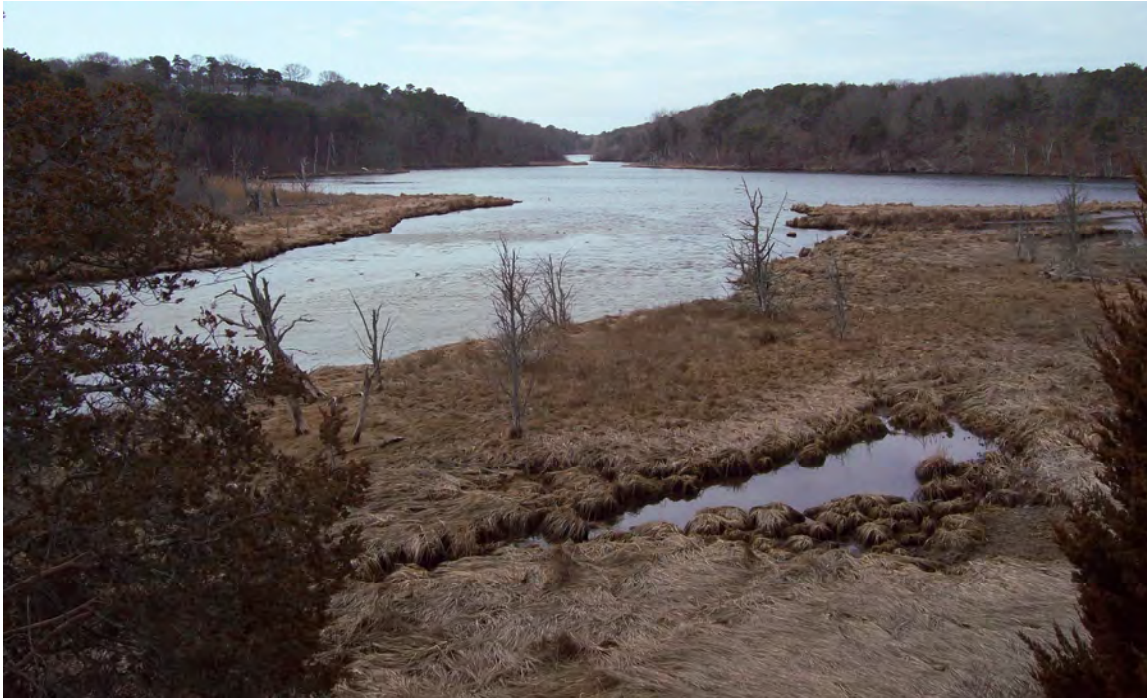
Figure 7 – Photo of Muddy Creek's Lower Basin, Facing Southwest From Orleans Road/Route 28 (March 5, 2011).

Additional hydrologic modifications to the system reportedly occurred in the upper basin in the 1890s with the construction of an earthen dike with a 3 - 4 foot wide adjustable sluiceway near the midpoint of the Creek, just north of the Round Cove at Riverview Drive intersection (Buckley, 2011). The dike and sluiceway reportedly allowed for the flooding of cranberry bogs originally located along the Upper Pond of Muddy Creek and across Queen Anne Road (Buckley, 2011). A previous study report in 2008 noted that the dike was reportedly breached during the hurricane of 1938 and not subsequently repaired, allowing limited tidal brackish conditions to return in Muddy Creek's upper basin (White, et al, 2008). A current photograph of Muddy Creek's lower basin is provided as *Figure 7* below.

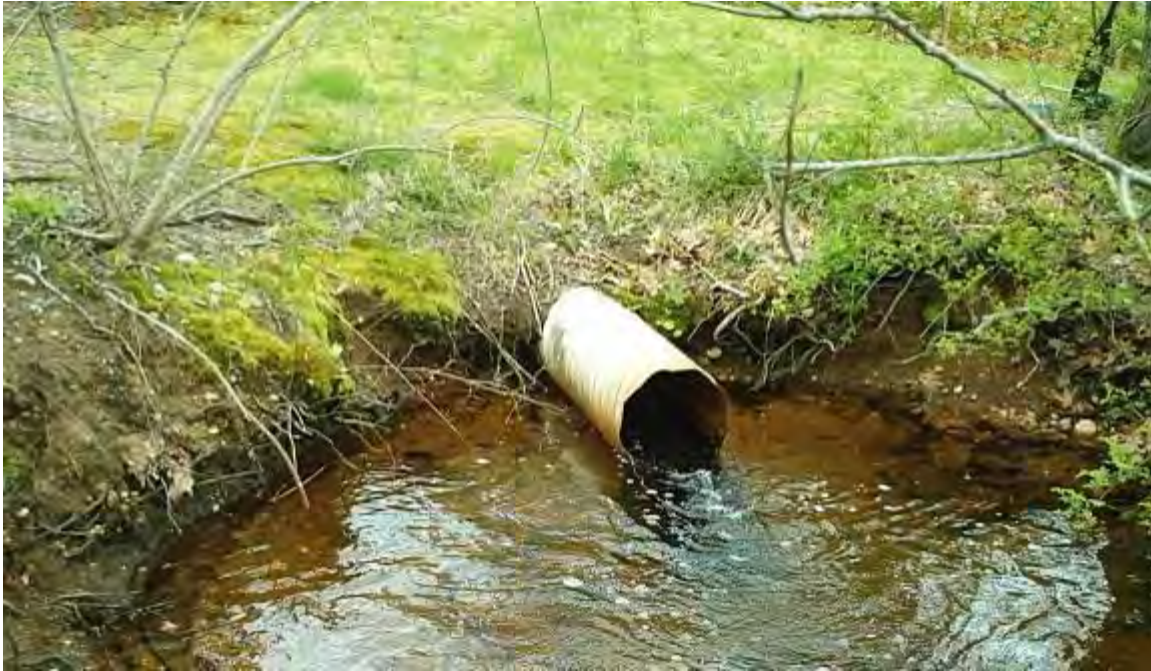
Figure 8 – Culvert Discharging Flow from Minister's Pond to Muddy Creek (18" CMP) with Eel Passage Ramp Substrate (submerged)

It is noted that a culvert conveying freshwater flow to Muddy Creek from Minister's Pond below Old Queen Anne Road currently remains in existence and has reportedly been modified by Massachusetts Department of Marine Fisheries staff in an effort to facilitate passage of elvers to this upstream waterbody. A photograph of this culvert is provided below as *Figure 8*, where the fish passage structure is inundated below the water level. At low tide conditions, the passage structure provides a substrate for elvers to swim upon and enter the culvert, where they are reportedly able to continue swimming upstream to Minister's Pond. This culvert and a nearby manhole were surveyed, as reflected on Sheet RC-107 in *Attachment A*.

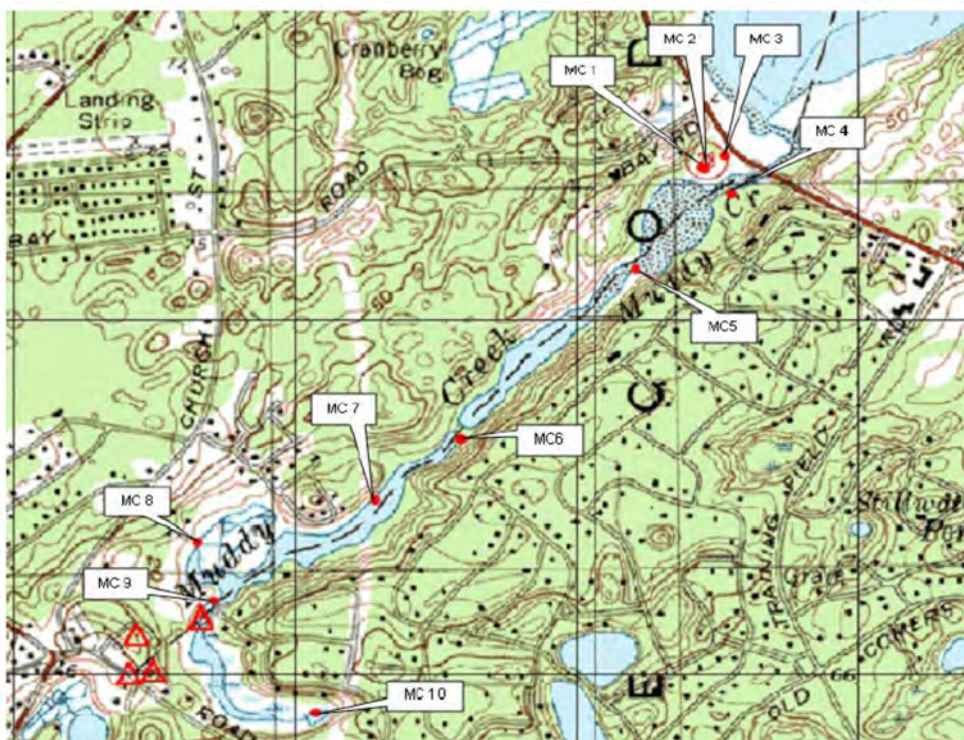
Figure 10 – Sediment porewater salinity measurement locations. (Adopted from White et al., 2008).

Vegetative communities observed at respective sampling locations in the 2008 study generally reflected the presence of freshwater invasive *Phragmites* and *Typha* communities at locations where salinities were below 10 ppt, principally at MC2 and MC3 in the lower reach (below the former dike location, at locations immediately adjacent the Route 28 culvert) and at MC7, MC8,

MC9 and MC10 in the upper reach (above the former dike location). Vegetative communities at locations MC8, MC9 and MC10 were noted as mixed assemblages of freshwater and salt-water tolerant species, reflecting limited mixing occurring in the upper reaches due to the dampened tidal range and freshwater inputs.

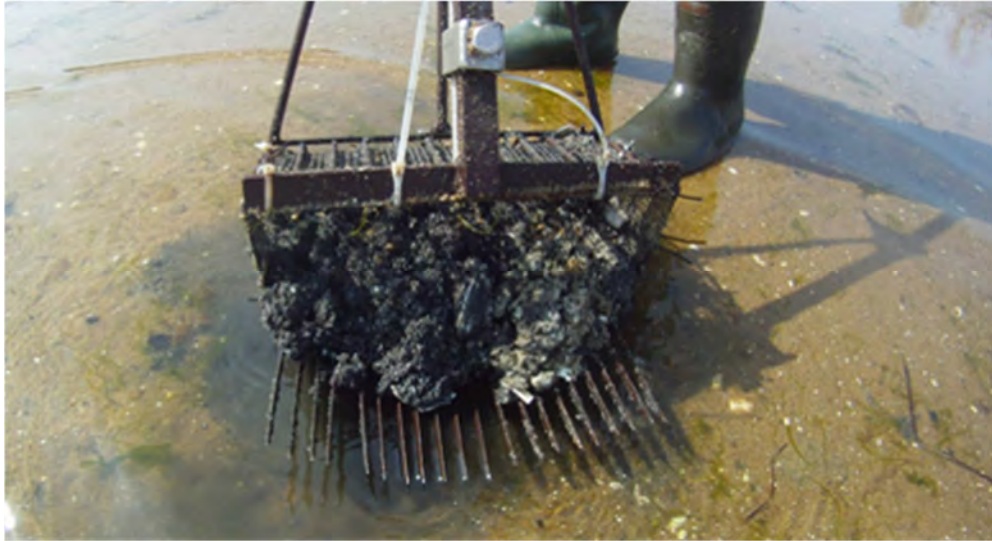
Figure 12 - Modified 1-cubic foot Bullrake for Shellfish Sampling

bottom type was generally unsuitable for shellfish. Each transect terminus was determined from just beyond the lateral extent of observed shellfish habitat on each end of the creek channel (e.g., from salt marsh bank to opposite salt marsh bank). PVC stakes were labeled and placed at each end of each transect, which were subsequently surveyed.

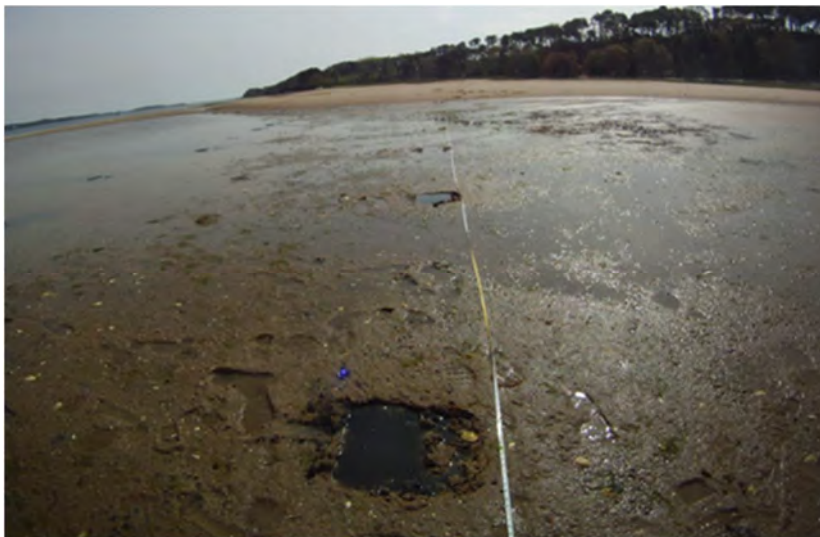
Figure 13 - Typical Layout of Transect Line Sampled at 10-ft Intervals

Samples were taken at 10-foot intervals along each transect (*Figure 13*). For each sample plot, the bull rake was utilized to obtain an approximately 1 ft² sample to a depth of approximately 1 foot, resulting in a 1 ft³ volume of sample. The samples were then sifted through the basket of the rake to allow for identification of individual species of shellfish. For each sample plot, data were recorded with respect to substrate characteristics, species observed, number of standard species, the size of species, as well as other pertinent characteristics of the habitat. All sampled material and species were returned to the sample area from which they were taken.

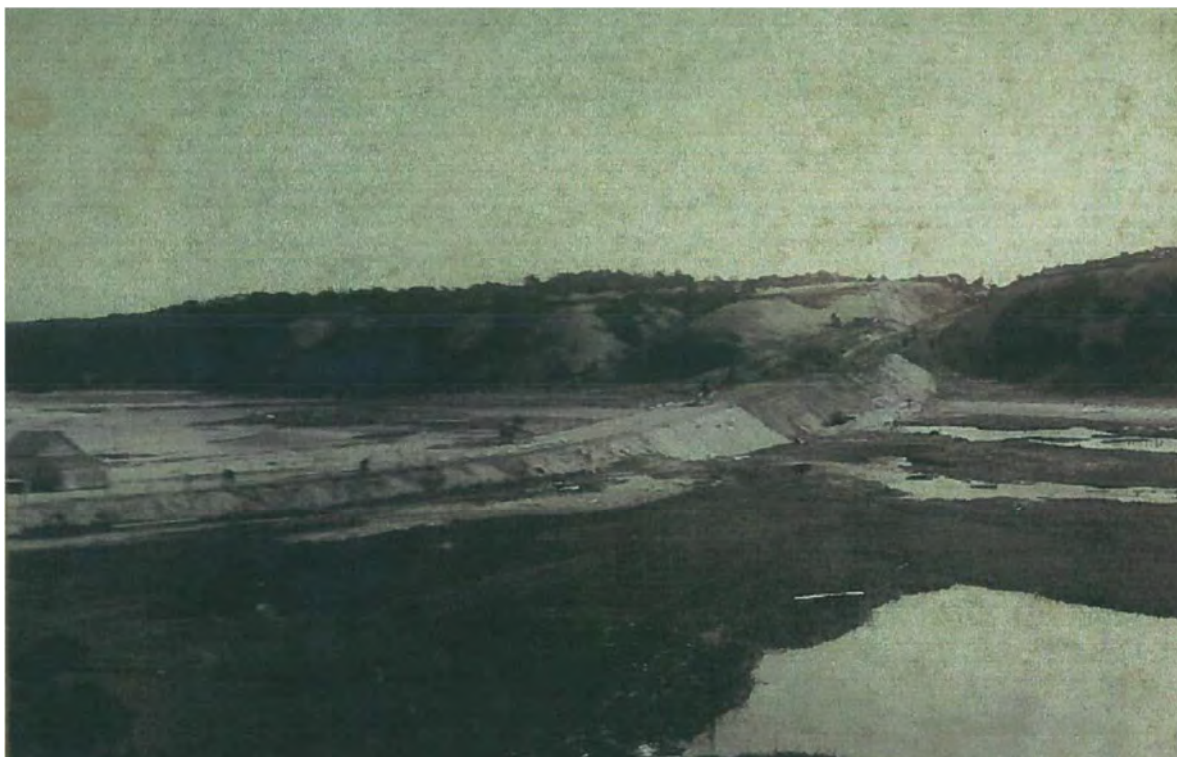
Figure 16 – Embankment Construction across Muddy Creek Estuary (c. 1900)

The first known records of an engineered crossing over Muddy Creek's outlet to Pleasant Bay place construction of an elevated timber bridge in the 1870's. After this date the crossing was filled with soil excavated from the adjacent hill in Chatham with the installation of a single culvert around 1900. A photograph of this embankment being constructed (looking from Harwich into Chatham) is provided as *Figure 16*. From this photograph, it can be seen that the soils used to construct the embankment are from adjacent land, comprised of what appears to be predominantly sandy material.

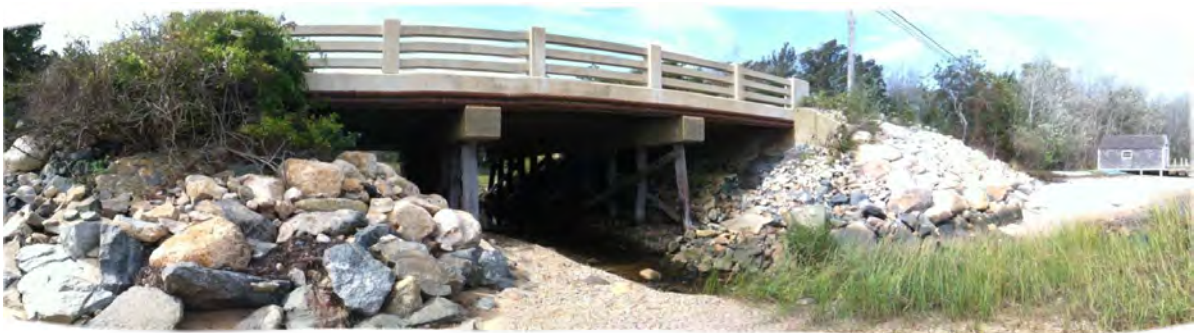
Figure 23: Example Pre-Stressed Concrete Deck Beam Bridge with Pile Bents

Adjacent pre-stressed concrete deck beams consist of pre-cast concrete beams which are placed side-by-side on conventional abutments and locked together using transverse post-tensioned steel wire. The wearing surface is comprised of either bituminous asphalt or an integral concrete wearing course. The system is well suited for shorter bridge spans over water crossings as the pre-cast beams require minimal maintenance. An example of this bridge type is shown in the photograph below as *Figure 23* (approx. 1.5 miles north of Muddy Creek on Route 28 in Orleans).
