## **1.0 INTRODUCTION**

This Land Management Plan for Island Pond in Harwich, Massachusetts was prepared by the BSC Group, Inc. at the request of and under contract to the Town of Harwich Conservation Commission. The evaluation is intended to be used by the Commission as a living guidance document for making management decisions at Island Pond and to assist the Commission in providing a safe multiuse passive recreation area while protecting wildlife habitat and natural resources.

c) **Purpose of This Management Plan:**

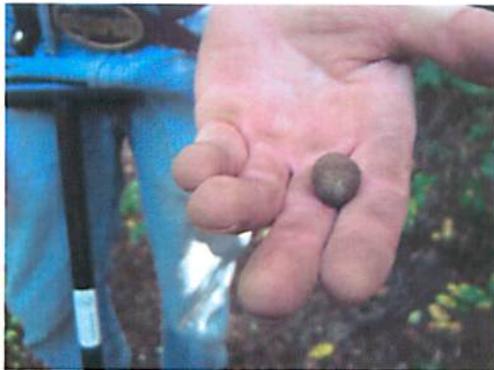
Harwich who was using a metal detector along a trail east of Island Pond. When talking with Mr. Cavanaugh, BSC discovered he had found two musket balls dating back, in his opinion, to the late 18<sup>th</sup> Century<sup>1</sup>. To confirm, BSC photo-documented the musket ball and sent a scaled photo to the state archaeologist at the Massachusetts Historical Commission (see Historical Response Appendix 14 &15). After our conversation, Mr. Cavanaugh gave one musket ball to BSC

<sup>1</sup> Mr. Cavanaugh stated that the musket ball was located by metal detector along a trail parallel to an old cranberry bog ditch and was one of two found that day and was down about 6" under the trail. The adjacent bog had a small pond with a perennial stream flowing out of it and evidence of past cranberry operation was evident, e.g. sluice and hand dug ditches.

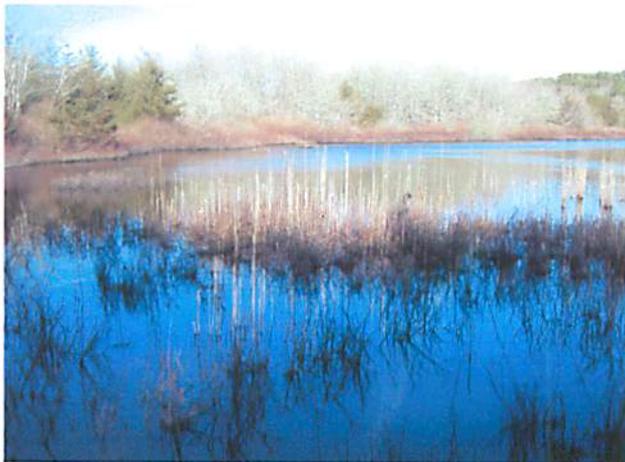
of the pond (see picture) growing within a floating bog along the edge of the pond and the second along the eastern shoreline and these *Phragmites* stands are listed as a top priority for removal and treatment. Maintaining water levels and pollution is necessary to protect the exceptional freshwater fish habitat within the pond. Also of note is that the Island Pond watershed drains into the Herring River via Coy Brook which is identified as one of the most important anadromous fisheries on Cape Cod for Alewife (*Alosa pseudoharengus*) and Blueback Herring (*Alosa aestivalis*).

shallow floating bog forming within Island Pond and the second is along the eastern shoreline of the pond. Both of these populations are small and should be treated and eradicated.

- Island Pond has two priority areas for invasive (Common Reed) removal (see Appendix 4):
- The most commonly used and safest treatment for invasive plants is a Glyphosate based herbicide solution like Rodeo Brand. Glyphosate is safe to use in and around wetlands and kills the root system of plants by absorption into the circulatory system of the plants via the leaves or fresh cut stumps and destroying the root system; thus eliminating the plant. Glyphosate is NOT listed as a chemical of concern that contaminates groundwater. The best time of year to use the herbicide is typically

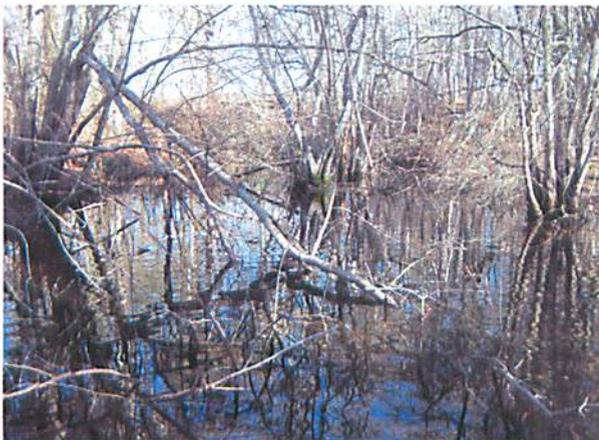
Isolated Vegetated Wetlands/Isolated Land Subject to Flooding is presumed to be significant to all the values in the act (310 CMR 10.57) and is defined as an isolated depression or a closed basin which serves as a ponding area for run-off or high ground water. According to the 2008 Natural Heritage and Endangered Species Atlas, 12<sup>th</sup> Edition, there is one vernal pool listed for the site (as of October 1, 2008) adjacent to Route 124 in the northeastern section of the property. However, the Mass GIS online viewer OLIVER, has two certified vernal pools and six additional pools listed as "potential" either on or adjacent to the site. Only one potential vernal pool is located on the Conservation Commission land with another one located on the Harwich Conservation Trust land to the north, one within the Island Pond Cemetery, one east of the cemetery near the corner of Route 124 and Main Street and two south of the cemetery directly across Main Street (see Appendix 9 & 10, Vernal Pool Certifications). The certified pools are

afforded additional protection under Wetlands Protection Act, Natural Heritage and Endangered Species Program and Army Corps of Engineers. However, the potential pools located on site or adjacent to the site do not carry these additional protections. Therefore, it is in the Town of Harwich's best interest to attempt to certify any potential vernal pools and to obtain adjacent land, if possible, that have potential vernal pools. These potential vernal pools should be considered high priority habitat, monitored and certified as vernal pools with the Natural Heritage and Endanger Species Program.

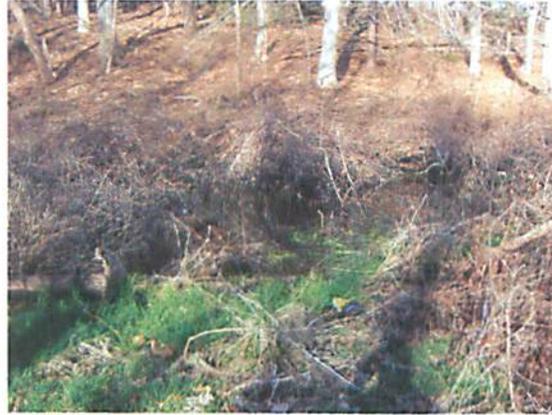
This pool was photodocumented during the Fall of 2011 and Spring 2012, and qualified for certification. Another larger pool, again supporting breeding Wood Frogs and Mole Salamanders, is located southwest of Island Pond, adjacent to a dirt trail connecting to the rail trail bike paths. Certification forms for these vernal pools should be prepared and submitted to the Natural

Heritage & Endangered Species Program, Division of Fisheries & Wildlife for certification. Also, the current stockpiling areas at the Cemetery are within the BVW associated with an intermittent stream, which floods into Island Pond. Improvements should be made to reduce impacts to the buffer zone and BVW in this area. Sediment containment and moving materials further upland would improve this buffer.
