# Bank Street Bogs at Cold Brook Evaluation of Natural Nitrogen Attenuation/Baseline Assessment

## FINAL REPORT

September 2016

## Town of Harwich

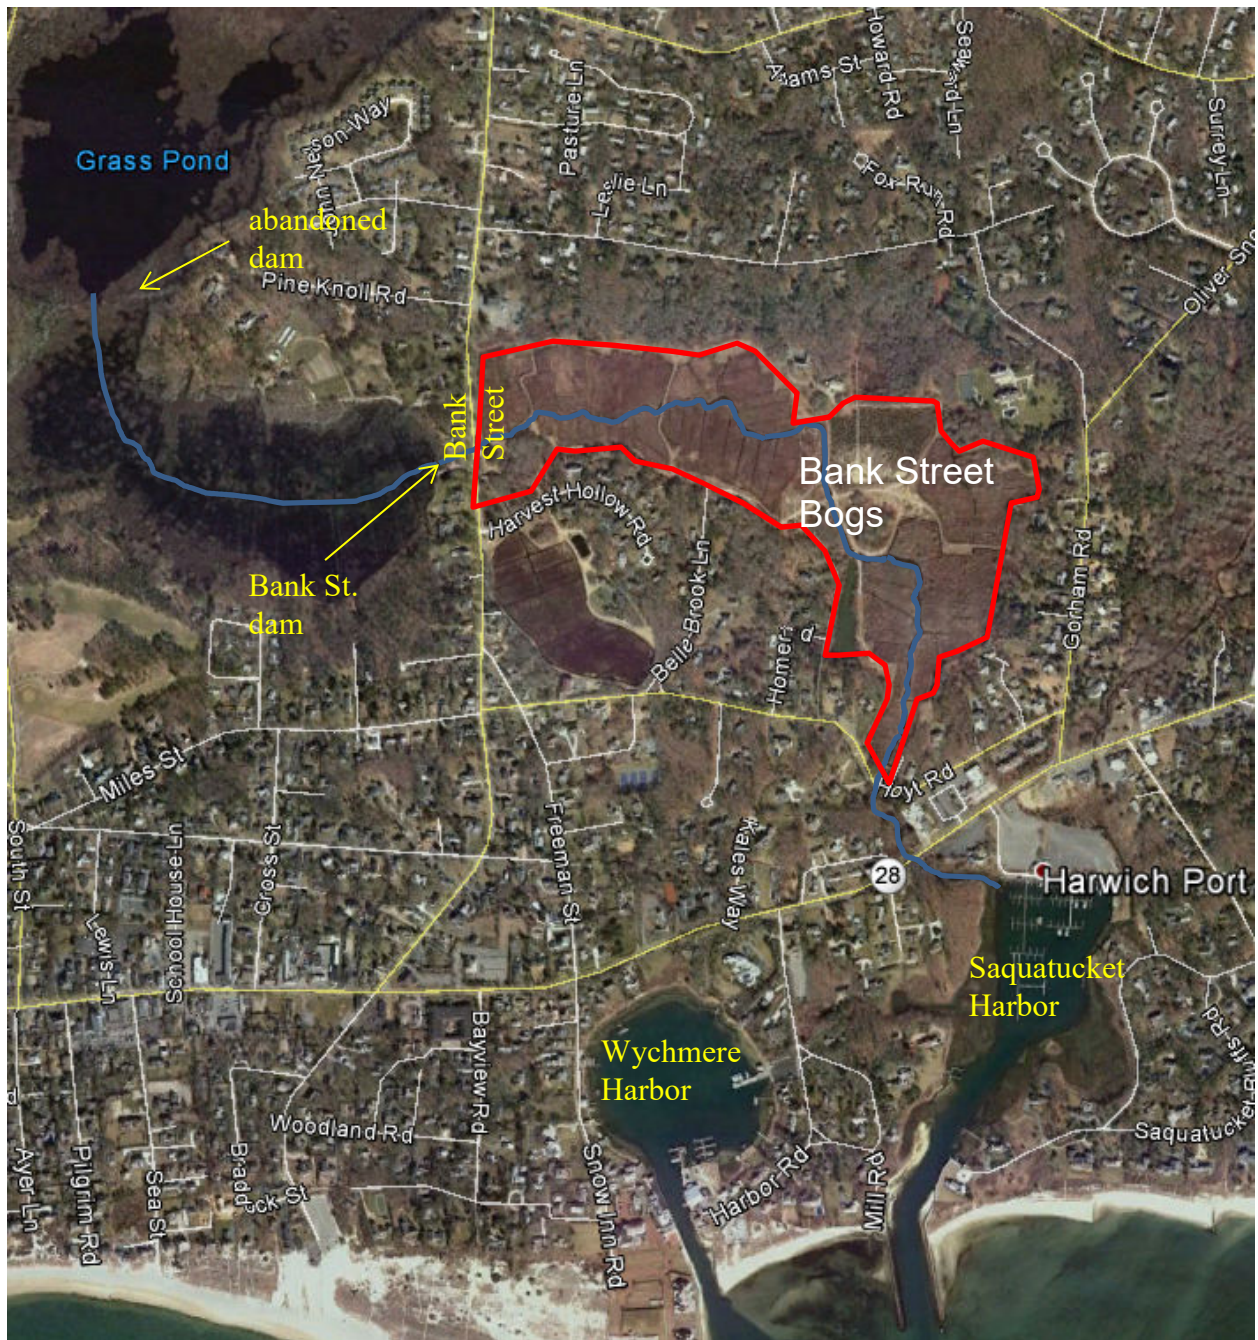
**Figure EX-1. Bank Street Bogs/Cold Brook Locus Map.** Red outlined area is the Bank Street Bog System, while the blue line indicates the current primary flow path of flow in Cold Brook from Grass Pond to Squatucket Harbor. Based on March 2012 aerial from Google Earth.

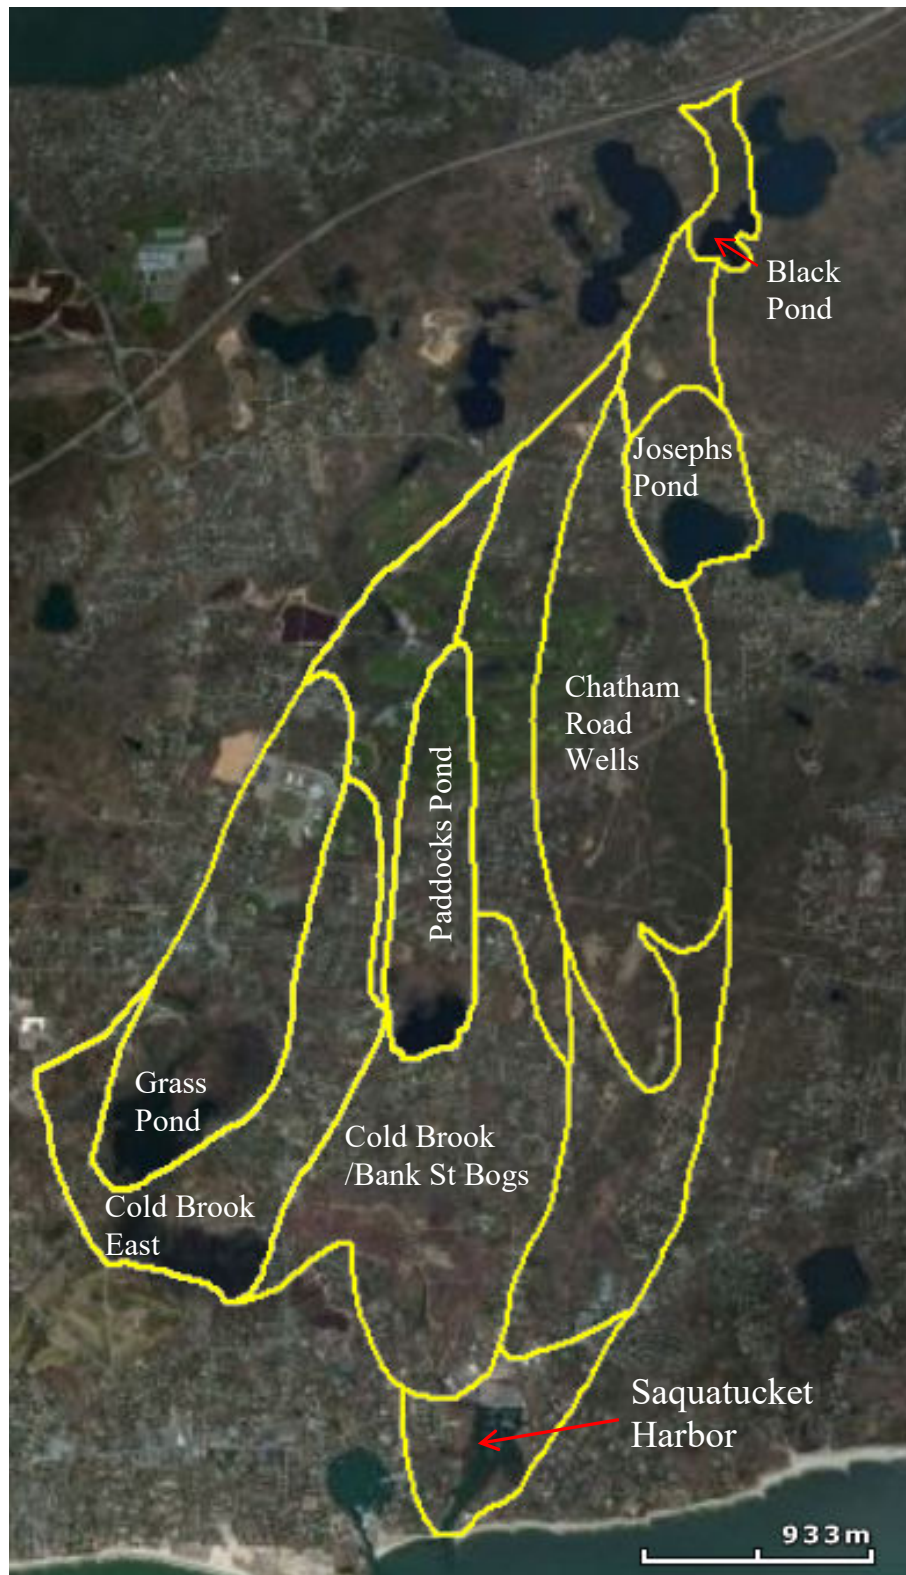
**Figure II-1. Saquatucket Harbor Watershed.** Watershed from 2010 MEP report showing subwatersheds to ponds, public water supply wells, and streams within the overall Harbor contributing area. Streamflow measurements at Hoyt Road confirm the estimated watershed flow based on watershed as shown.

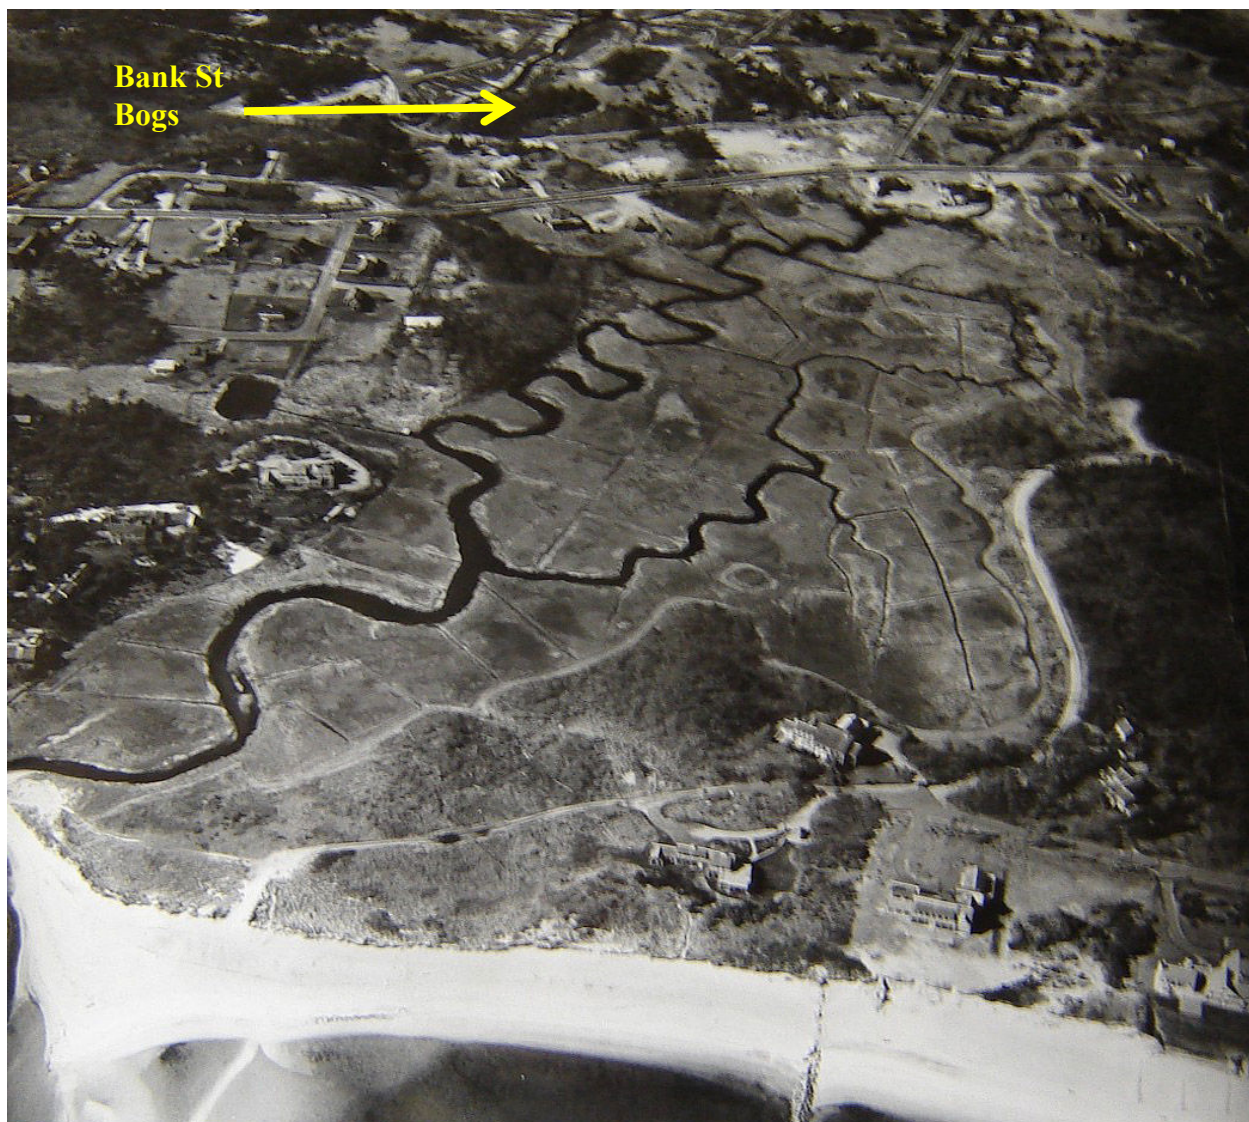
**Figure II-2. 1964 Aerial Photograph of Andrews River Estuary, Harwich.** Andrews River was dredged in 1968-1969 to create Saquatucket Harbor. The southern portion of the Cold Brook/Bank Street cranberry bog system is shown in the upper portion of the photo.

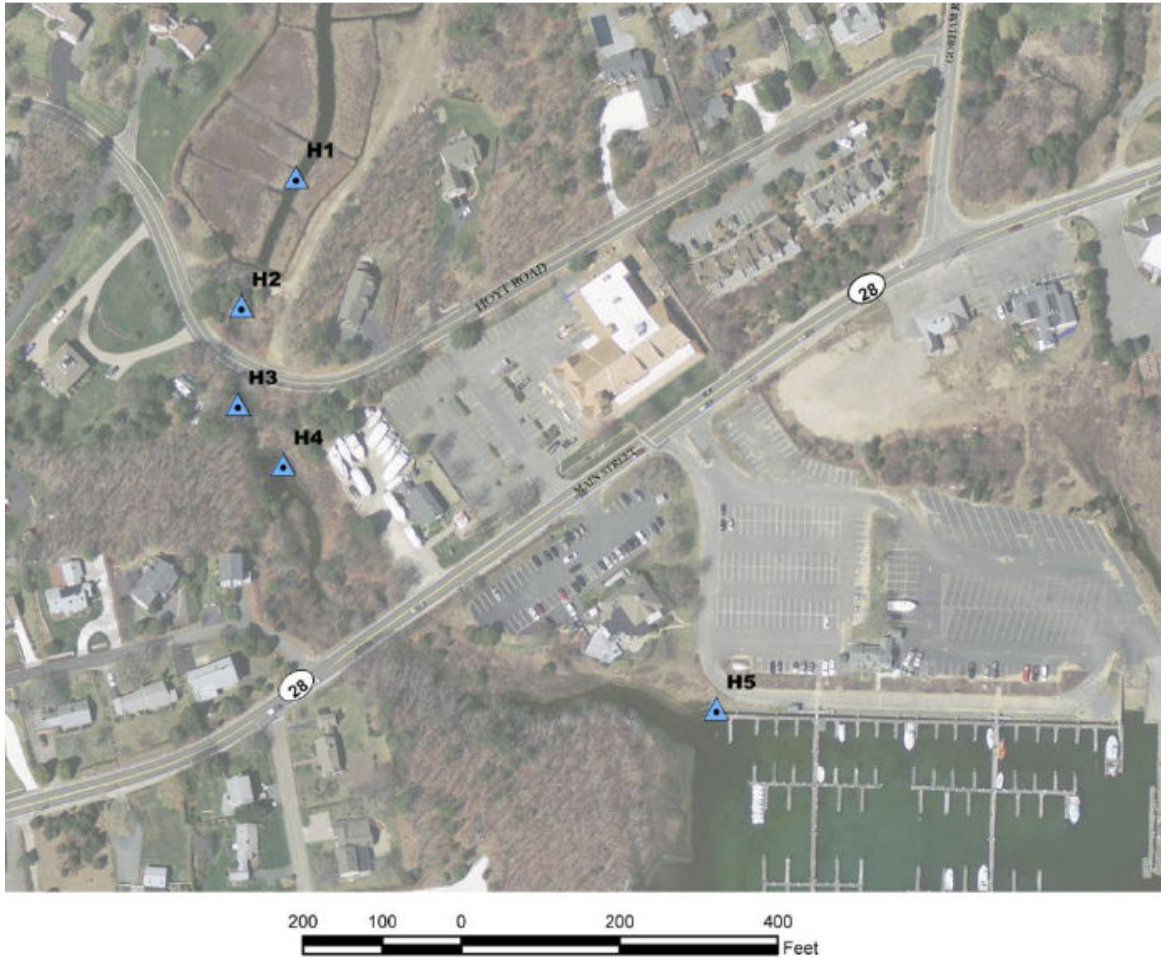
**Figure II-4. Cold Brook tide gauges locations for Geosyntec Consultants.** Gauges (5) were installed and recorded between May 12 and June 10, 2011 (29 days) using 6 minute recording intervals. Modified from Figure 4 in Geosyntec Consultants (2011).

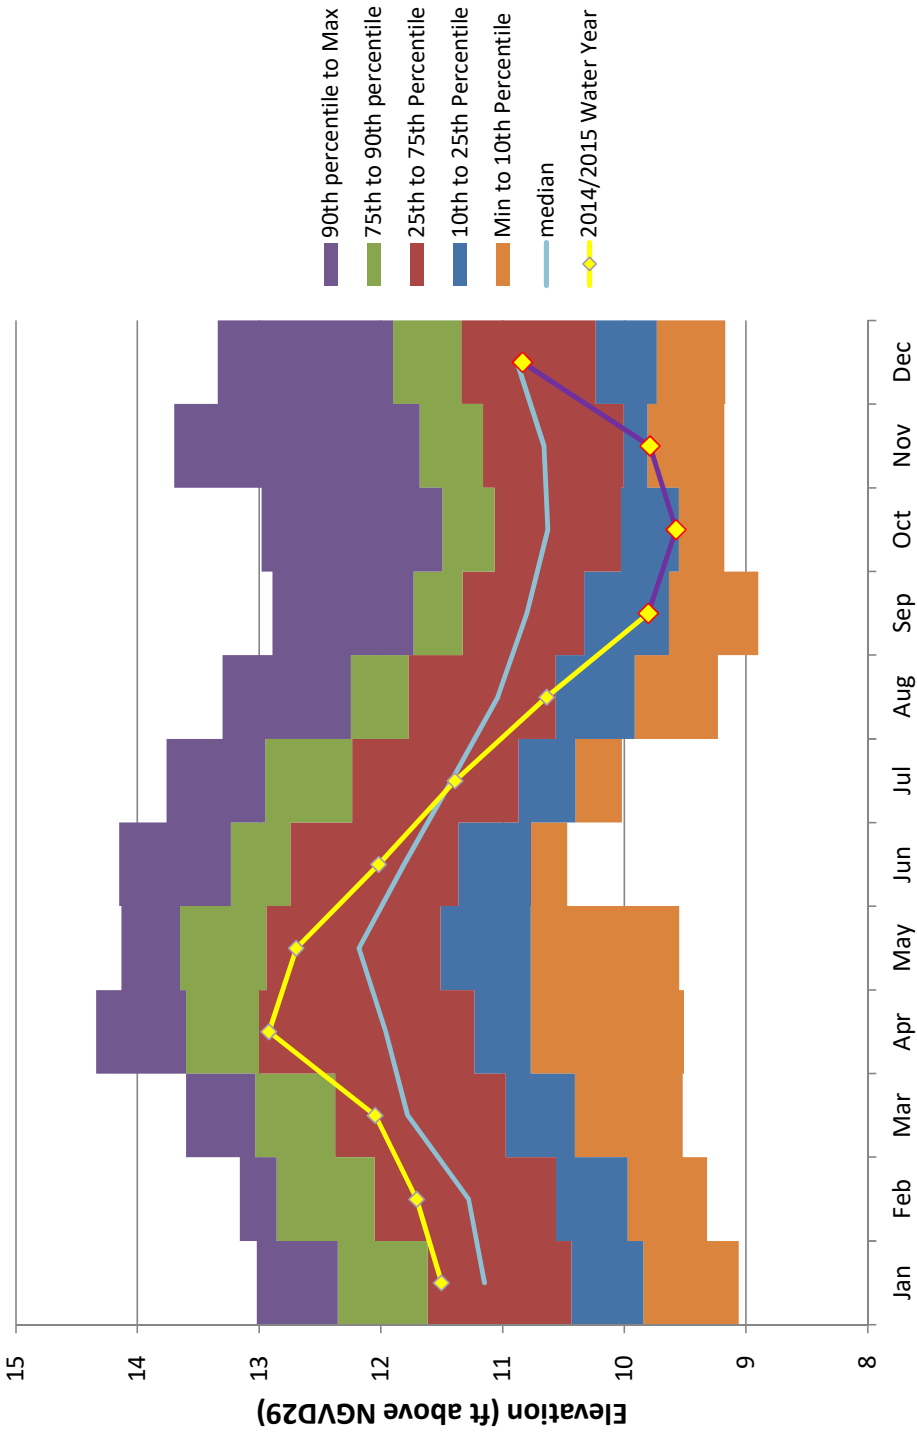
**Figure IV-7. Groundwater Elevations during 2014/2015 Water Year (CGW138).** CGW138 is a groundwater well where water levels have been measured mostly monthly for more than 50 years. Project staff developed monthly percentile ranges and median elevations and compared these to monthly readings during the 2014/2015 water year when flow readings were collected in Cold Brook. Water levels in September and October 2014 began near the 10<sup>th</sup> percentile before recovering to approximately median levels in December (purple line and red outlined datapoints). Between January and May, groundwater elevations were near the 75<sup>th</sup> percentiles for each month before declining to median levels in July and near the 25<sup>th</sup> percentile in August (yellow line and datapoints). Stream flow readings at all stations reached maximum flows in late March, which coincides with the maximum groundwater levels during the water year.

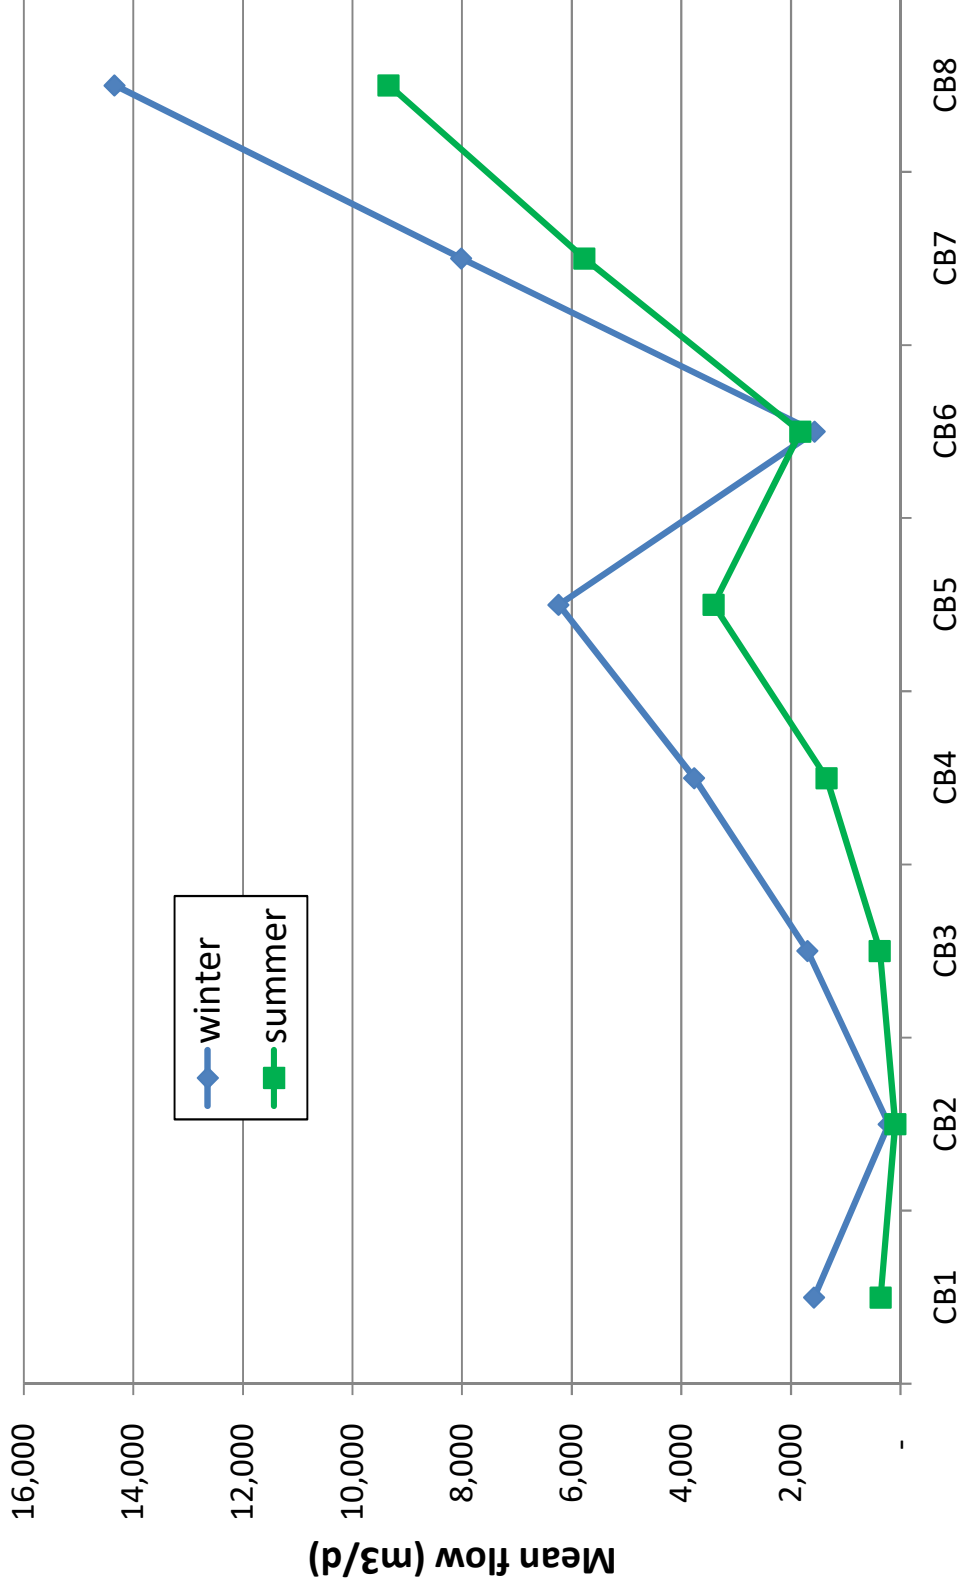
**Figure IV-8. Seasonal Discharge Flows at Bank Street Bog Stations (2014/2015).** Mean summer (June to September) flows at stations CB-2, CB-3, CB-4, CB-5, and CB-8 are significantly less ( $p < 0.05$ ) than winter (May to October) means. Seasonal reductions at CB-1 and CB-7 are significant a  $p < 0.1$  level. There is no significant difference between mean flows out of the former irrigation pond (CB-6): summer ( $1,824 \text{ m}^3/\text{d}$ ) and winter ( $1,739 \text{ m}^3/\text{d}$ ). Differences between summer and winter mean flows generally decrease as flows move downstream.

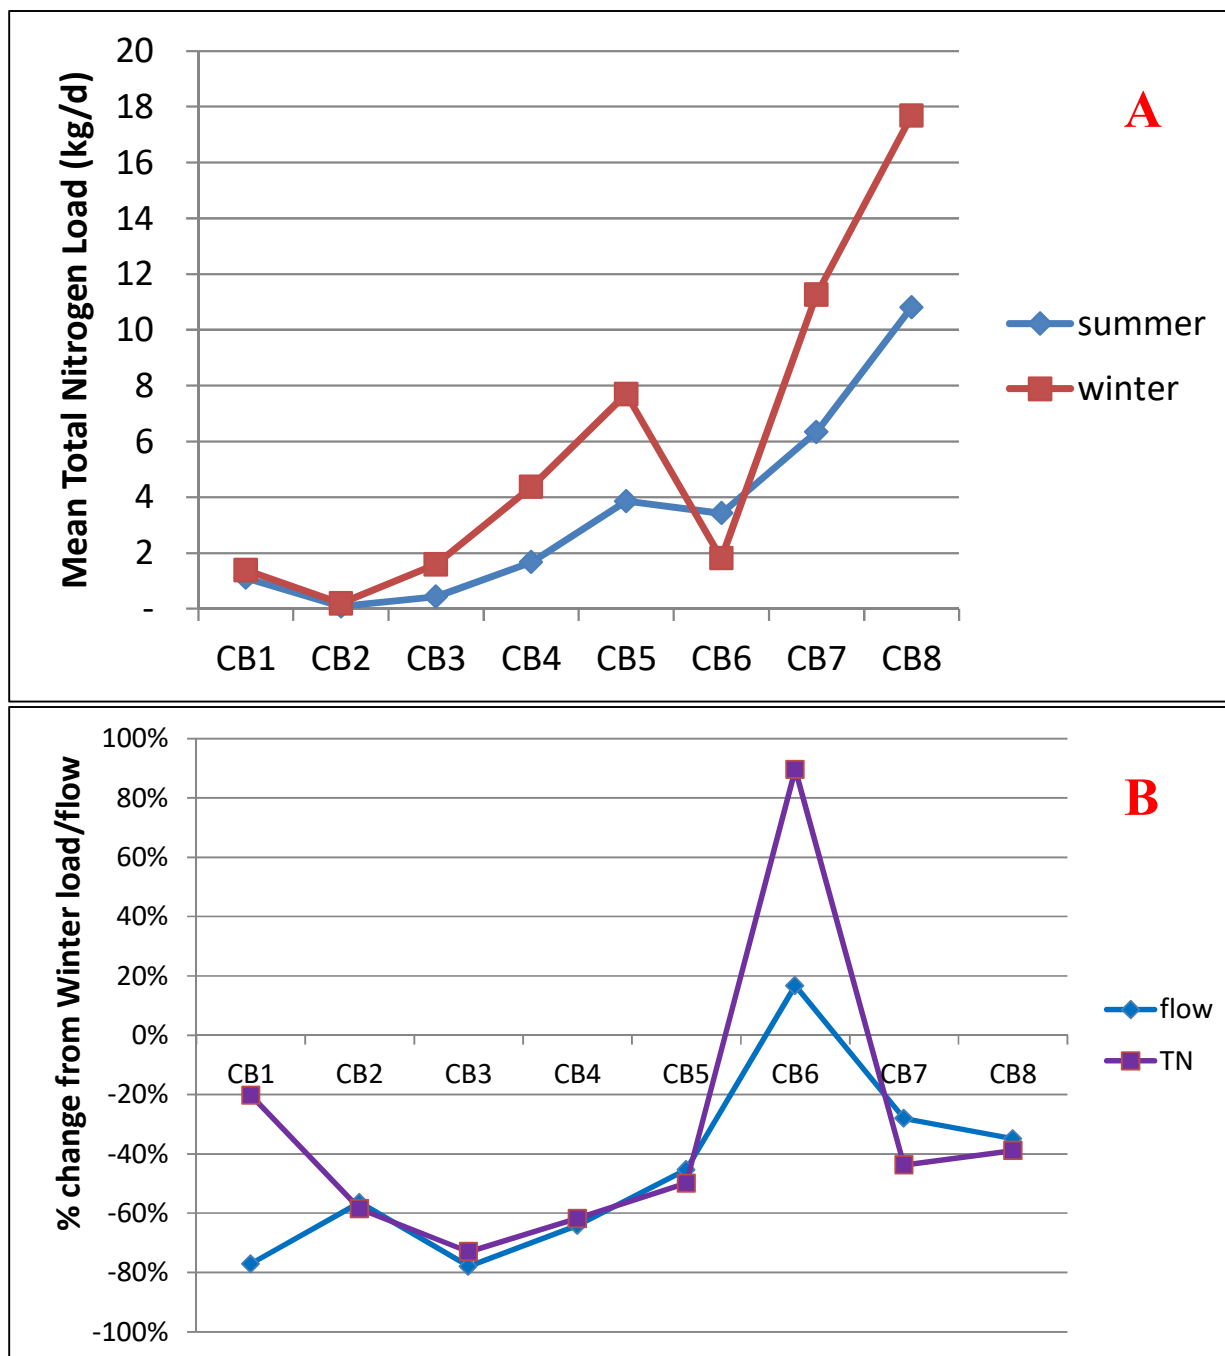
**Figure V-6. Bank Street Bog Water Quality Stations: Seasonal Total Nitrogen Loads.** Total nitrogen loads are generally lower in summer and higher in winter, except for CB-6 (Plate A). TN changes generally move in tandem with seasonal changes in water flow (Plate B). Summer mean TN loads at CB-6 are significantly higher than winter mean loads and are higher than the increase in flow at CB-6. Since CB-6 was in the outlet from the former irrigation pond, flows are relatively stable across seasons and, on average, slightly higher during the summer.

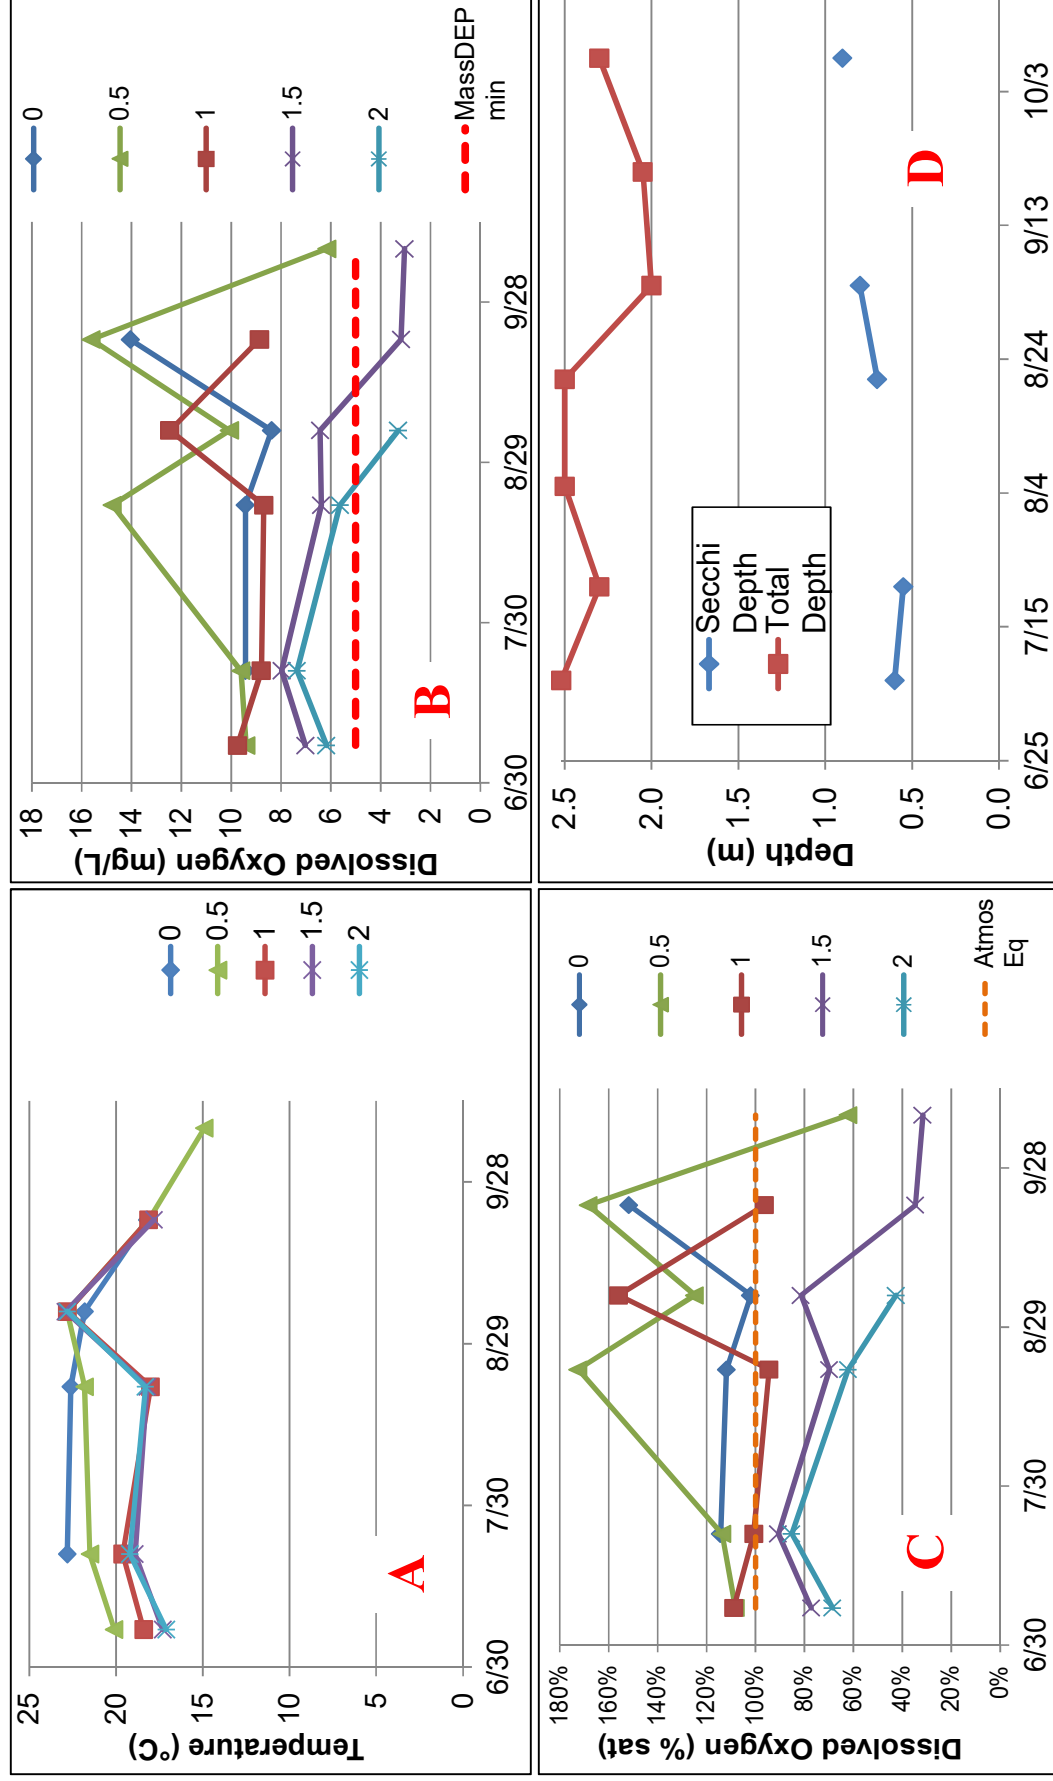
**Figure V-9. Former Irrigation Pond: Dissolved oxygen, temperature, and Secchi/clarity.** Plate A shows temperature collected at 0.5 m depth increments throughout the water column; readings in early summer would enhance the salinity restrictions of mixing of the water column. Plate B shows dissolved oxygen concentrations; deepest readings beginning in September are less than the MassDEP 5 mg/L minimum. Plate C shows % saturation levels of dissolved oxygen; late August and September surface readings indicate supra-atmospheric concentrations consistent with a phytoplankton bloom. Plate D shows Secchi/clarity readings; average clarity is only 31% of the water column.
