# Brooks Free Library

739 Main Street  
Harwich, Massachusetts 02645

## Exterior Assessment Report

July 17, 2015

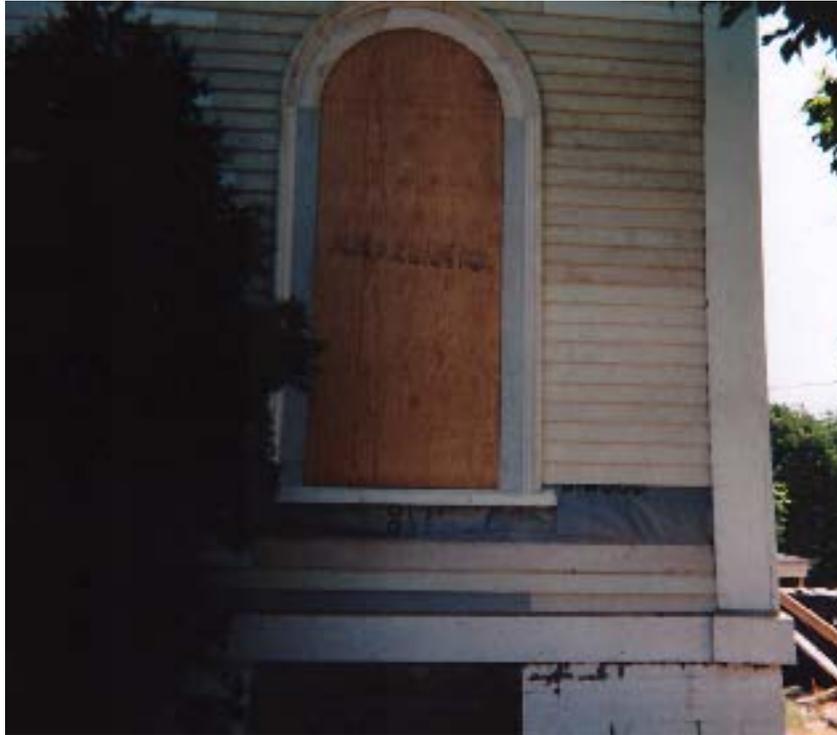
**Photo 13: Photo from 1989 renovation shows new clapboard installation.**

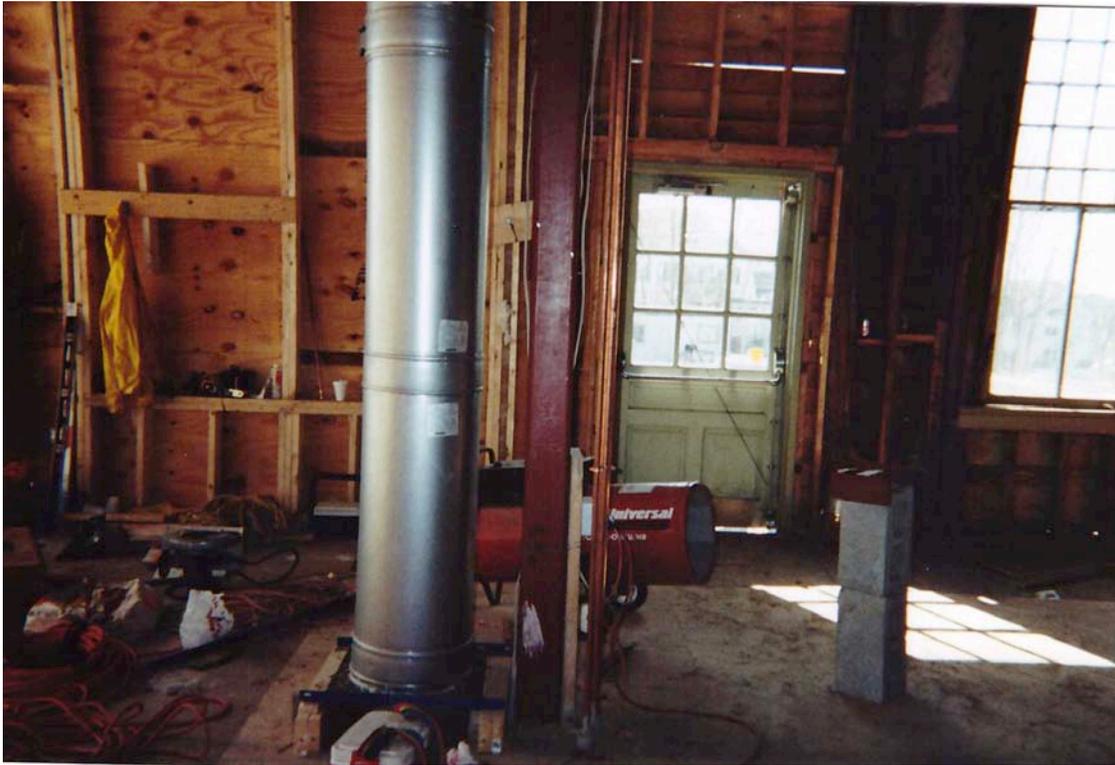
Detail drawings from the 1998 renovation called for the installation of insulation and a vapor barrier at the exterior walls of the existing building (see figure 15) and a photograph taken during the 1998 renovation shows that the interior finishes were removed to allow for this installation (photo 16). It can be assumed that the work was constructed as directed in the contract drawings from 1998, and that the paint failure is therefore not caused by a lack of vapor barrier in the wall construction.

**Photo 16:** Photo from 1998 construction shows interior finishes stripped to add insulation and vapor barrier.

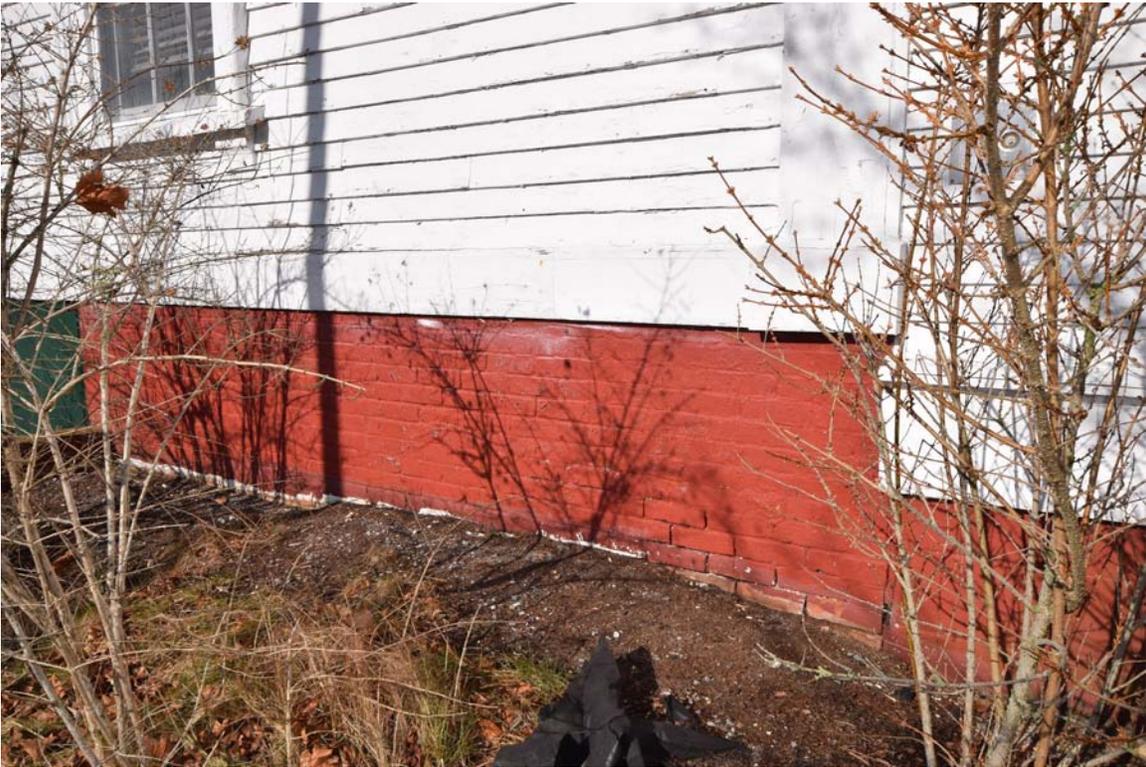
The building features an exposed brick foundation that varies in height around the building. On the south and west elevations, the brick has been painted. Overall the brick is in good condition on these elevations, with only some minor re-pointing required (see photo 26). The grade line has eroded somewhat, leaving a 2” high line at grade that is un-painted. The grade could be raised to correct this (probably by merely adding mulch). There are also areas of painted brick that have peeling paint and these areas should be scraped and painted. At the north elevation, mortar joints are in worse condition (see photo 27) and require pointing (see photo 28)

**Photo 26: Painted brick foundation, South Elevation.**

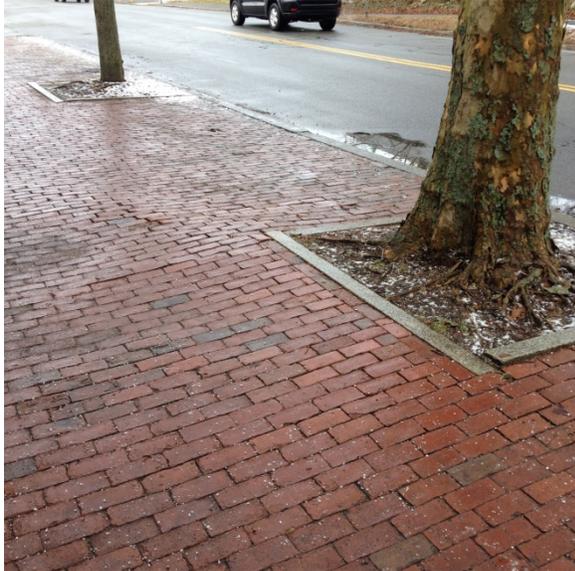
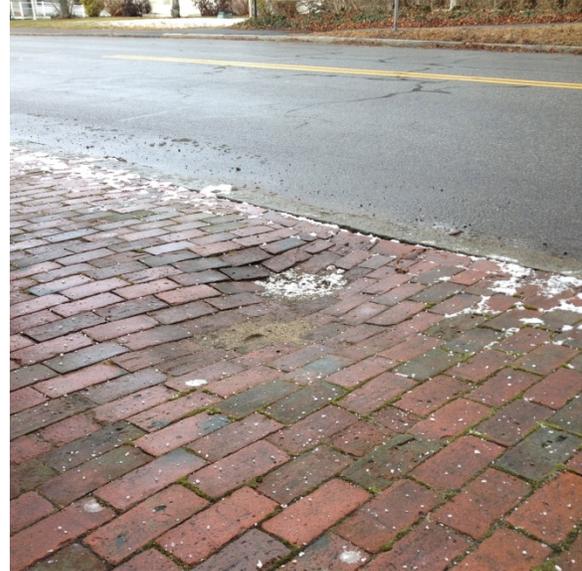
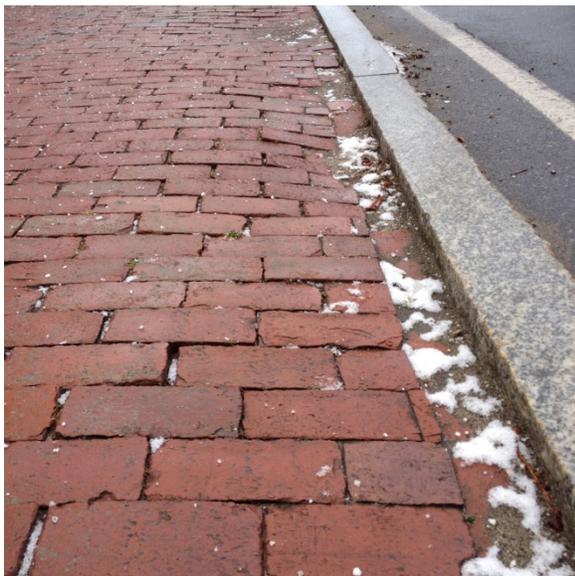
The brick pavers along the Main Street frontage of the Library are showing signs of settling and uplifting. Most of this is due to the growth of the root systems of the two trees in this area. Other areas of settling are perhaps due to differential settlement of base materials, especially along the curb. The granite edging around the tree planters is also showing signs of settling and uplifting due to the growth of the trees.

In order to repair the issues and mitigate any further damage, the Town of Harwich may want to remove and replace these trees. New trees with deeper tap root systems, such as Oak, can be installed in the planters. If the Town elects to replace the trees, then the planting soil currently

in the planters should be removed and replaced with a structural soil that is more typical for a street tree installation. Drainage components can be installed around and between both planters which will ensure proper drainage. The areas of pavement that exhibit the most severe settling and uplifting should be removed and replaced. Base materials should be inspected and amended as needed. Any damaged or broken pavers should be replaced. Any difference in elevation between pavers of 1/4" or more require removal and resetting.

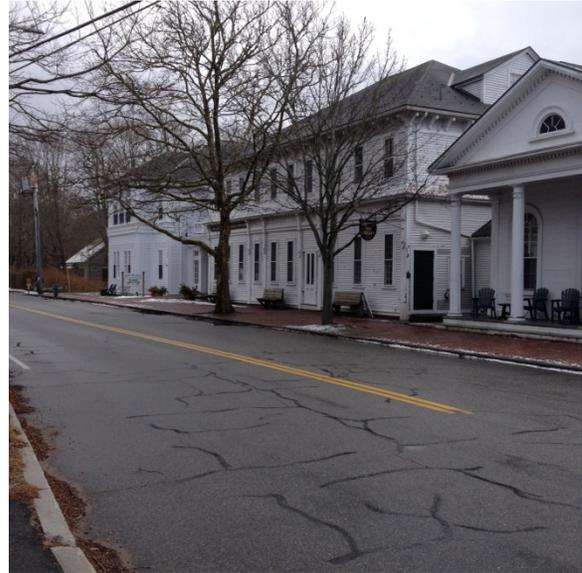
Upon closer inspection, there are small areas that are part of the north façade streetscape that feel and appear unkempt. Gravel pavement close to the building has become scattered and there is no harmony to the site furnishings. The area along Main Street is not conducive to being used as a quiet reading area due to the noise of traffic and the shaded northern exposure. However, it would be in the best interest of the Library to provide seating for visitors or pedestrians. This site furniture should complement the exterior materials, styles and colors of the Library. Most commercially available site furnishings for installation at this type of facility can be secured to pavement or installed in the ground to prevent theft.

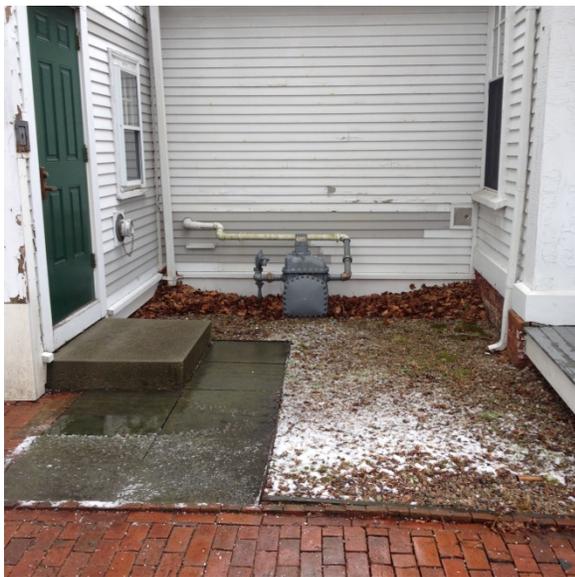
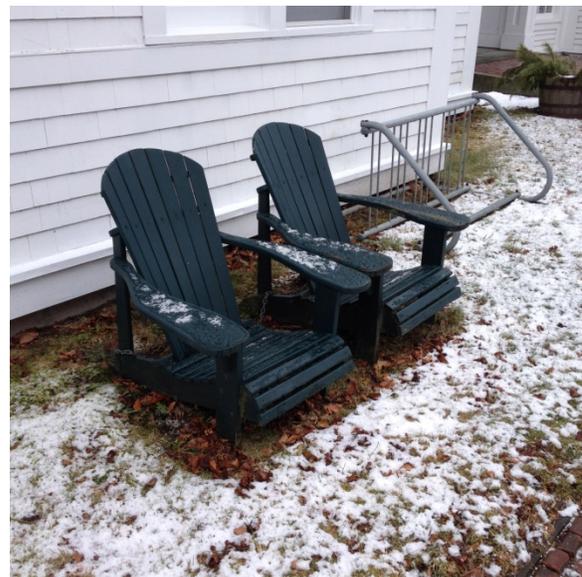
The bike rack that is currently located near the main entrance is undersized, given the Library's proximity to the Cape Cod Rail Trail. The bike rack should have a dedicated paved area that is closer to the door. If it is not located close to the door, bikers will not use it and simply store their bikes haphazardly against the building. The bike rack should be chosen to complement the other outdoor furniture and should have two points of contact for each bike. Similarly, the bike

rack at the parking lot entrance should be replaced with a rack to store more bikes. It should also match the rack installed near the north entrance so that all site furnishings are in harmony with each other.

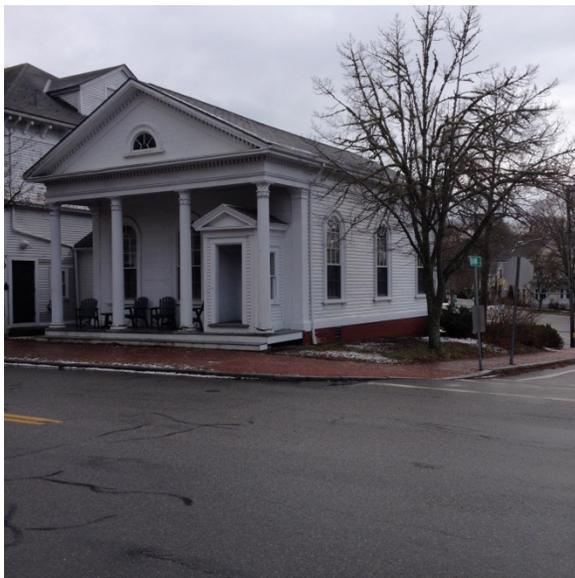
The landscape on the west side of the building is in poor condition. The two trees along this façade of the building are in poor health with a number of damaged limbs. Due to the safety risk and risk of damage to the building, these trees and their stumps should be removed. New plantings in this area should be low so as not to block views in and out of the windows. The new plantings should also include large evergreen shrubs that will provide a visual frame of the building, especially for travelers approaching from the west. The existing plants adjacent to the parking lot are in good shape and only require some minor trimming to remove portions of the shrubs that overhang the walkway and parking area.

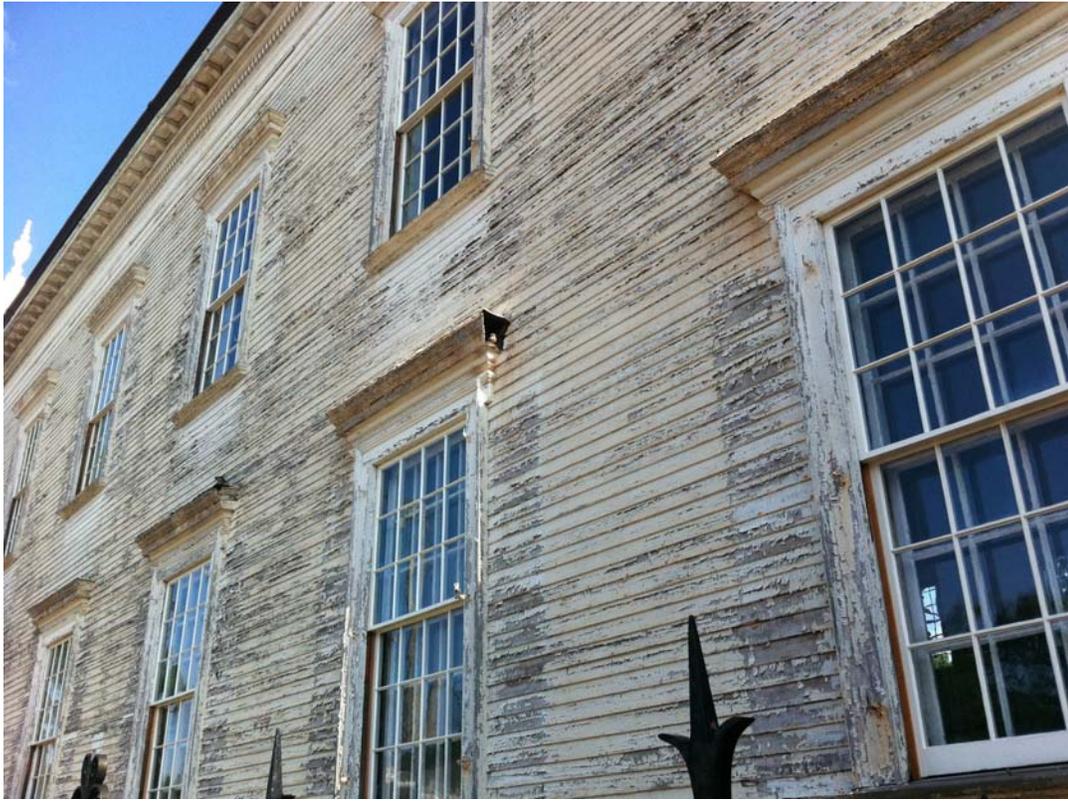
“Before” condition of paint at the First Parish Church in Dorchester

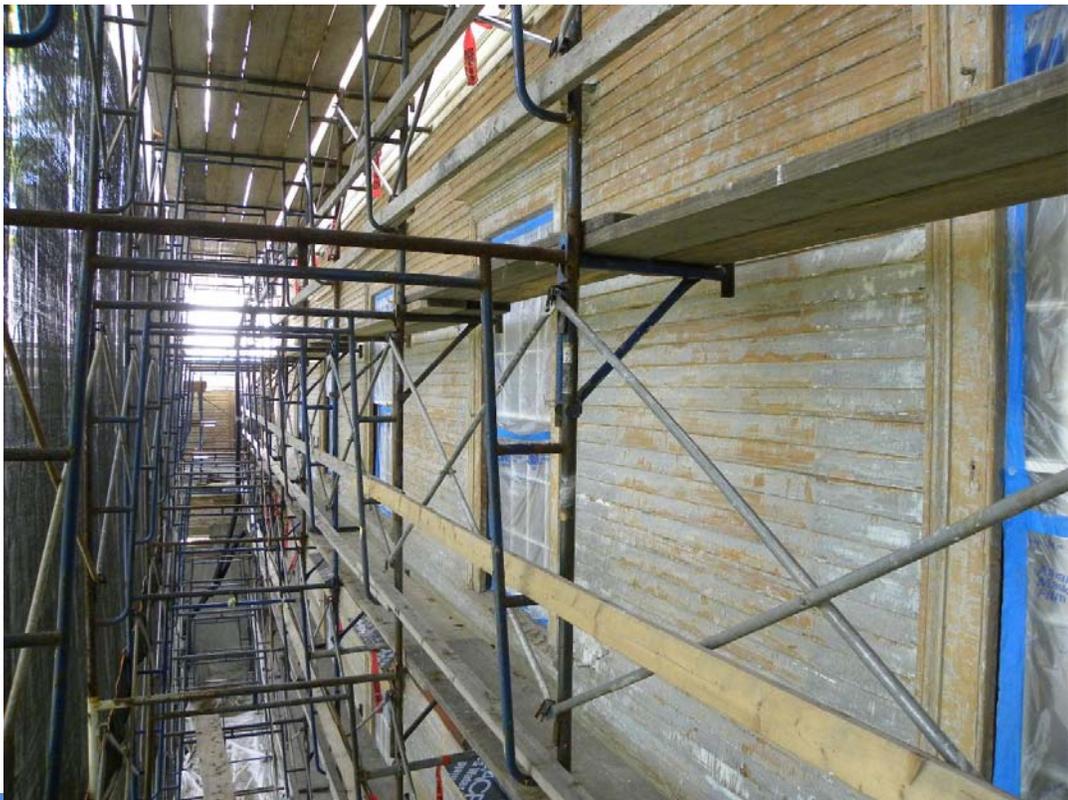
“During” photo shows staging and staging enclosure in place during chemical stripping

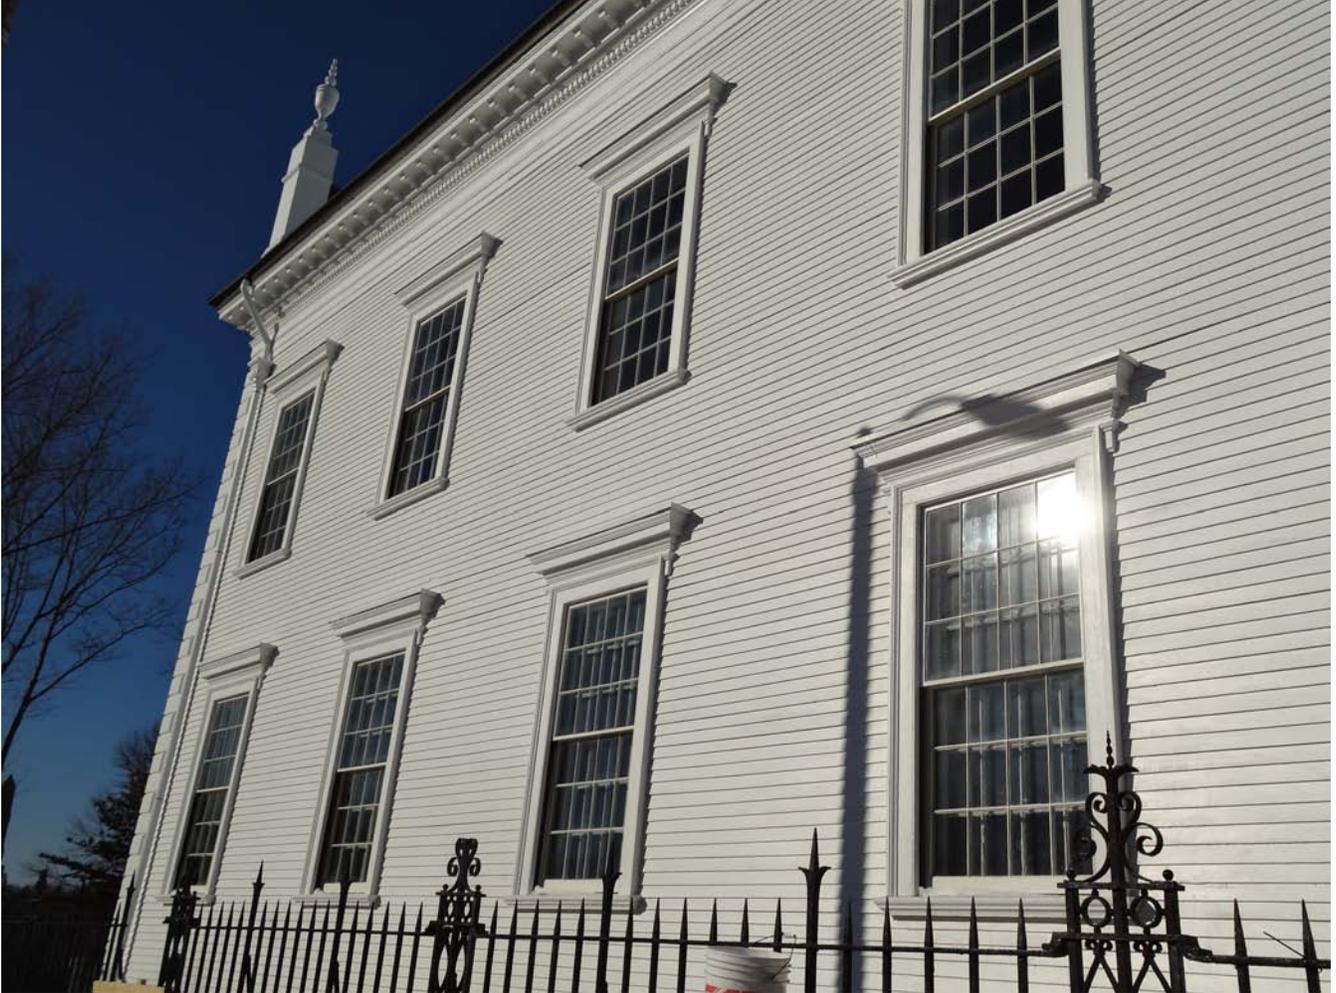
“After” view of painted exterior
