3 December 2020

Reference: Brooks Academy Museum
Structural Conditions Assessment Report

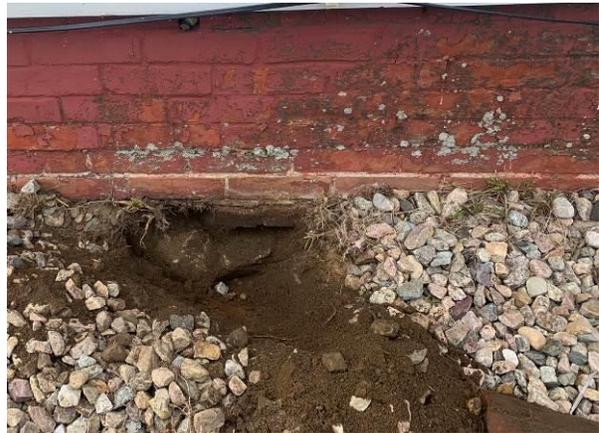
- As with the 1844 section, the 1909 section's foundations are also in poor condition:
 - The exposed brickwork dips between the northeast and southeast corners and the deeper underpinning foundation of the dug-out mechanical area, which provides a hard point of support.
 - The brickwork at the southeast corner is rotated the eastward direction.
 - The south and east walls have eroded mortar joints and debonded brick units.

- According to two test pits, the stone foundations below the brickwork consist of loose, rounded fieldstone that are dry laid in soil to a depth of only a few feet below the ground surface.

Because of their extremely poor conditions we recommend that the south and east foundations be replaced. This would be done in the same manner as described for the 1844 section.
