**BOARD OF WATER & WASTEWATER COMMISSIONER'S**  
**MEETING AGENDA\***  
**Harwich Water Department, 196 Chatham Road, Harwich MA**  
*Thursday, March 23, 2023*  
*11:30 a.m.*

**MINUTES**  
**HARWICH WATER DEPARTMENT**  
**BOARD OF WATER/WASTEWATER COMMISSIONERS**  
Thursday, March 9, 2023  
11:30 a.m.

### Pleasant Lake Water Storage Tank

HARWICH WATER DEPARTMENT  
PLEASANT LAKE TANK 2022 ANNUAL INSPECTION

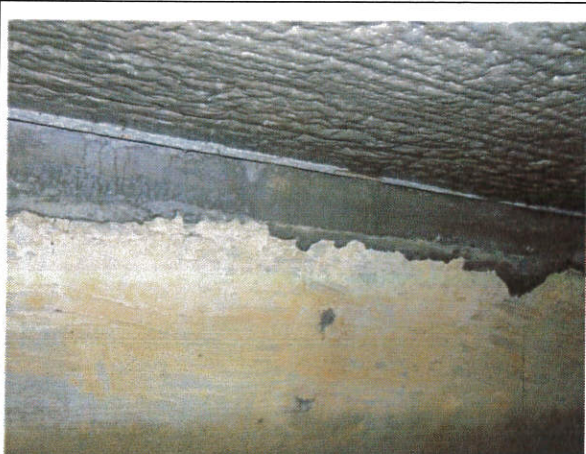
13) Closer view of interior roof to shell intersection

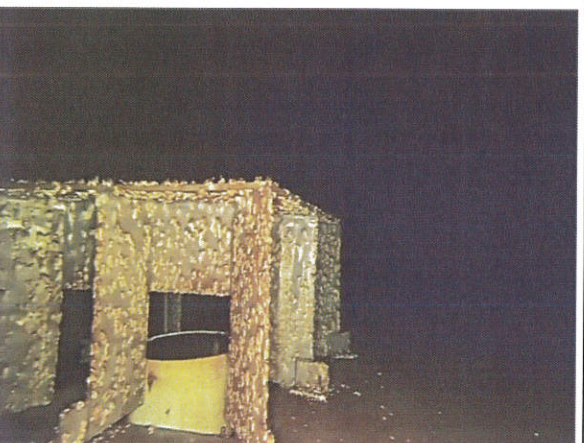
21) Outlet pipe with sediment ring and  
diffuser 13:11

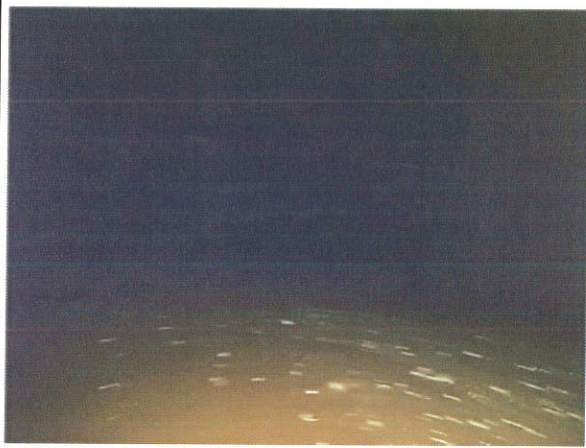
25) Dusting of sediment on floor 26:30

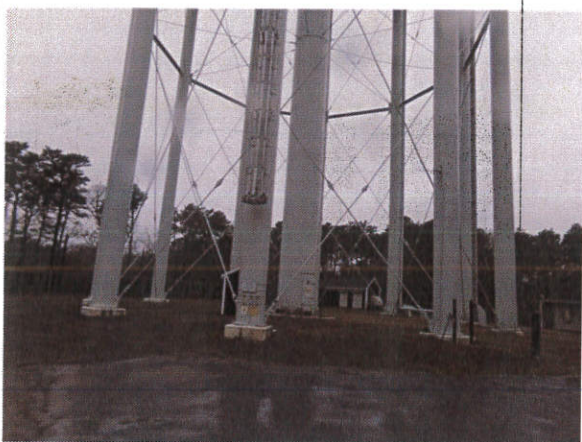
2) Lower portion of tank

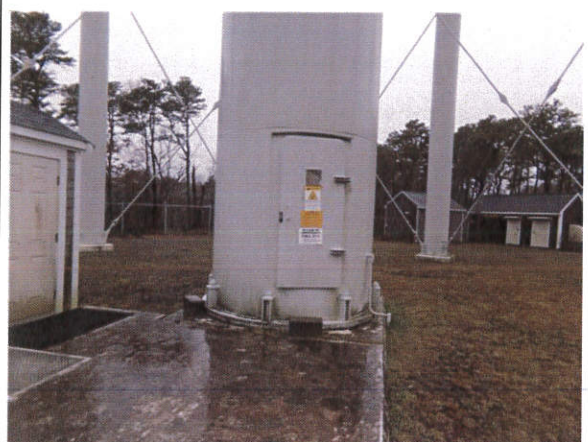
5) View of lower riser pipe

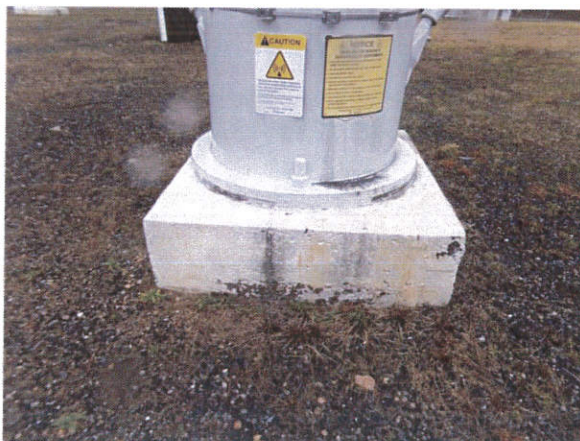
3) Typical view of leg base

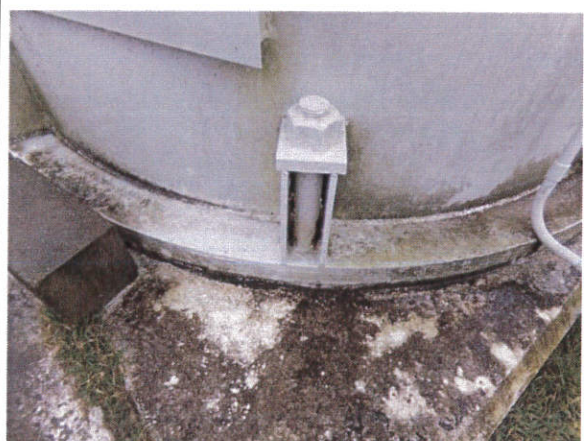
6) Close up of anchor bolt for riser pipe

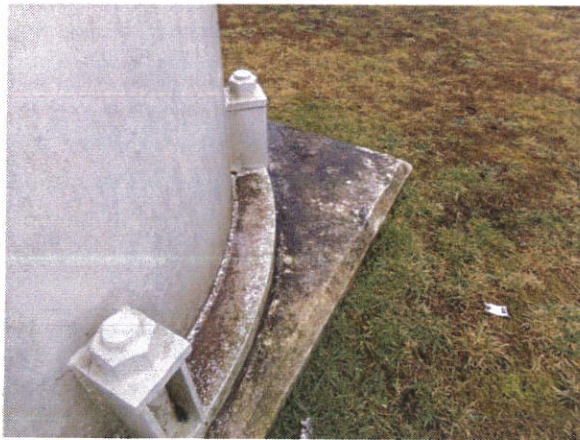
Riser foundation pad is intact. No large cracks, spalls, or exposed rebar were noted.

7) Riser pipe base with anchor bolts and foundation

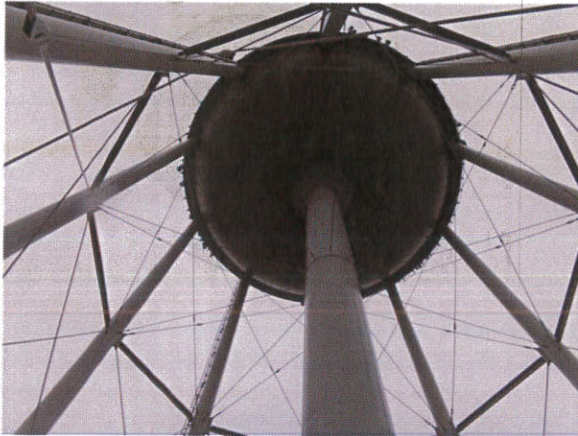
Tank bowl coating is more than 99% intact. Minor biological staining and moderate rust staining was observed.

8) Wide view of lower tank bowl with moderate rust staining

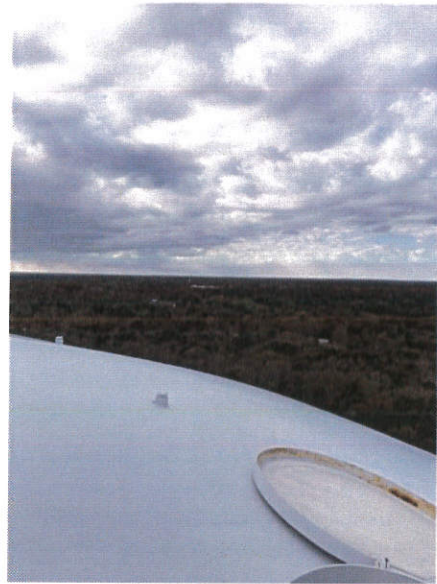
Roof coating is 95% intact with minimal active corrosion.

14) General roof view

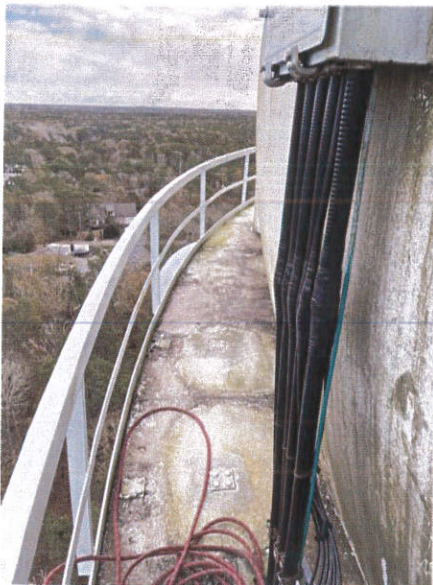
13) Clockwise view of balcony with mildew staining

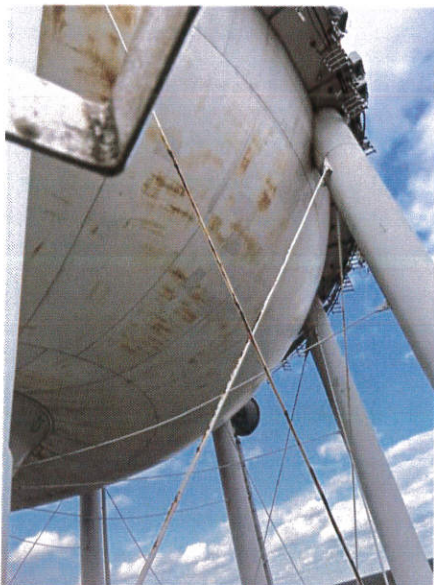
16) View of bowl underside with some surface rust

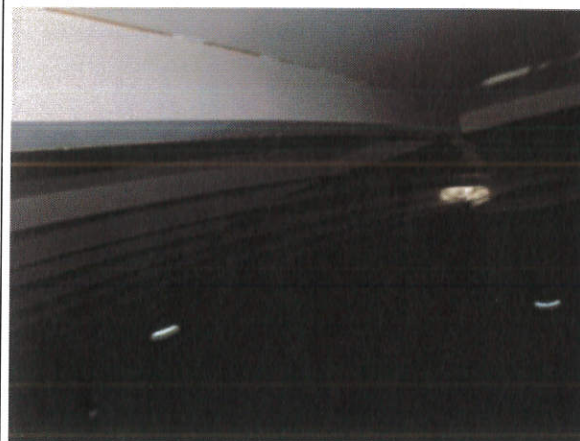
19) General interior roof view

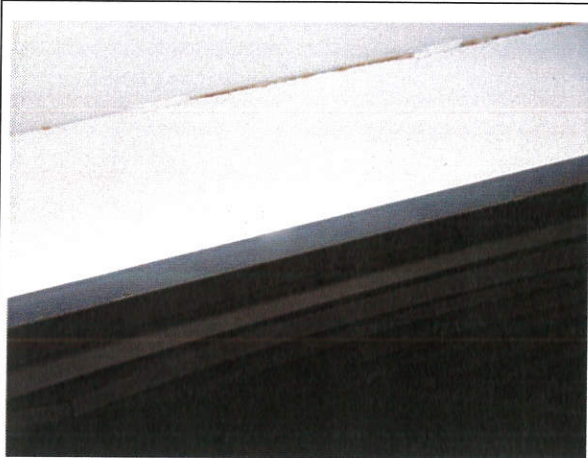
20) Close up of typical roof beam

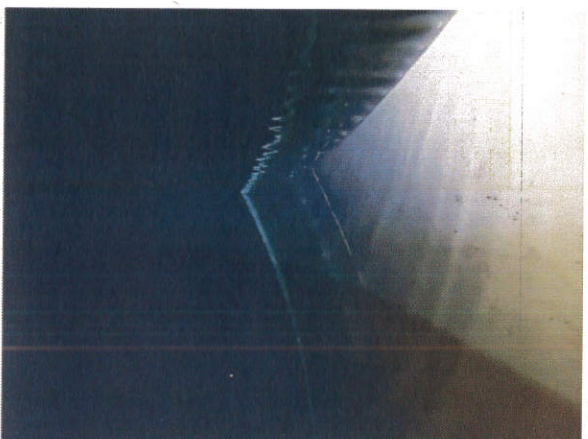
21) General view of upper shell interior 1:11
