Town of Harwich Road Safety Audit Route 39 (Orleans Road) at Pleasant Bay Road

July 29, 2016

Prepared by the Cape Cod Commission in cooperation with the Town of Harwich and MassDOT Highway Division, Traffic Safety, and District 5 Offices.

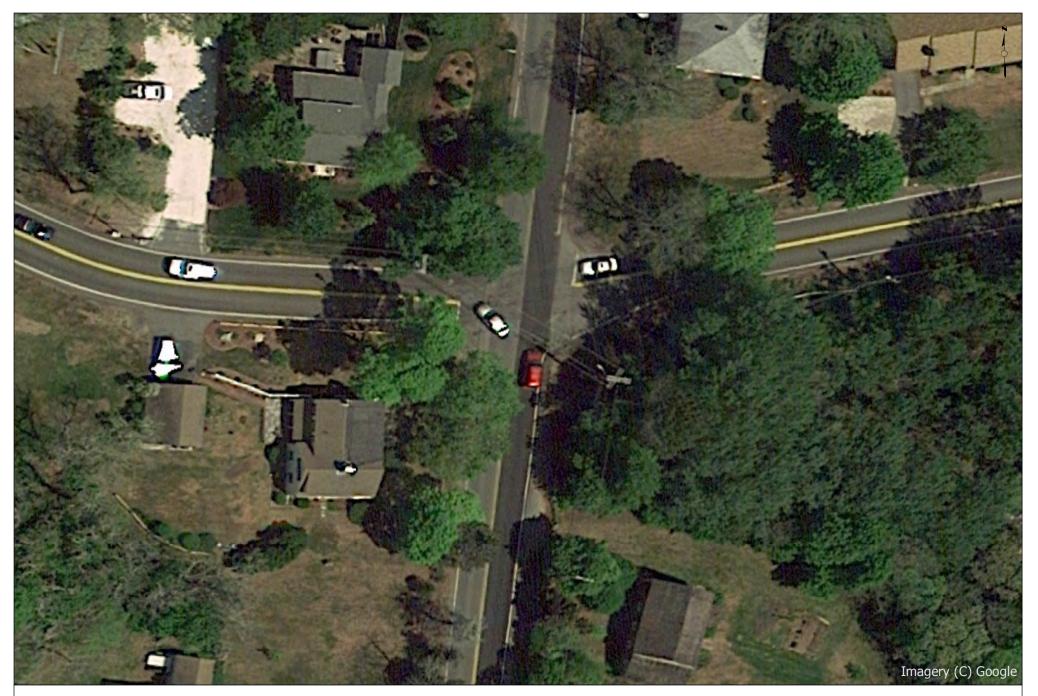
Figure 3 – Close Aerial View of Intersection

Figure 3 shows a close-up view of the intersection (imaergy from May 2015). All four approaches cosistet of a single multi-purpose lane. The westbound and eastbound Pleasant Bay Road approaches are stop controlled. There are no dedicated pedestrian or bicyclist accommodation.
