Documents for Continuance of the 4/20/22 Hearing on May 11

Project Address: 708 Main Street

**Application for Certificate of Appropriateness
Town of Harwich Historic District and Historical Commission**

**Historical
Residential Renovation
Schematic Design**

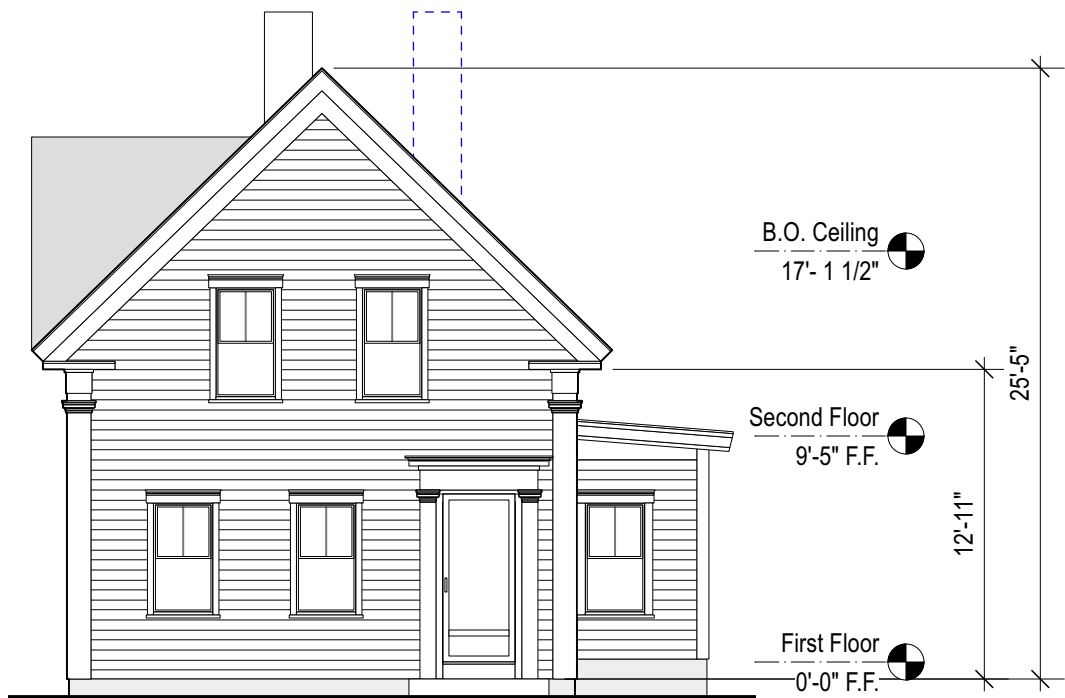
1 Existing South Elevation
Scale: 1/8" = 1'-0"

Note:
1. Remove flower box holders

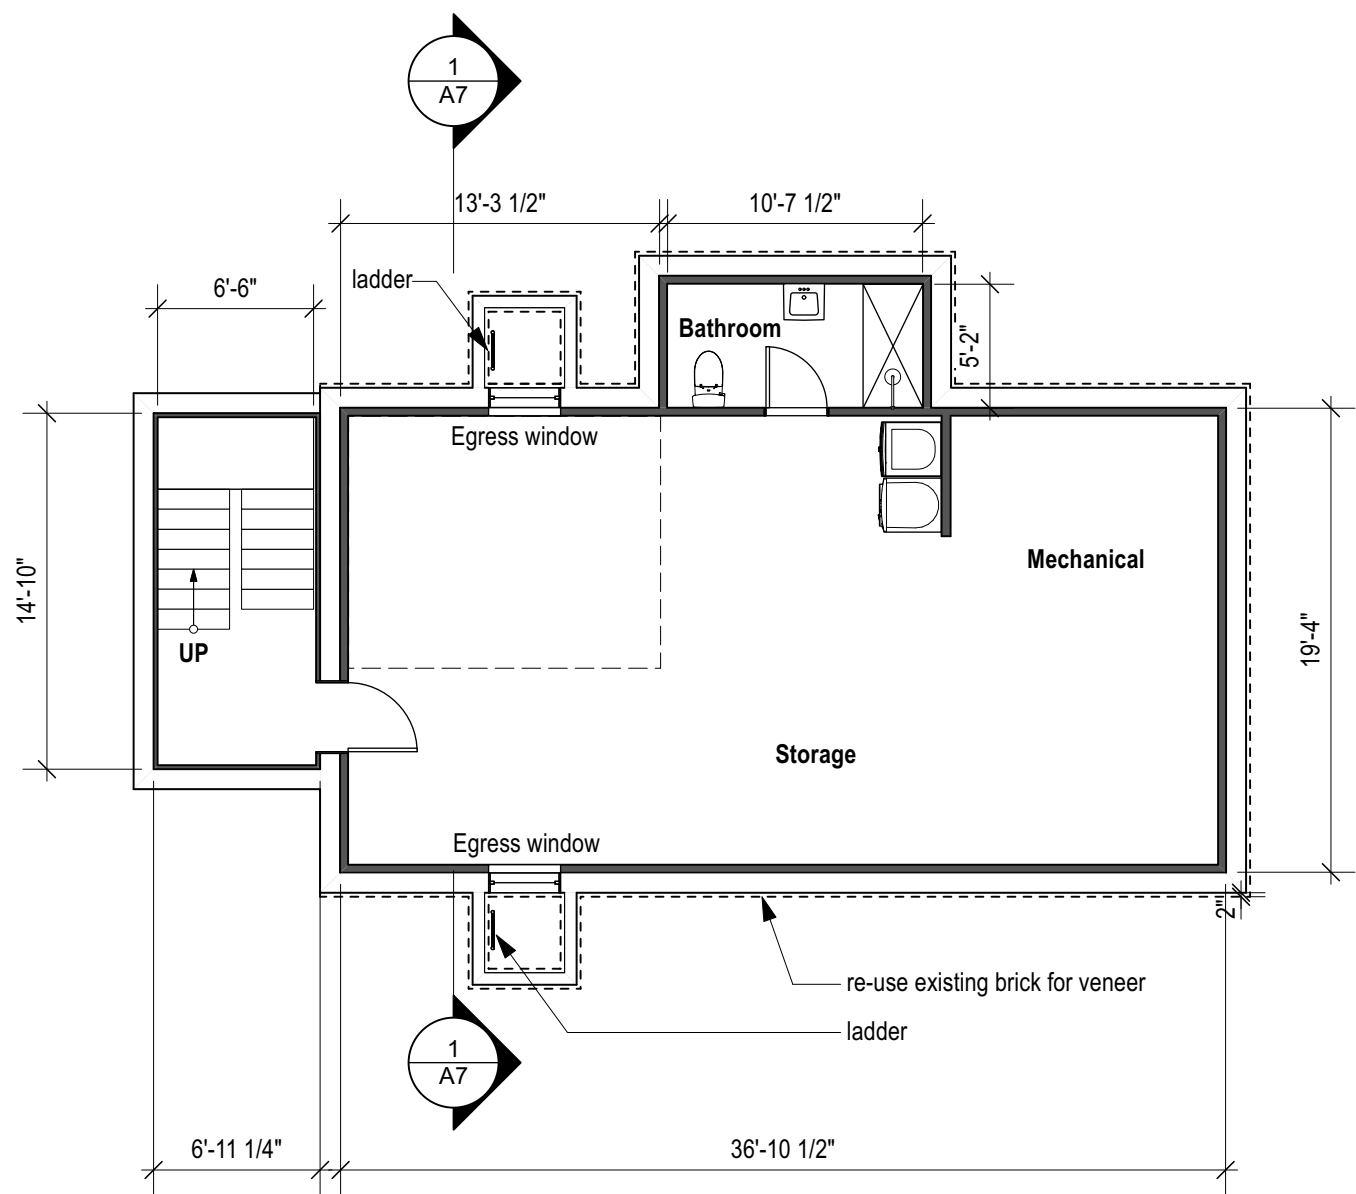
1 Proposed Basement Floor Plan
Scale: 1/8" = 1'-0"

Note:
Dimensions need to be adjusted

2. Constructing a new poured concrete foundation with a concrete slab and basement area, replacing the unstable brick foundation.	We want to move forward with the new foundation wall as proposed. The concrete wall will be veneered with brick. We will salvage the existing brick and re-use as much as possible.

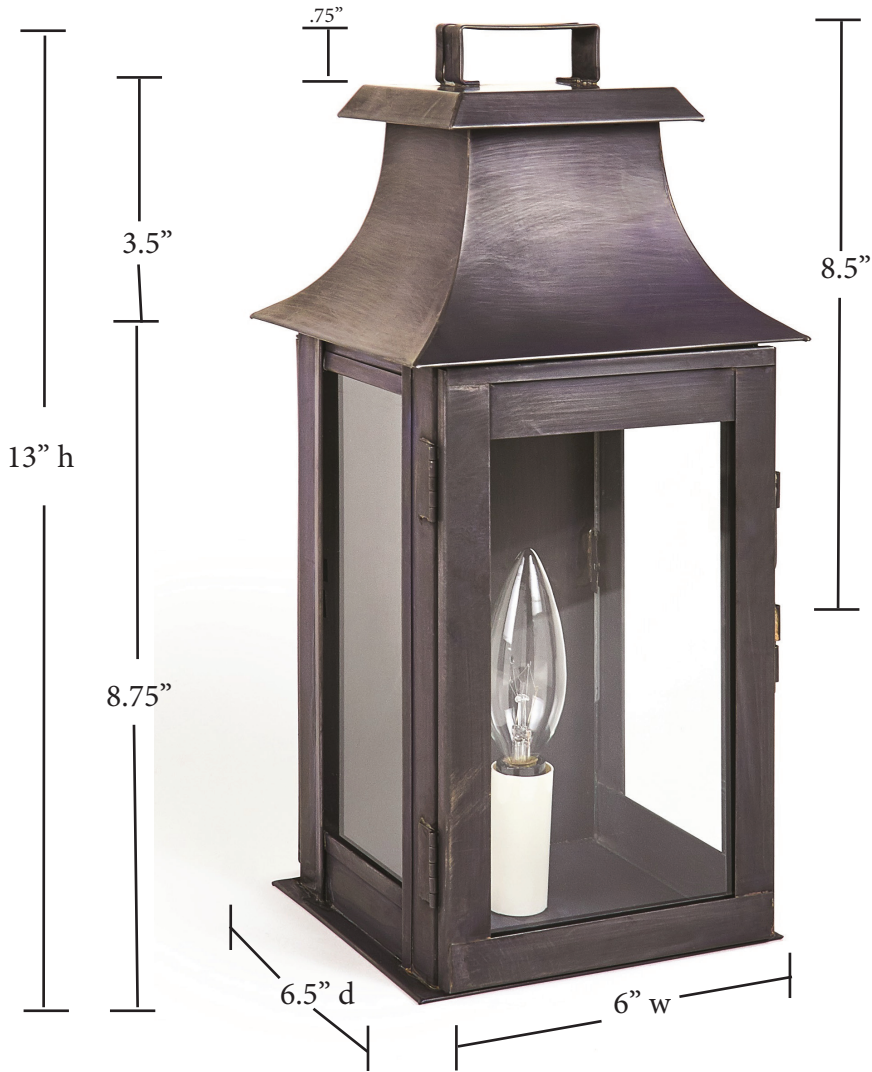
5611
Concord Collection
Wall Mount

Depth: 6.5"

Width: 6"

Height: 13"

(MED) Medium Base; 75 watt max
w/ (CIM) Chimney

(LT2) Candelabra Base; 60 watt max
2" candelabra sleeve

14. Light fixtures	We are proposing new light fixtures. See spec sheet.

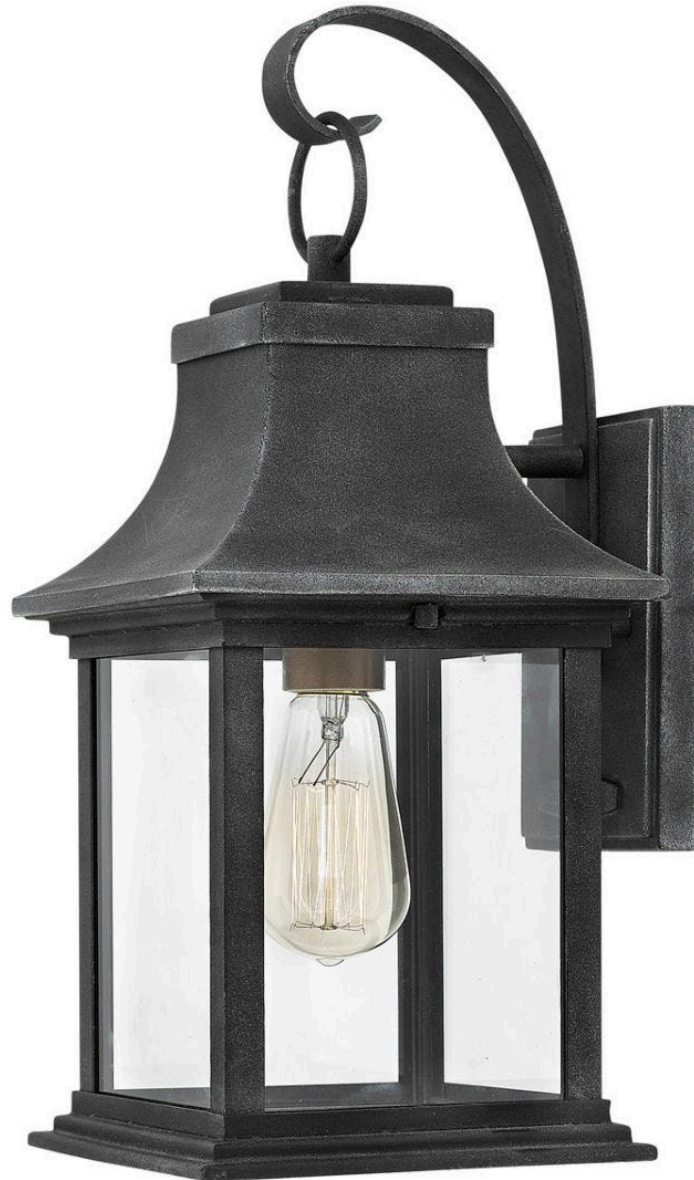
SMALL WALL MOUNT LANTERN

Inspired by the early American coach lights popular throughout New England, Adair features a clean and stately form composed of hardy aluminum. An Aged Zinc finish accented by either Heritage Brass or Antique Nickel candle sleeves is complemented with robust construction details.

WIDTH: 7.5"

HEIGHT: 16.5"

WATTAGE: 1-100w Med.

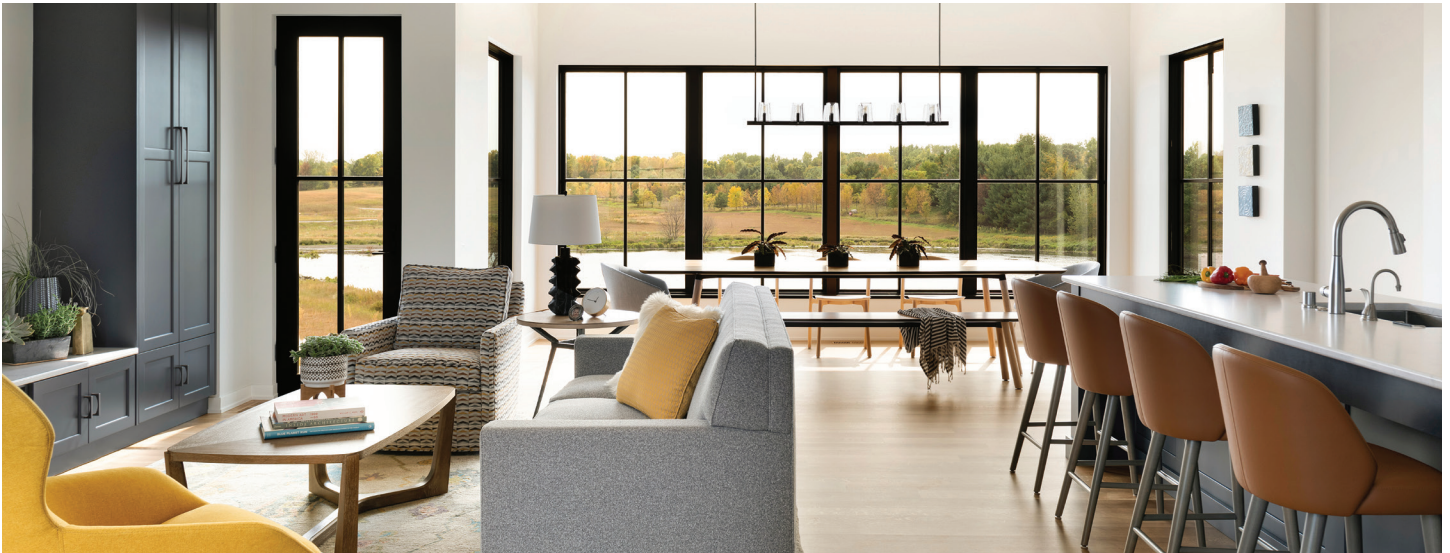
FULL DIVIDED LIGHT

For an authentic look, full divided light grilles are permanently applied to the interior and exterior of the window with a spacer bar between the glass.

Full Divided light with energy spacer has grilles that are permanently applied to the interior and exterior of the window. The narrow spacer bar minimizes transfer of heat and cold to the interior surface, improving the overall thermal performance. Products will have the same U-Factor, SHGC and visible transmission as they would with simulated divided light grilles.

Simulated divided light offers permanently applied grilles on the exterior and interior with no spacer bar between the glass.

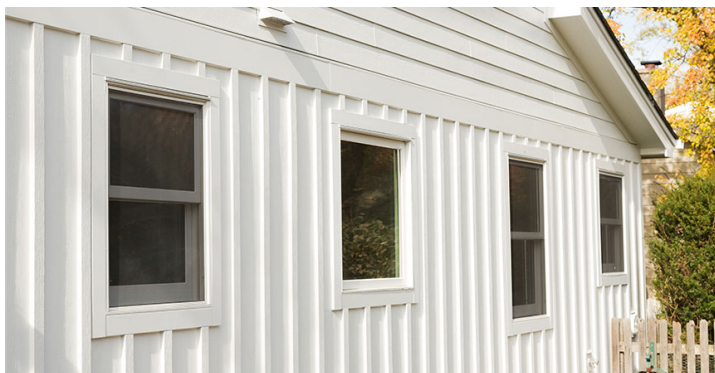
Prefinished white vertical siding, board and batten as shown in picture below.
