# PHASE I ENVIRONMENTAL SITE ASSESSMENT LIMITED PHYSICAL TESTING

5 Bells Neck Road Map 10 Parcel G1 West Harwich, MA 02671 Project #BEA10-10288

**DECEMBER 14, 2010**

# **BENNETT ENVIRONMENTAL ASSOCIATES, INC.**

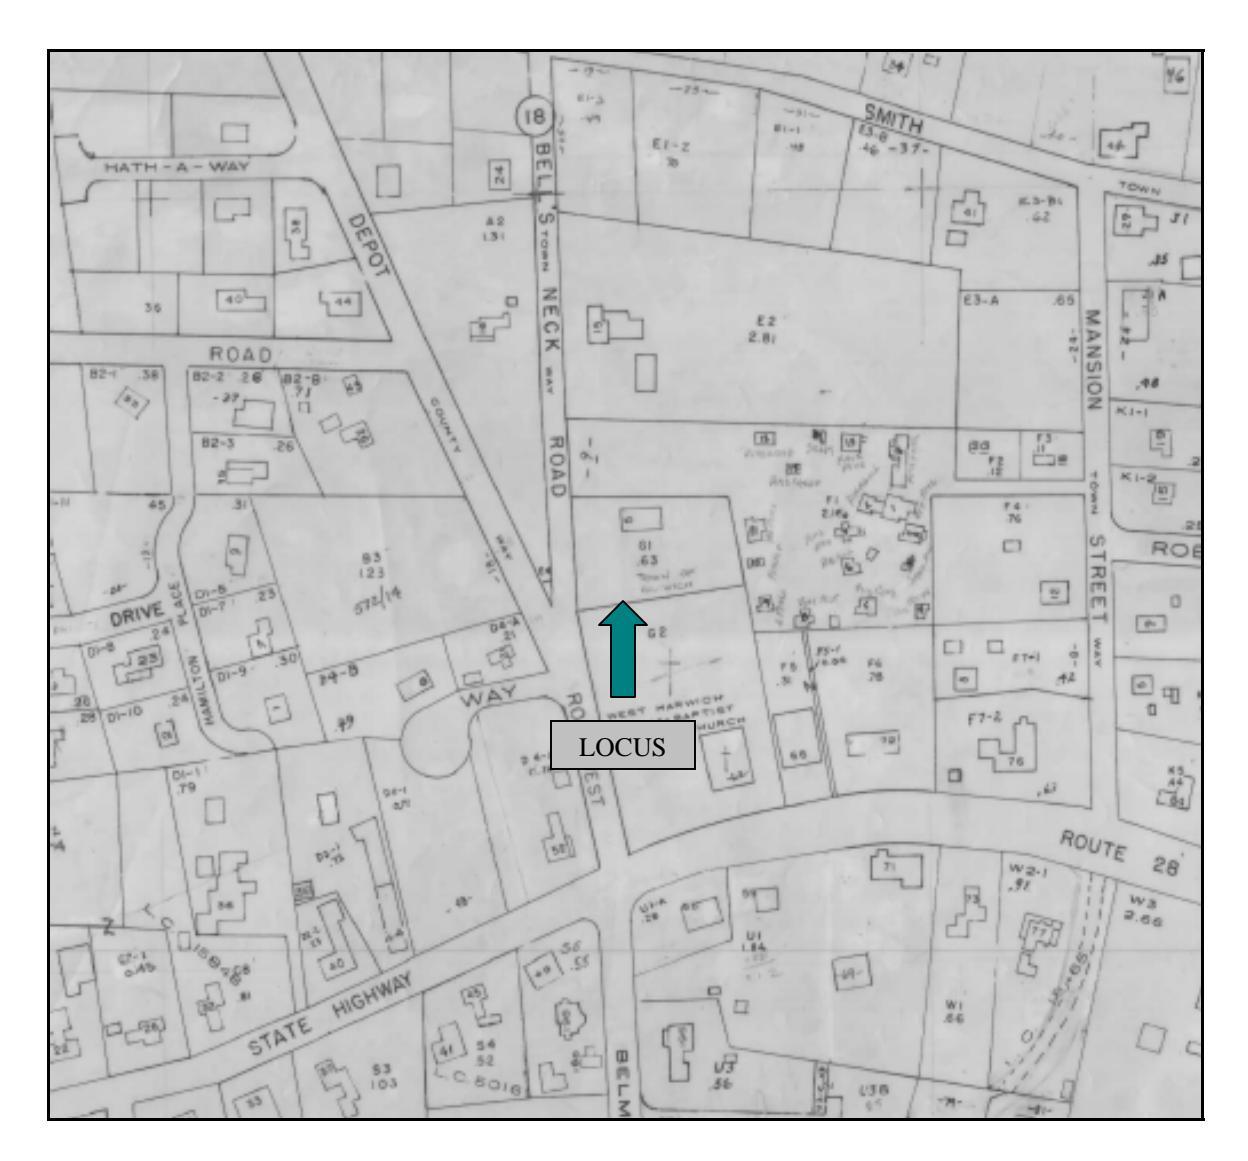
**FIGURE 2:** The Subject Property contains 29,600 SF of land area located at 5 Bells Neck Road in West Harwich, MA.

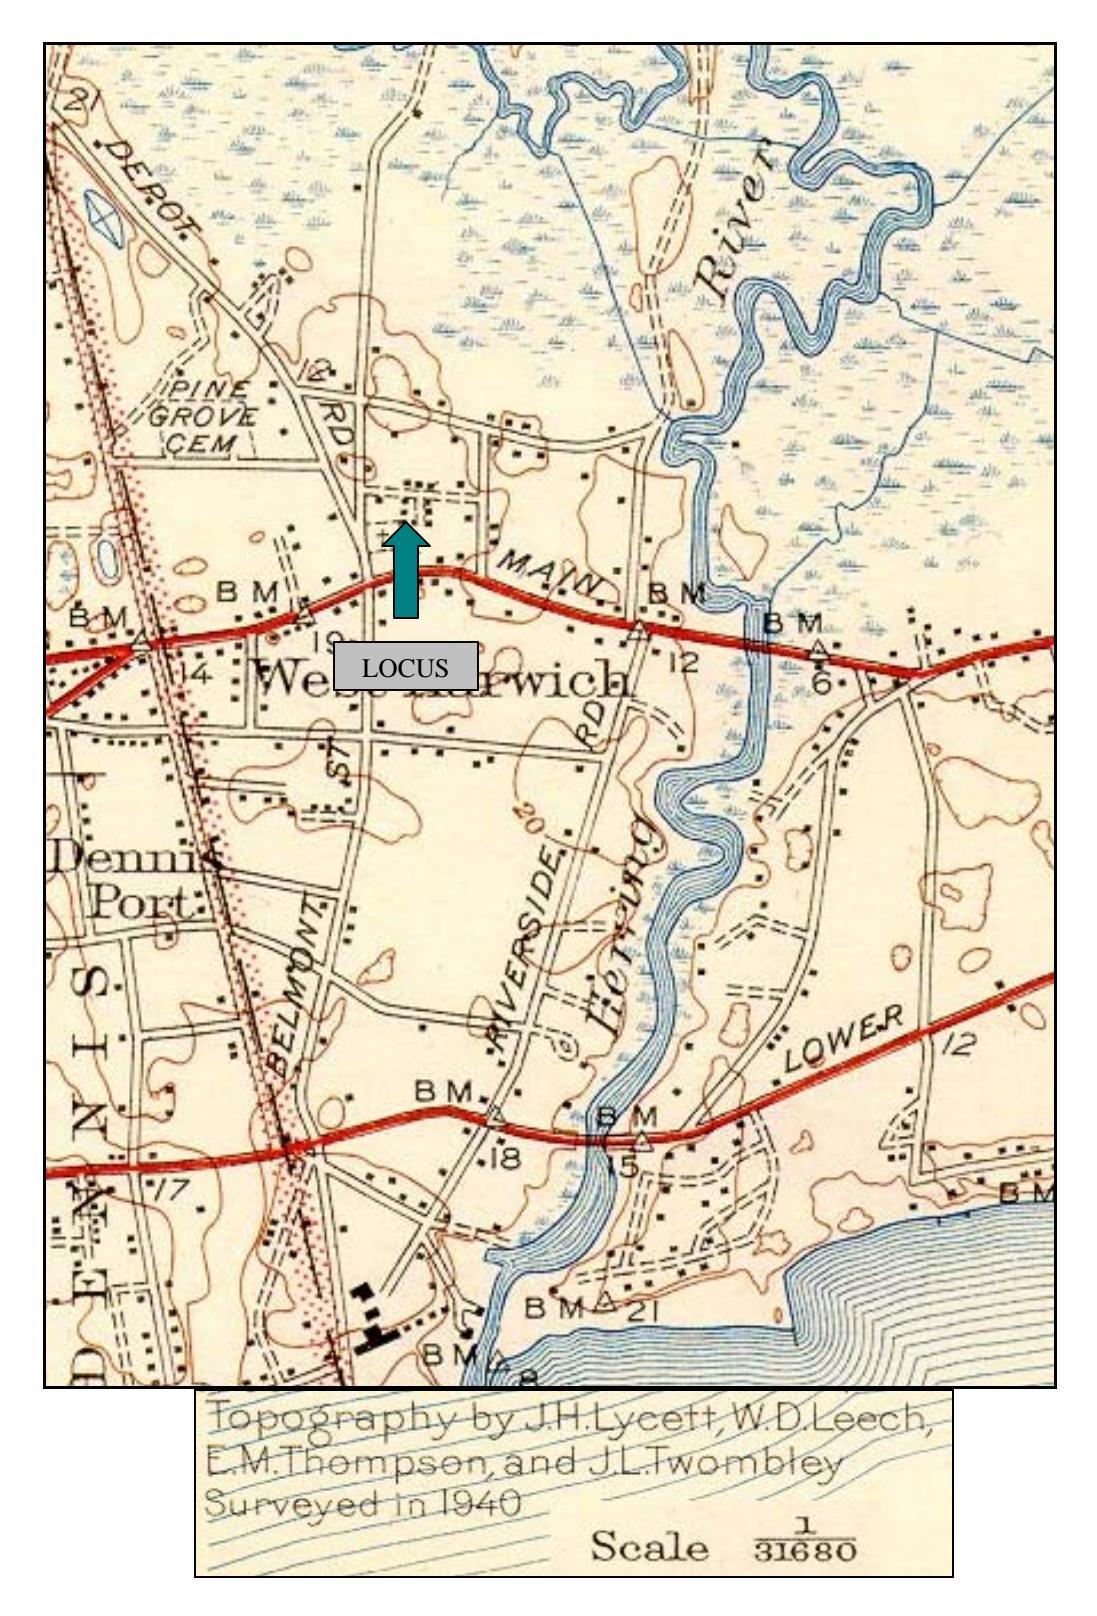
**FIGURE 3:** Review of a historical topographic map surveyed in 1940 shows the area of the Subject Property as developed at that time, as is consistent with information that the subject building was constructed in the 1870s. Topographic data in the 1939 mapping is consistent with that of 1998.

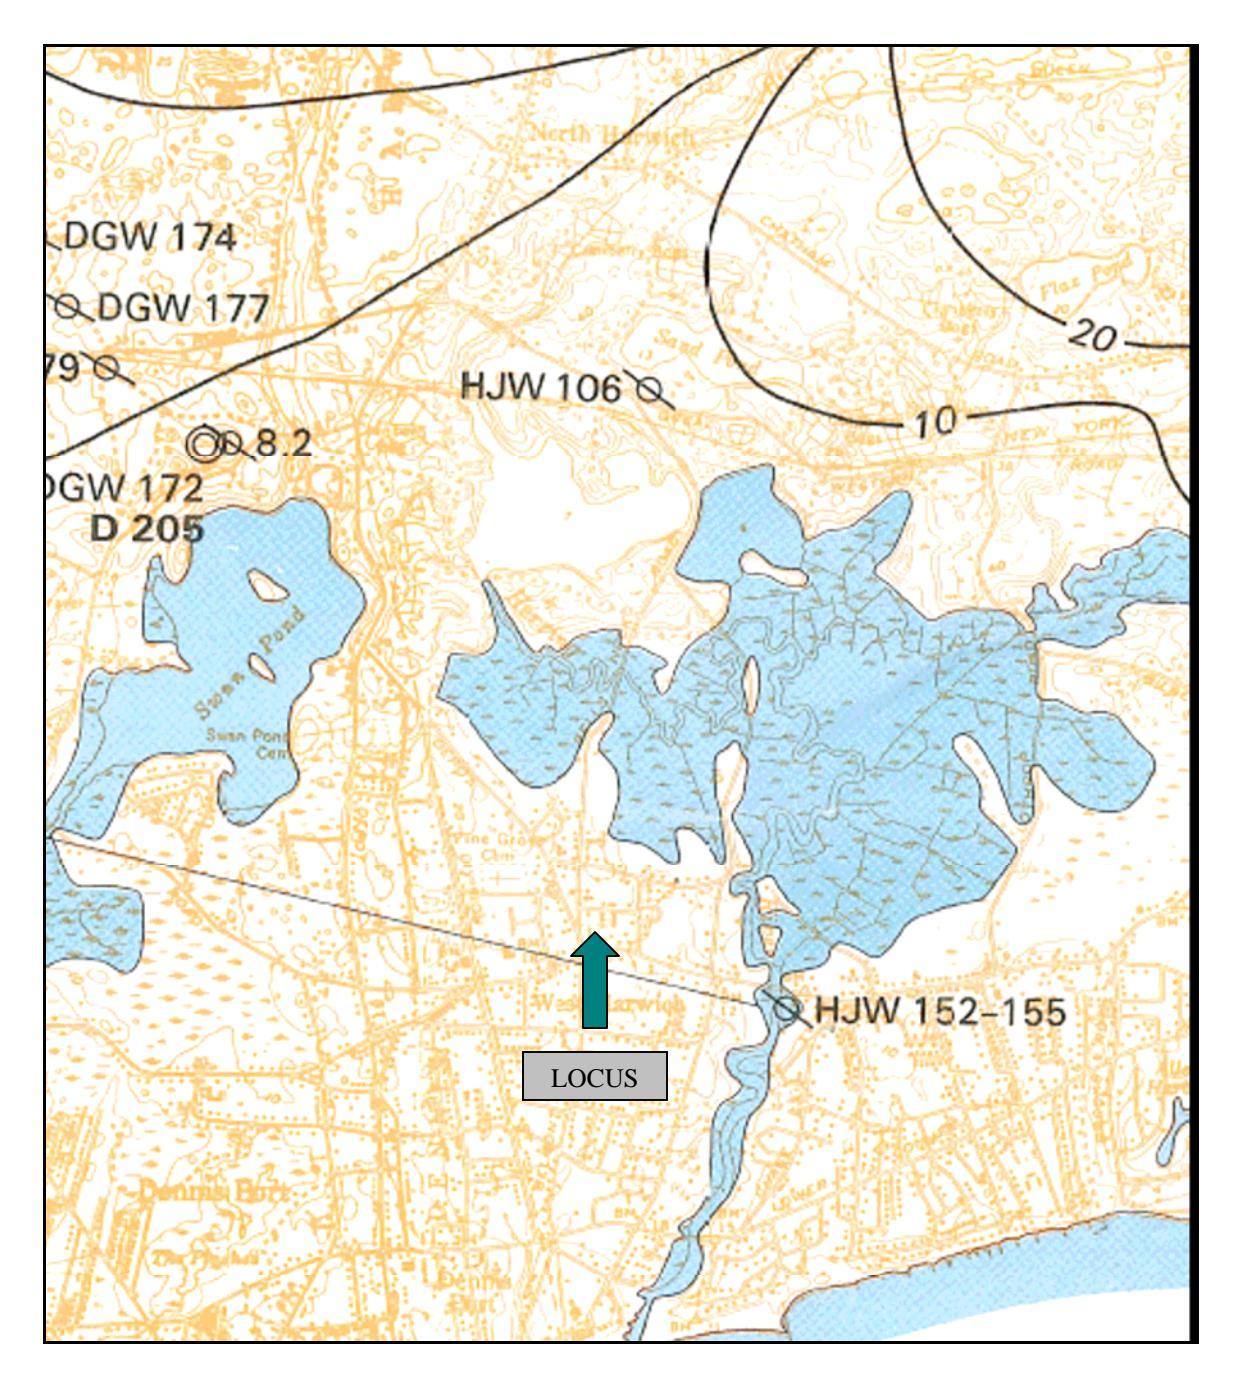
**FIGURE 4:** Groundwater is estimated at approximately 8' below grade surface (bgs)+/-. Regional groundwater contours illustrate a northeasterly flow direction.

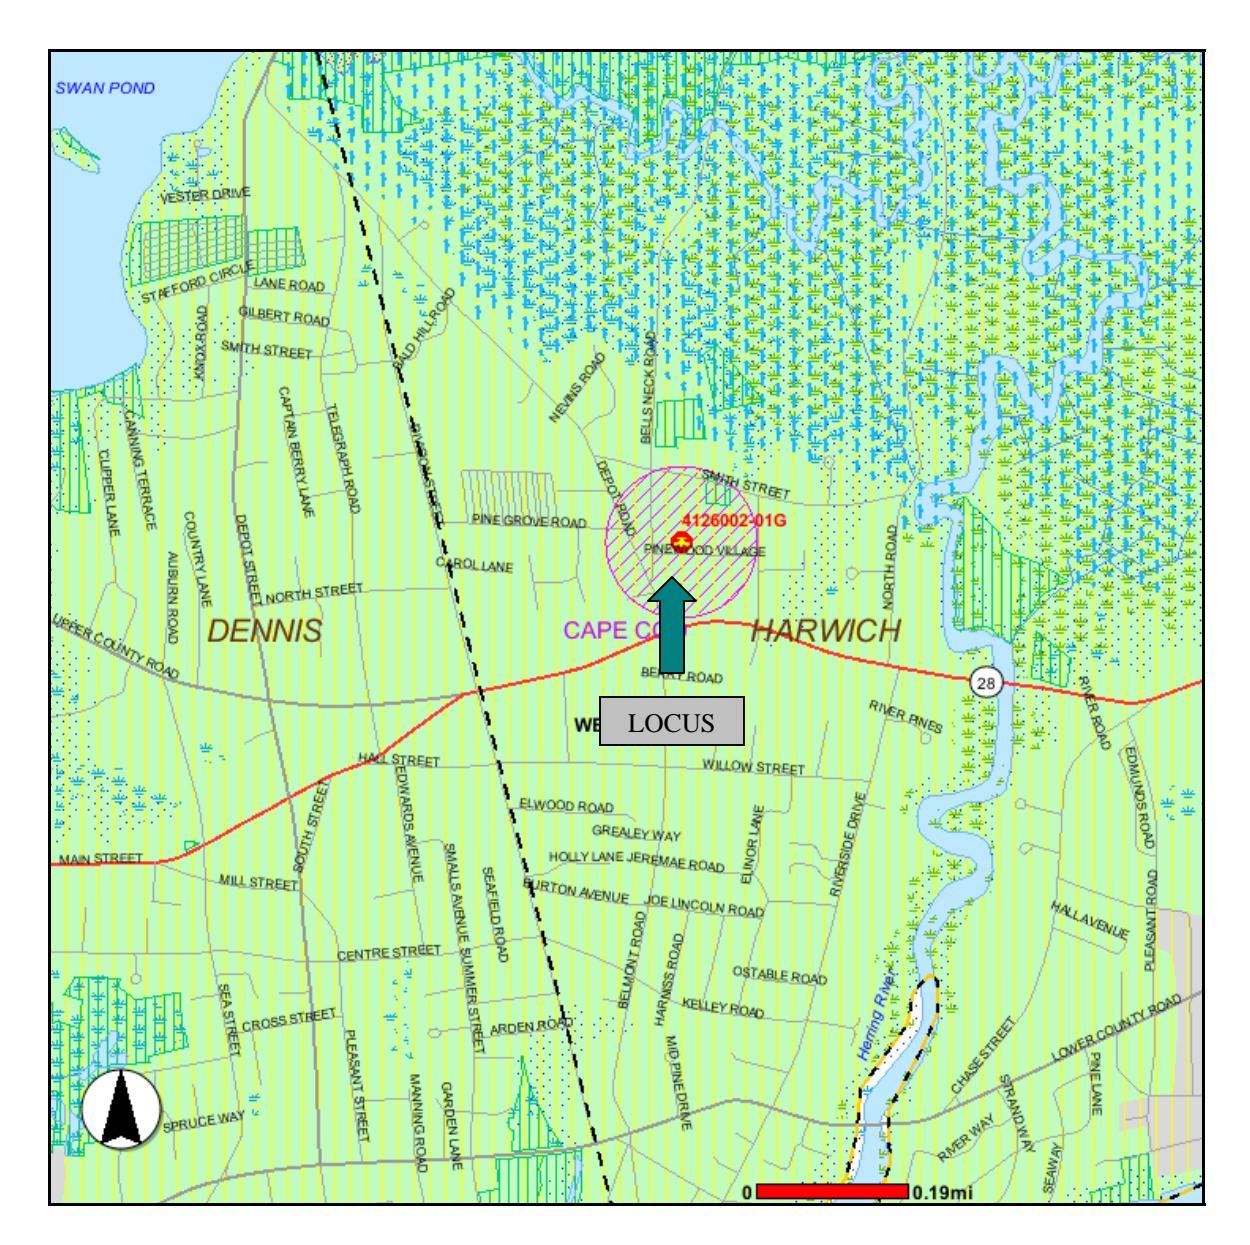
**FIGURE 5:** According to the MA DEP Priority Resource mapping, the Subject Property is located within a medium yield Potential Drinking Water Source Area (PDWSA). The property is within an Interim Wellhead Protection Area (IWPA) based on the presence of non-community public water supply #4126002-01G. As such, the RCGW-1 Reportable Concentrations are applicable for groundwater quality, as are the GW-1, GW-2 and GW-3 groundwater criteria under Method 1 - Risk Characterization in consideration of routes for potential exposures associated with ingestion and dermal contact. Additionally, based upon site features, the RCS-1 Reportable Concentrations are applicable for soils, while the S-1, S-2, S-3/GW-1, GW-2 and GW-3 soil categories are considered applicable relative to frequency/intensity of use and accessibility in Method 1 - Risk Characterization. This criterion is used to determine notification and/or remedial response liabilities pursuant to 310 CMR 40.0000.

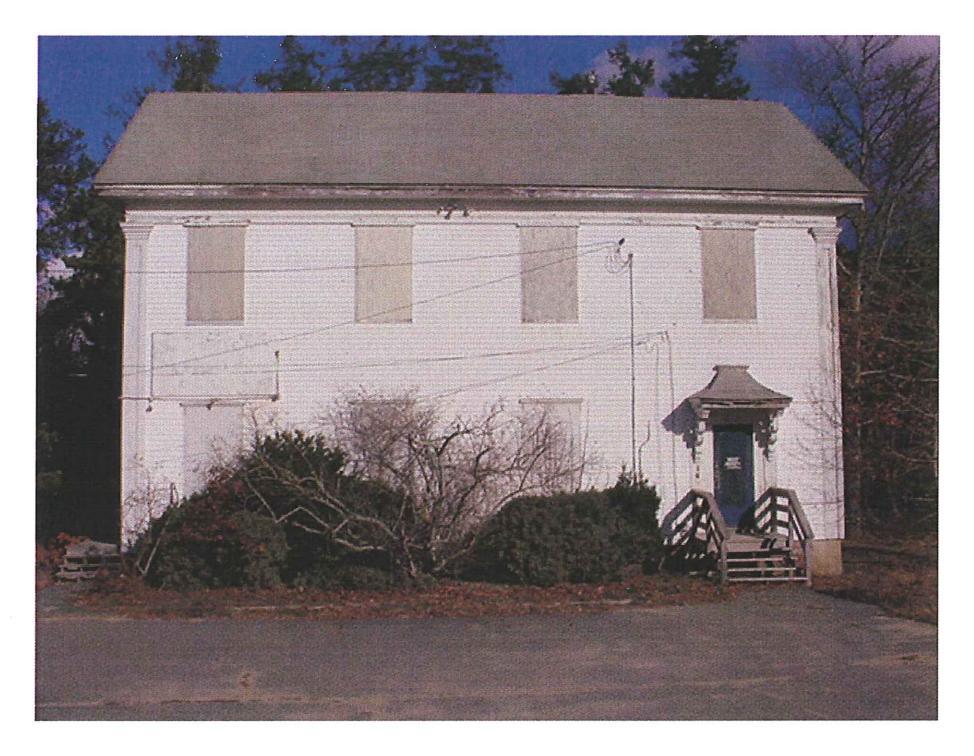
View of the unoccupied subject building facing north

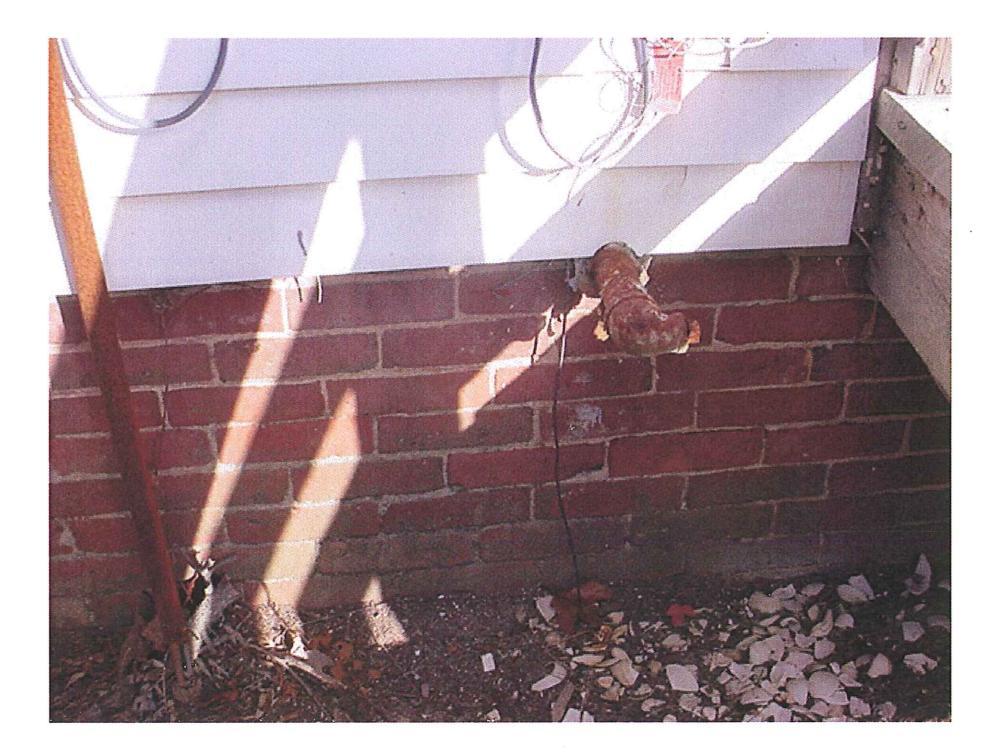
The subject building is currently vacant and therefore not heated, though overhead and wall-mounted natural gas heaters were observed in the common rooms and kitchens on the first and second stories of the building. The gas meter was observed as removed and the line capped at the time of the site inspection conducted.

View of the capped natural gas line

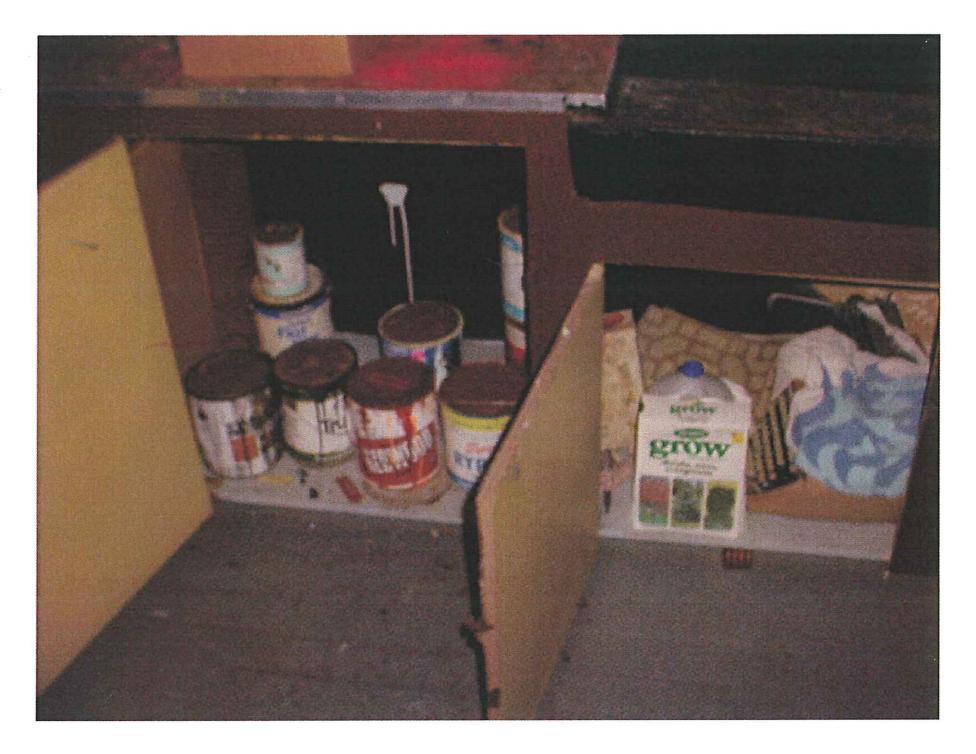
Small quantities of standard cleaners and building maintenance products were identified at the Subject Property at the time of inspection, as stored beneath the sink in the kitchen, located on the second story of the subject building. All materials appeared to be properly stored with no evidence of release. No stained surfaces were observed at the time of the inspection.

View of the storage of maintenance and cleaning products

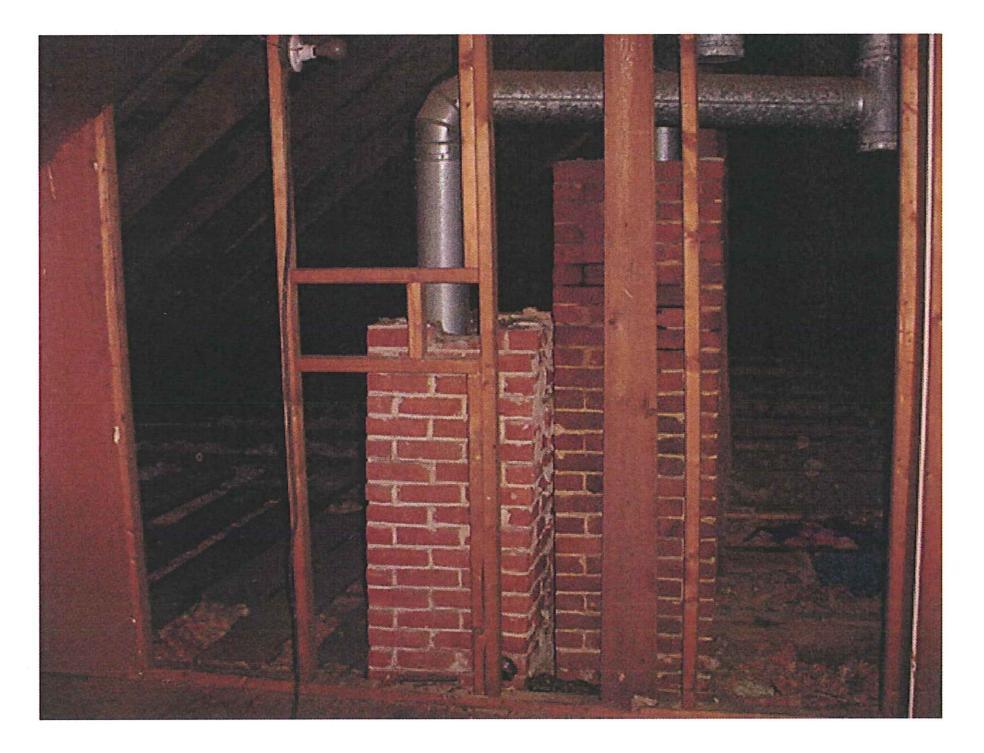
View within the attic of the subject building

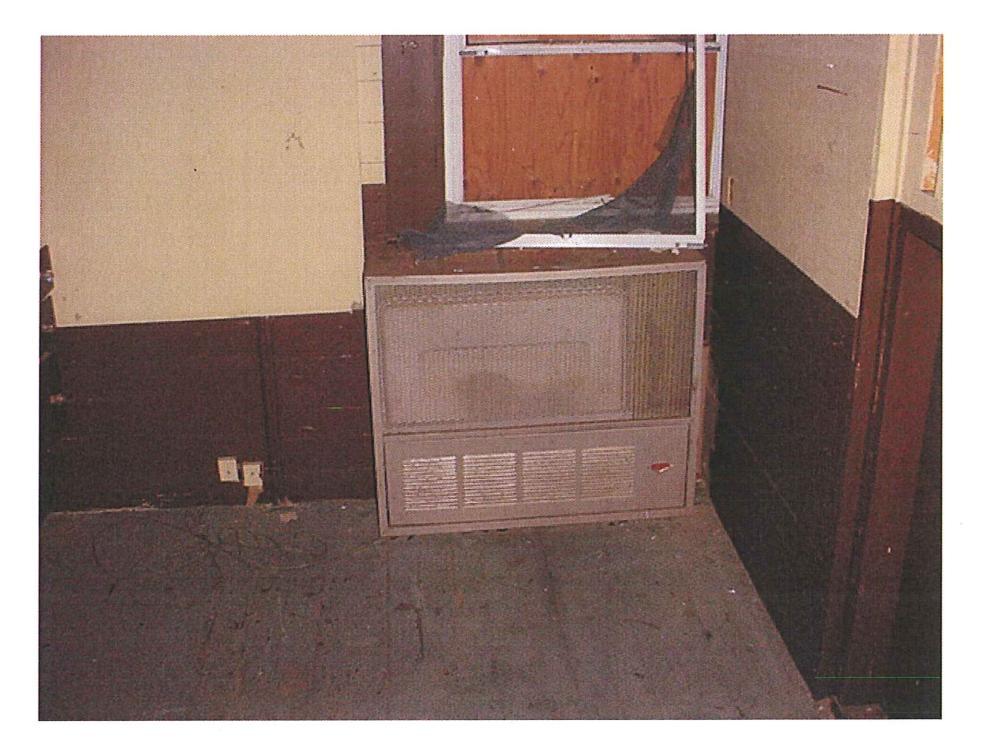
View of a wall heating unit within the subject building

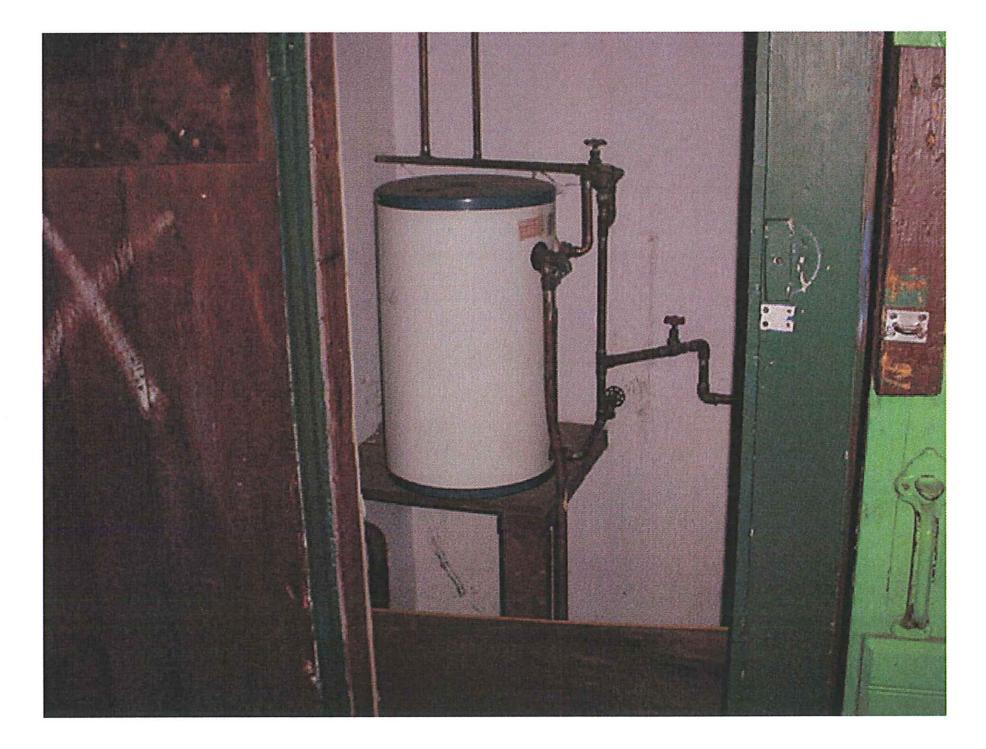
View of the hot water heater

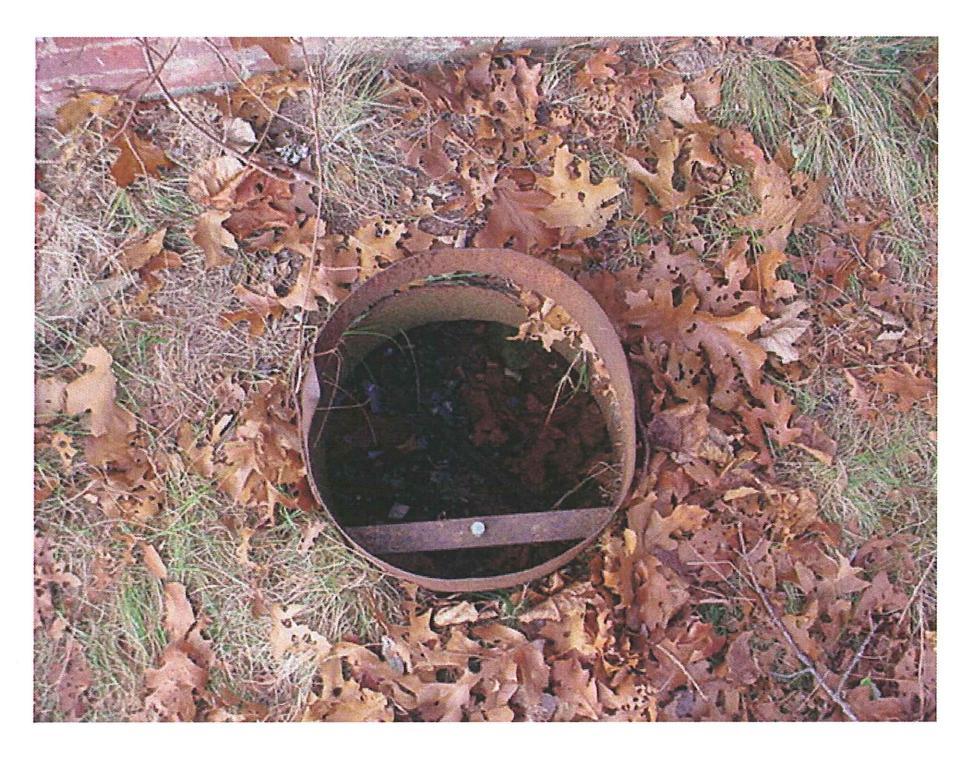
An unidentified metal ring was identified on the exterior of the Subject Property at the time of the inspection conducted. A shovel was used to remove soil from the area of the object which drops into a large subsurface metal box which appears to extend beneath the adjacent foundation wall. Wherein this object could not be identified, it is noted as a **PEC** for which recommendations are made.

View of unidentified metal debris

The inaccessibility of the crawl space basement is noted as a Limitation to this investigation. The inability to fully investigate and identify the metal object adjacent to the chimney at the subject building is noted as a Limitation to this report. Finally, the selling price of the Subject Property was not reviewed relative to real estate values in the area. Such work should be conducted by the user's attorney prior to purchase.

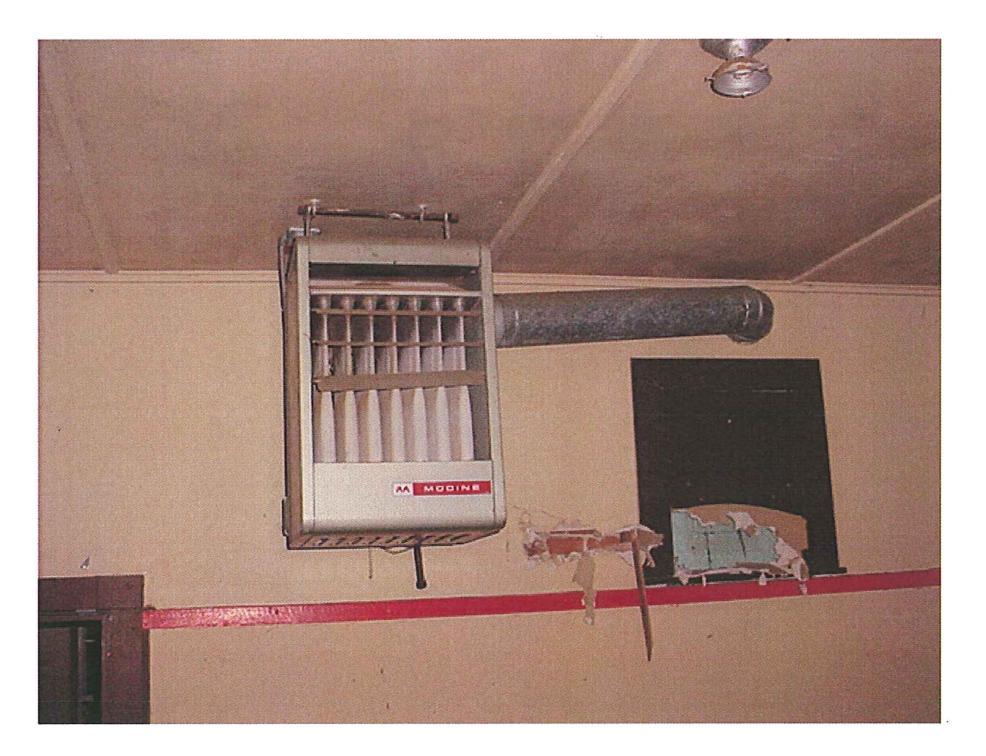
View of an overhead heating unit within the subject building
