**BOARD OF WATER & WASTEWATER COMMISSIONER'S**  
**MEETING AGENDA\***  
**Harwich Water Department, 196 Chatham Road, Harwich MA**  
*Thursday, March 23, 2023*  
*11:30 a.m.*

**MINUTES**  
**HARWICH WATER DEPARTMENT**  
**BOARD OF WATER/WASTEWATER COMMISSIONERS**  
Thursday, March 9, 2023  
11:30 a.m.

### Pleasant Lake Water Storage Tank

HARWICH WATER DEPARTMENT  
PLEASANT LAKE TANK 2022 ANNUAL INSPECTION

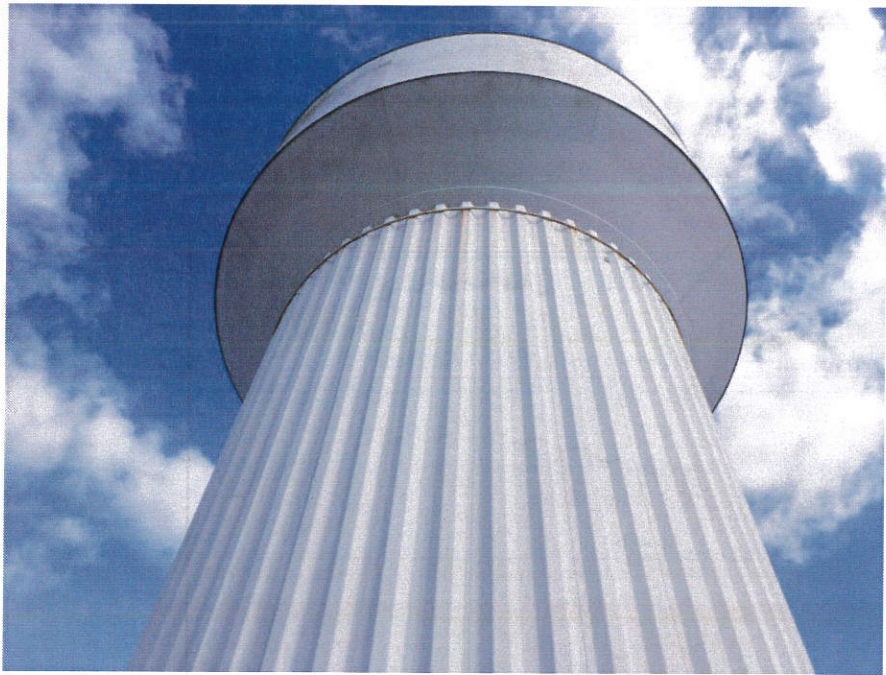
<b>Photo No.</b> 11

<b>Photo Date:</b> 11/15/22	
<b>Site Location:</b> Pleasant Lake Tank	
<b>Description:</b> Full tank	
<b>Photo By:</b> MBK

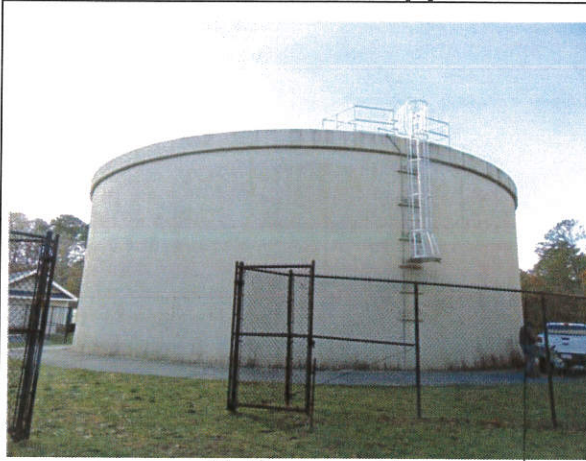
1) Tank overview

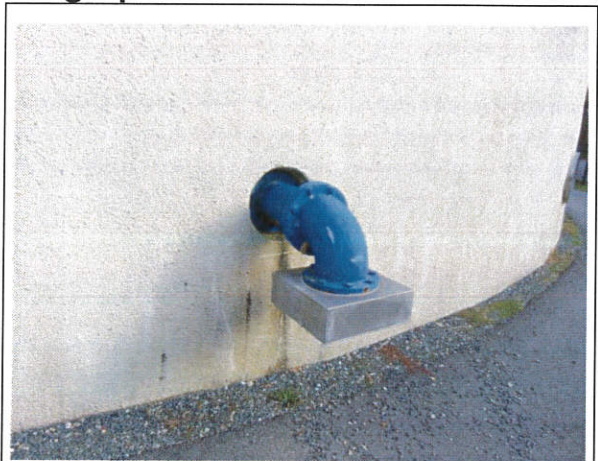
4) Overflow pipe tank termination

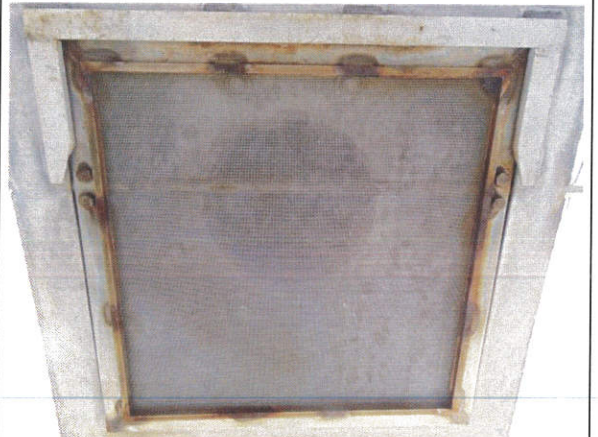
5) Fine mesh protective overflow screen

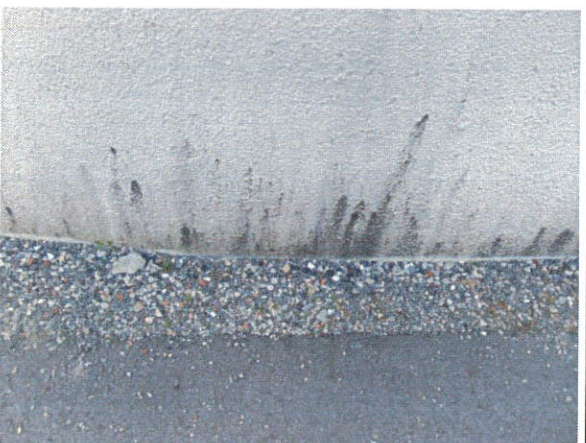
3) Where tank shell enters grade

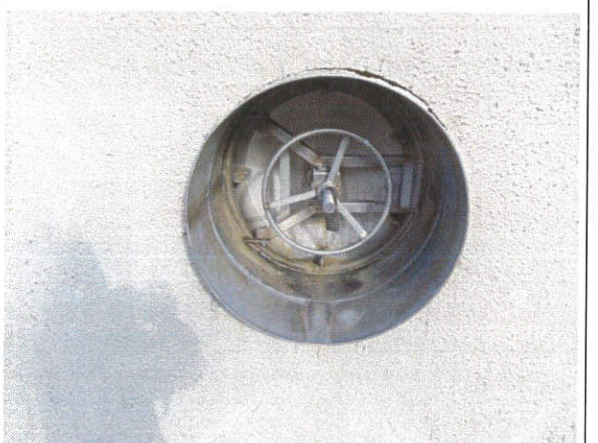
6) Pressure relief style manway

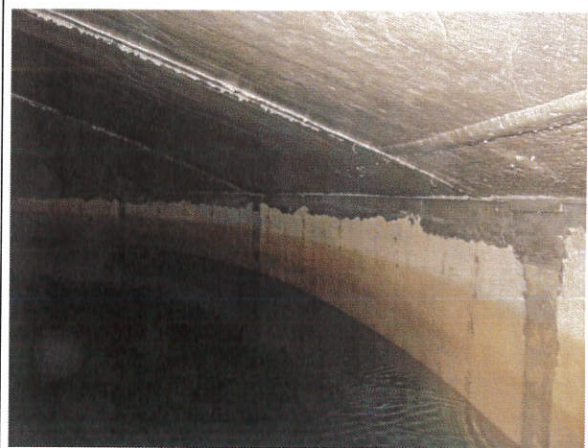
12) Roof to shell intersection

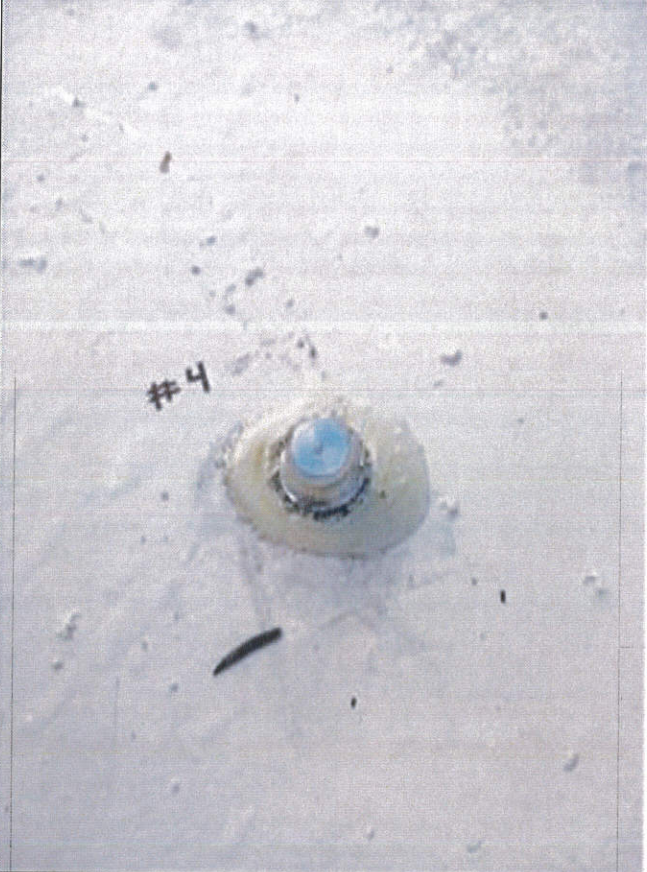
No	Description	File Attachment
3.	Dolly glued on roof prior to ASTM D4541 adhesion test

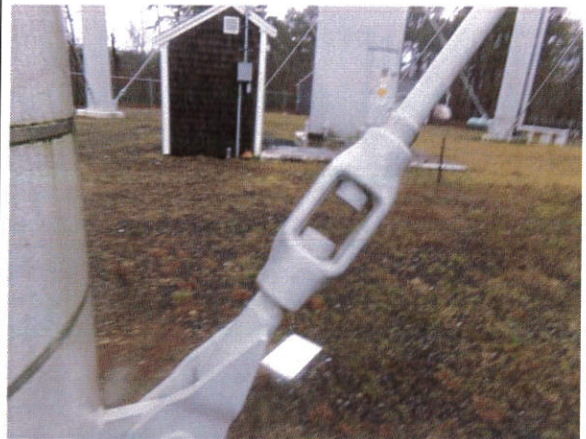
4) Typical turnbuckle connection

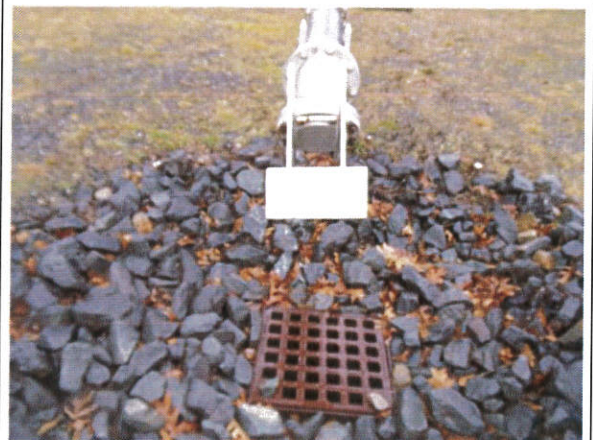
10) Overflow termination with grate for drain

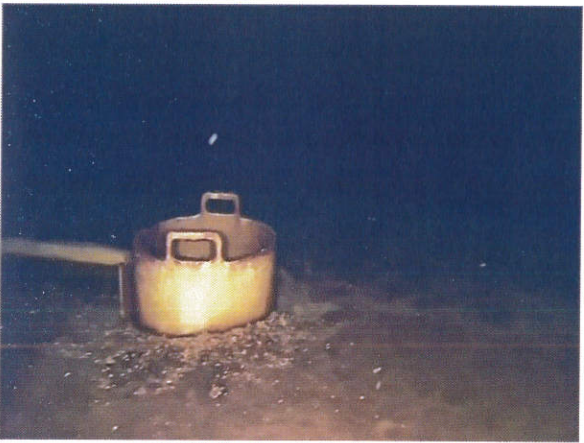
27) Inlet/outlet pipe 21:29

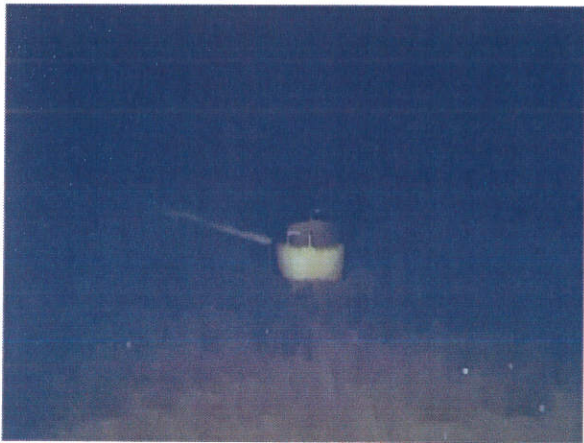
28) View of floor sediment 21:57
